# CORDIA MEDAN

## Project Site Visits ~ Aceh

### Leprosy Communities at Trienggadeng and Po Diamat Villages

Indonesia  
March 2007

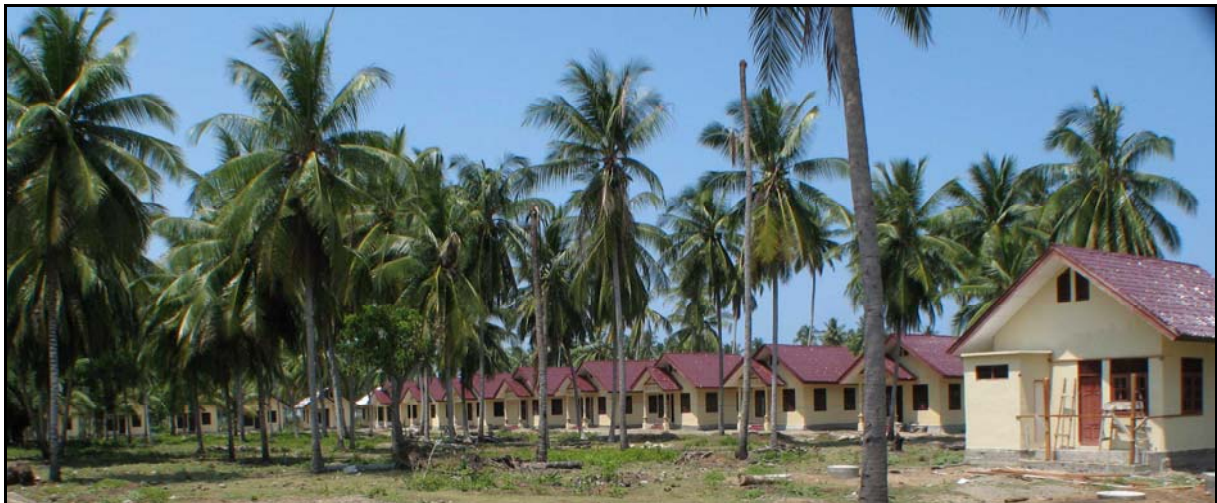
Overview of Trienggadeng Village

The houses of Trienggadeng village are situated in a U-shape around a central park area with coconut trees (left in photo above). The total land area is four hectares, with the individual plots measuring about 10 m x 20 m. The distance from the sea of the line of houses shown in the middle of the photo above is not very great. The house on the far right is located in the second row of houses. The houses seen behind the coconut trees (left) are in a line perpendicular to the coast. The possible recurrence of a similar, large-size tsunami has not really been considered as the land is only slightly above the high seawater line. Along the coastline, a small dike has been created to protect the village from small tsunamis.

*Apart from the small dike on the coast, four other measurements can be taken to improve disaster preparedness for this site.*

- 1) Dense plantations should be realised between the shoreline and the houses.*
- 2) No extensions should be built between the houses, obstructing the flow of onrushing seawater.*
- 3) No fences or barbed wire barriers should be erected in between the houses, blocking escape routes towards safer locations.*
- 4) An elevated construction or communal building on columns should be erected in a central location with easy access from all sides. The ground floor columns of that building should be self-supporting and have no infill walls.*

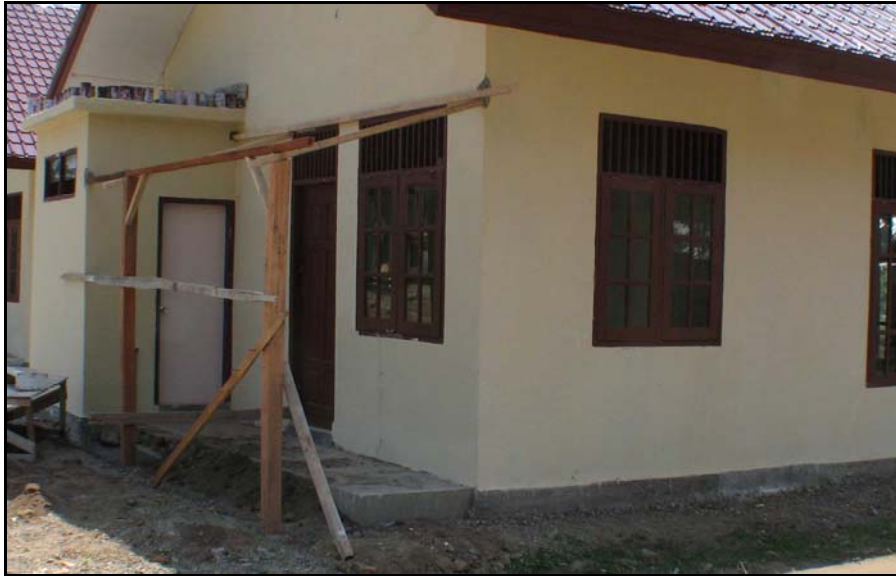
Kitchen Extension at Rear of House

The 59 houses, some with wheelchair ramps for the disabled, are almost completed. It has been decided to add a kitchen on the rear platform of the houses, next to the WC, because the occupants (ex-leper patients) would have no financial means to realise this themselves. The kitchen extension has been designed with a wooden post and a masoned wall. The timber roof support has been fixed with a nail into the plaster of the house. However, with an earthquake, this will come loose immediately. In addition, the joint between masonry and timber post will always remain visible.

*The kitchen extension should be made by using a masoned wall with an infill stiffener column of 10 cm x 10 cm (instead of the wooden posts). Over the top of the wall, a reinforced concrete stiffener beam 10 cm x 6 cm thick should be cast with two 10 mm bars. These two bars need to be connected into the reinforced columns of the building by opening the concrete and filled in after attachment.*

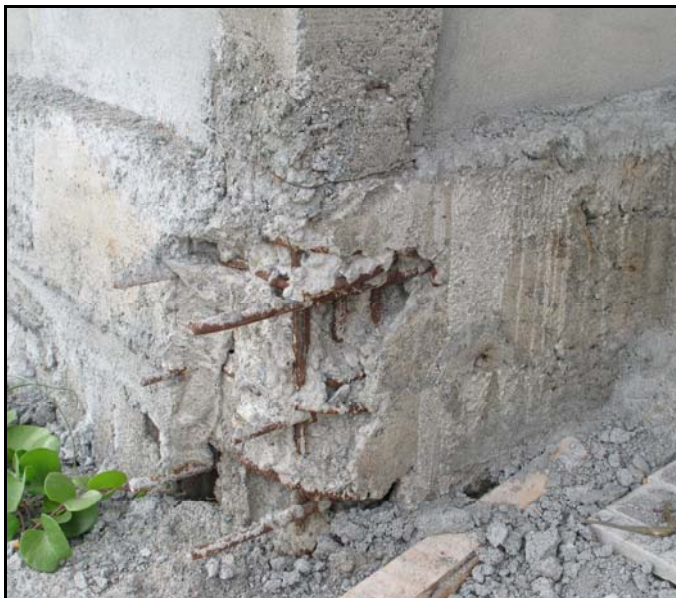
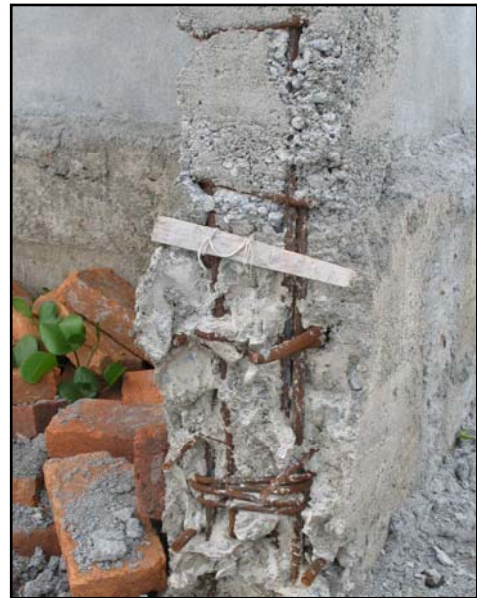
The reinforcement of the foundations in the above photos (houses very near to the Aceh east coast) is not adequately covered with good quality concrete. In addition, the plastering will not provide sufficient protection against the salty sea air. Such construction quality will self-destroy due to corrosion.

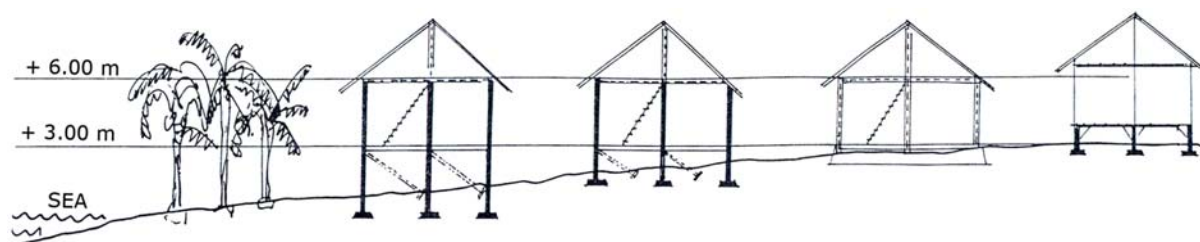
One of the lessons learned from the 2004 tsunami is that houses built on columns (stilts) are safer than houses built directly on the ground. The height of the floor above the average sea level and the distance from the shore determines the safety of a house and its occupants. The Po Diamat location is very vulnerable, being low, flat open land. With the current one-meter elevation above the soil level, this height provides sufficient clearance for common flooding or a small tsunami. However, considering the height of the past tsunami in the reconstruction zone, the height of the first floor should have been preferably three meters above the average sea level.

The coastal soil in Po Diamat between the surrounding fish tanks has shifted regularly over the years and is rather sandy. While the 13-column structure seems to be adequate, the footings under the columns are only 60 cm x 60 cm, giving doubt to their bearing capacity in the sandy soil. During a prolonged earthquake, the sandy soil can easily settle under the small footings, with a destructive result. Neither the heavy floor ring-beams nor the 12 cm thick reinforced concrete floor may be able to withstand the settlement of a few columns and crack. The one-meter depth of the column footings, however, is adequate against scouring by moving water.

*The column footings on the sandy soil along the coast should be minimal 80 cm x 80 cm.*

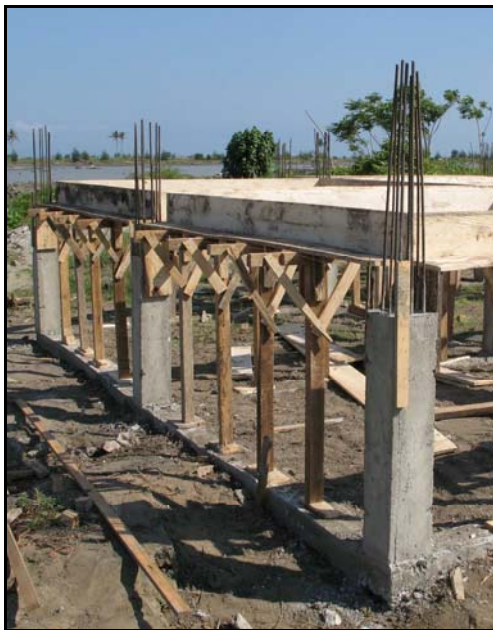
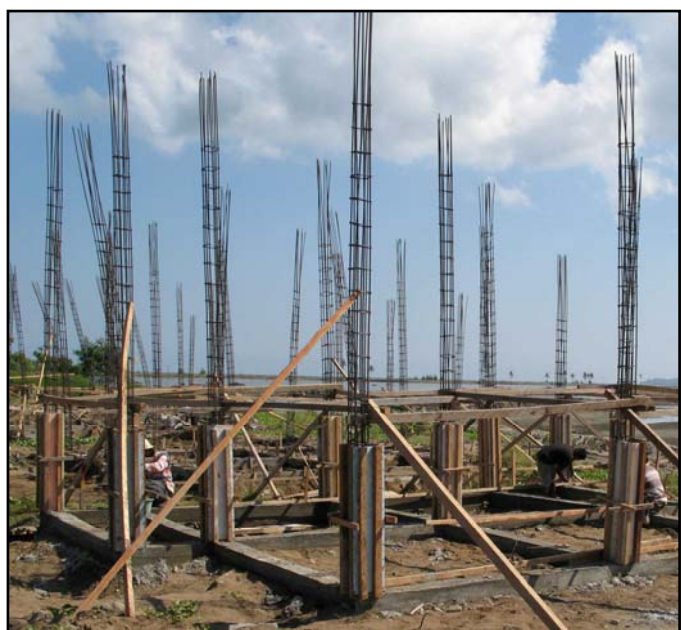
The foundation columns continue structurally into the columns of the first floor. In one construction site (left photo below), the reinforcement bars stop about one meter above the floor level, while the second contractor (right photo below) has placed the complete vertical reinforcement as one piece. Although the later requires some temporary support, this design is better as it does not require overlapping of the reinforcement bars in the base of the columns above the floor, thus saving steel reinforcement.

*The reinforcement of the columns should be in one piece, where possible, to minimise overlaps.*

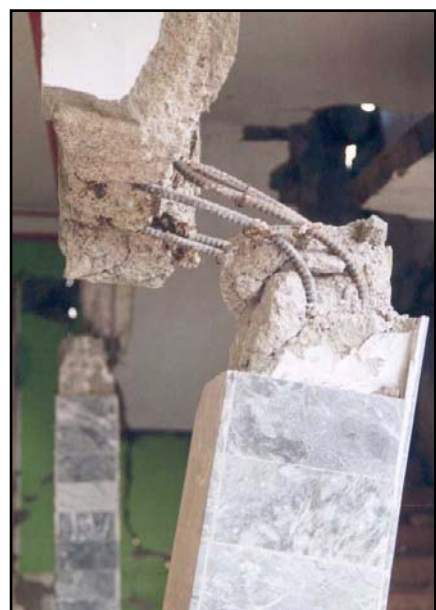
Typical Column Failure – No Stirrups

Observation on photo – page 12 (bottom right): At the vital maximum moment zone, there were insufficient stirrups. As a result, the concrete crumbled and fell out during an earthquake. The sketches below explain the process of failure during one shock. In reality, a series of shocks occur during an earthquake, continuing the described process and resulting in the column collapsing and with that bringing the house down.

Each column end should be reinforced with a cage of stirrups at its maximum moment zone to avoid broken concrete from falling out of the construction when earthquake forces exceed the design forces. This is especially the case when the floor beams are stronger than the columns. The column ends should therefore have 6 mm stirrups every 5 cm over a length of minimal 1.5 times the column width under the floor beam, followed by two stirrups 10 cm apart and then continuing with stirrups every 20 cm for the rest of the column.

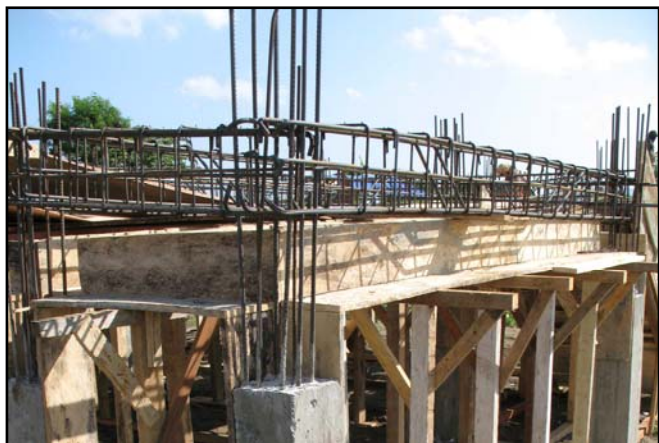
Observation: The eight reinforcement bars in the beam are not going around the 90° corner into the other horizontal beam section, but instead end with hooks inside the column. The eight hooks in the column, coming from two directions, totally congest the space inside the column. When casting the column with concrete, air pockets will be created. Because of the inadequate length of the hooks, the junction will be far below the required structural strength. The situation is aggravated in two other corners because two additional bars were added.

The strength of the beam-column junction depends on the continuity of the bars from one beam into the other and their adequate anchoring length in the concrete, not on hooks in the junction. The error in these junctions is based on the following issues:

- The design drawings were not specific enough in the reinforcement bar design.
- When the BRR recommended additional bars, the modified design was not reviewed.
- There were no calculations provided with the reinforcement design.
- The design drawings did not have a reinforcement bar cutting-folding schedule.
- The contractor does not have the required experience in reinforcement design.
- The site supervisor does not have the required experience in reinforcement design.

The reinforcement design of the ring beams should be detailed showing the reinforcement bars going around the corner, instead of ending with hooks inside the columns.

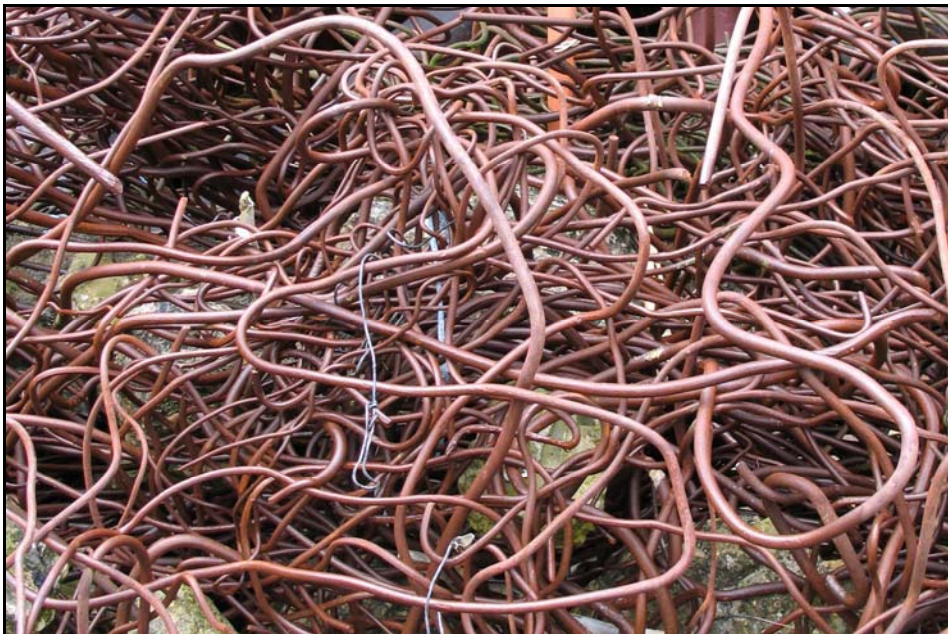
The photo above shows how reinforcement bars can just pull out of the concrete, demonstrating insufficient adherence to the concrete. This is often due to poor concrete quality, but sometimes can be caused by inappropriate steel design.
