Dhamar Aided Self-Help Reconstruction Project

Post 1982 Earthquake Reconstruction: Site Selection

By: Sjoerd Nienhuys April 1984 (Reprint and Photo Update 2008)

BUILDING TECHNIQUE REPORT, BUILDING SITE SELECTION PLANNING ACTIVITY NO 33

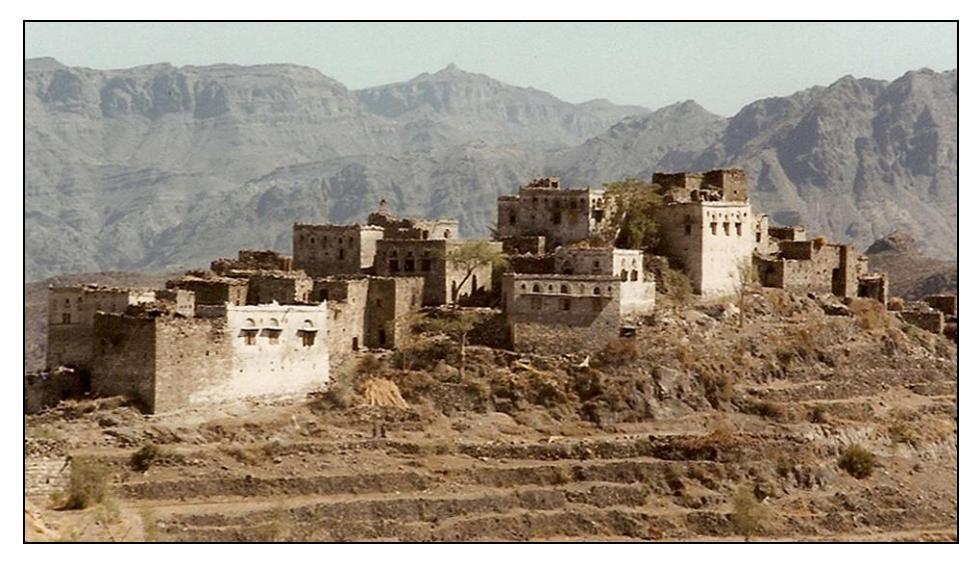
EXAMPLE OF SMALL VILLAGE ON A ROCK OUTCROP

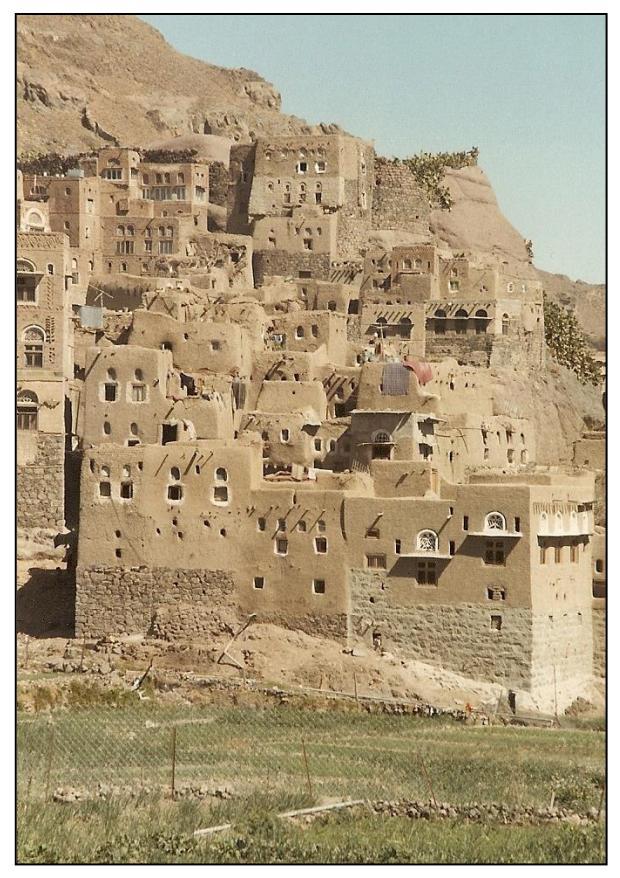
Some of the plateau houses on the right have stone construction basements with a lighter adobe upper structure. Regular maintenance of the adobe by filling in cracks may have contributed to their better resistance.

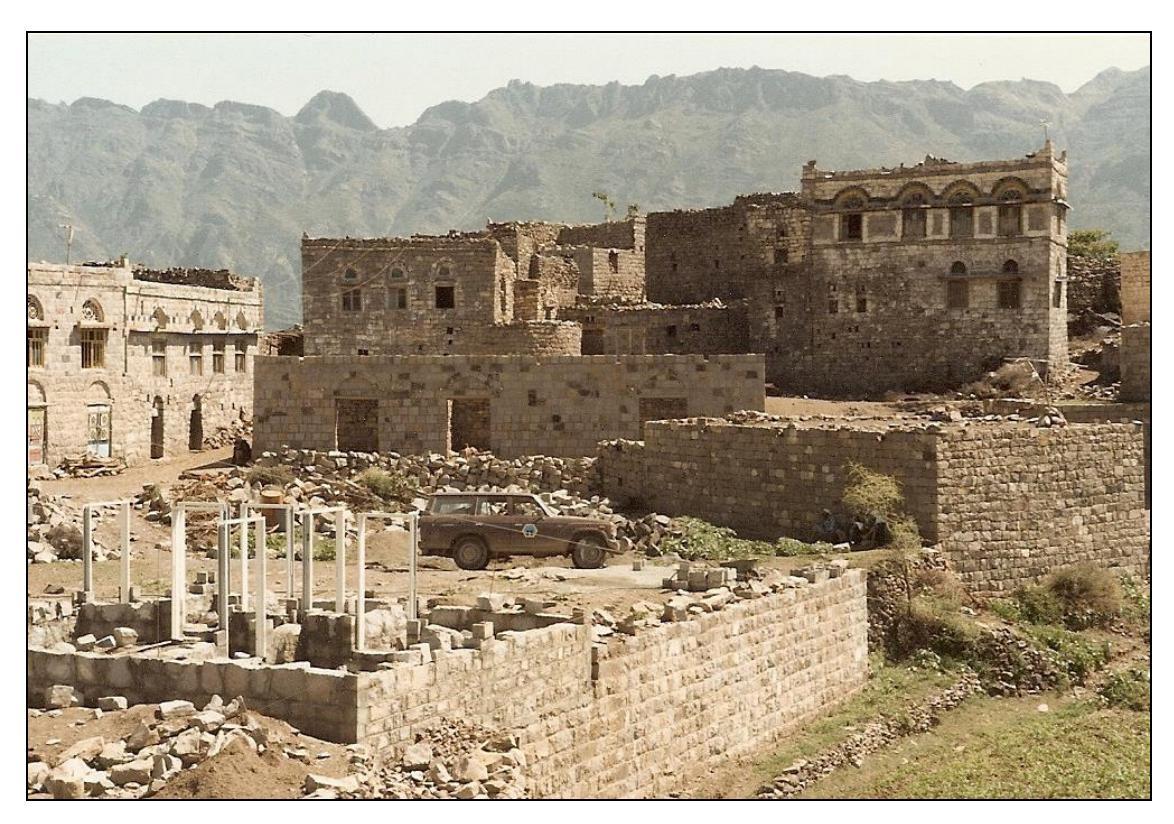
RECONSTRUCTION ON AN EXISTING PLOT IN A VILLAGE. THE MASONED RETAINING WALL WAS CONSIDERED ADEQUATELY STRONG ENOUGH FOR THE NEW ONE-STOREY HOUSE. AFTER THE RECENT EARTHQUAKE, THE WALL DID NOT SHOW ANY DAMAGE.

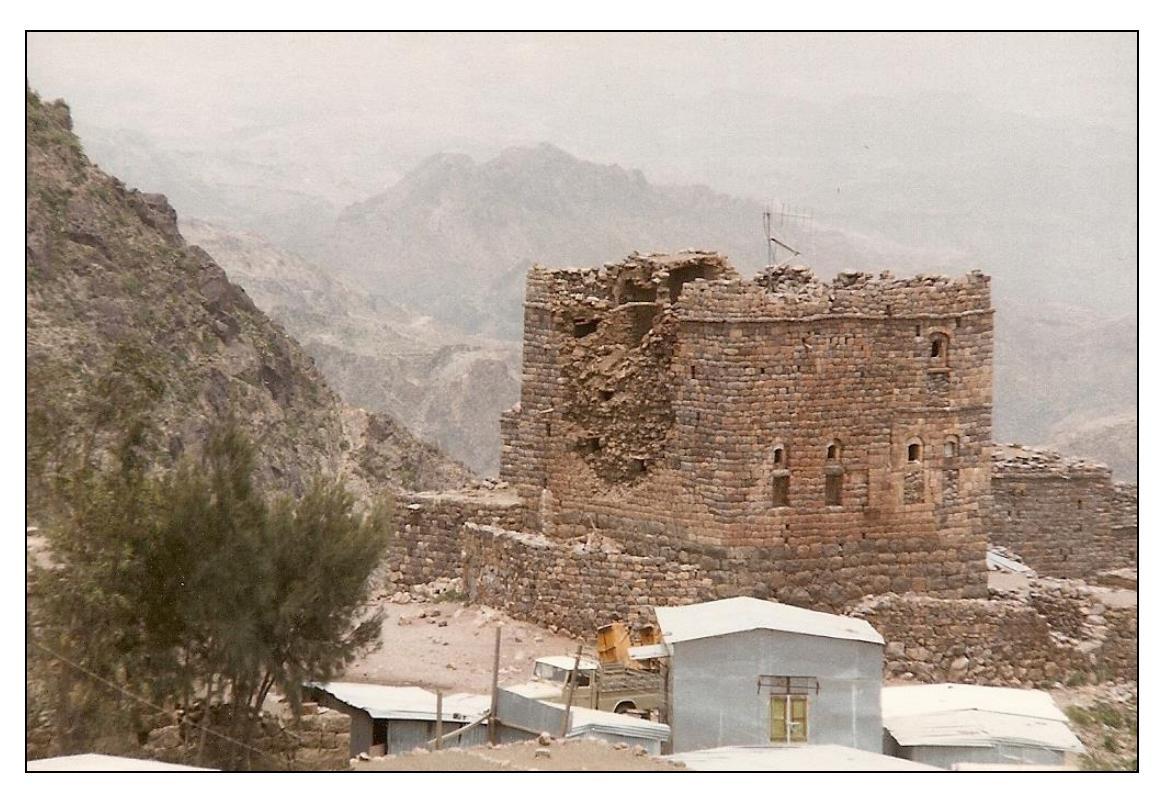
BUILDING A NEW EARTHQUAKE-RESISTANT HOUSE ON THE LOCATION OF THE ABOVE MASSIVE STRUCTURE POSSIBLY REQUIRES (TEMPORARY) TERRAIN SWAPPING WITH NEIGHBOURS

In the picture above, one can see that the cut-face dressed stone façade has fallen off the rubble inside wall. The above case is typically a situation where retrofitting is not an option, but reconstruction on the same site will eventually take place. The new house should have larger rooms, more windows for solar heat intake in the winter, and improved sanitation and kitchen facilities.

In the case of the above building, only about $1/3^{rd}$ of the mass of the stones (or even less) should be used in the reconstruction of the same size building. To make buildings more earthquake resistant, the total mass of the building needs to be considerably reduced and the structure tied together. The open inside space in the building will substantially increase, keeping the same outside perimeter. This also means that a new smaller building made from the same materials as the old building will most likely be more spacious inside than the old one.

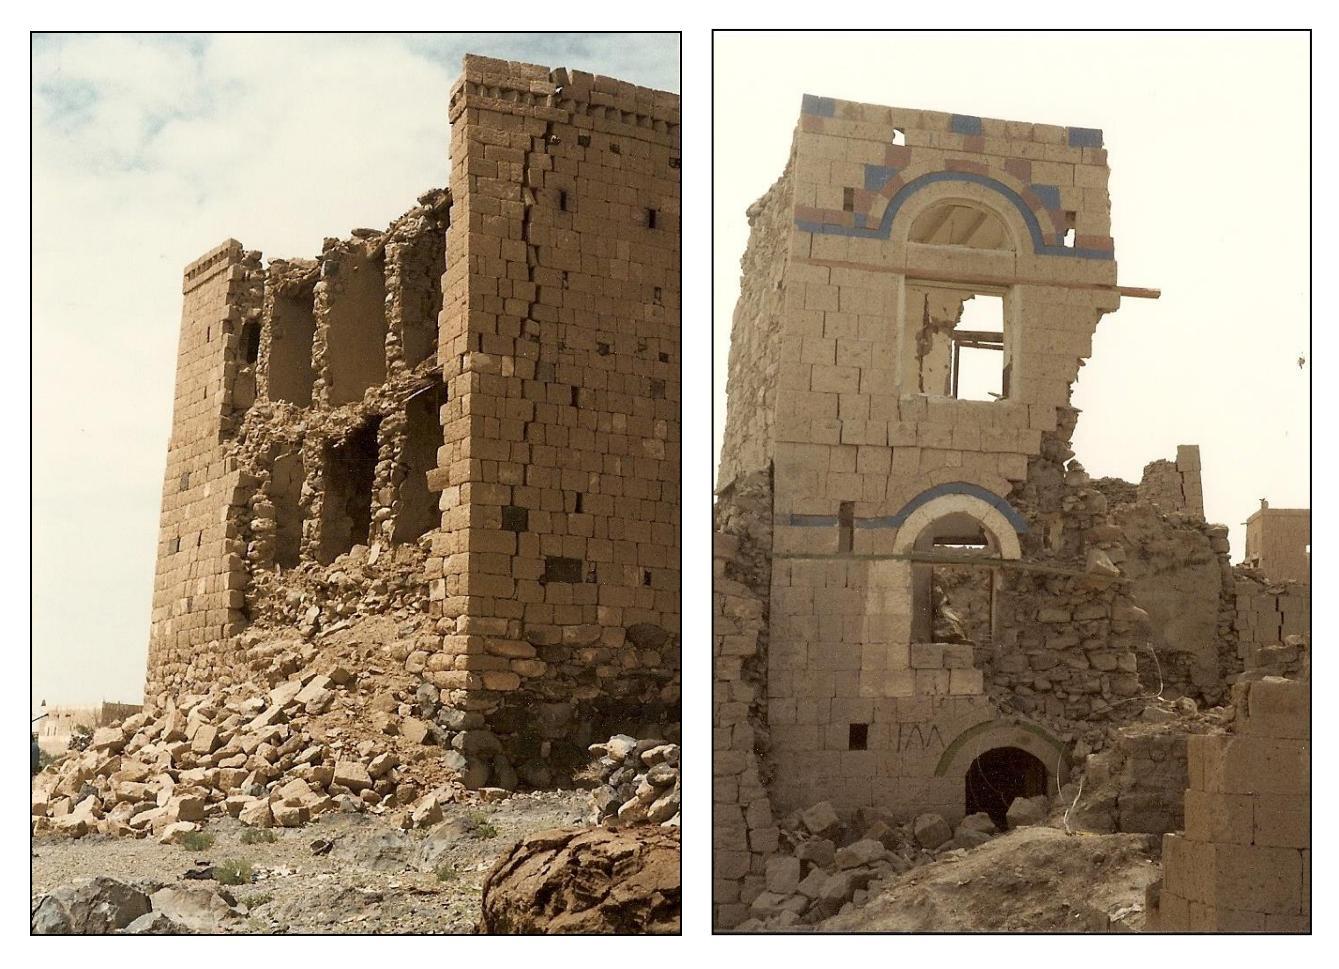
The cut-face façade stone assures that the outside face of the stone looks nice and flat with straight edges. To achieve this at minimum labour cost, the back of the stone is cut back inwards. This way the outside edges of the stones support, but the inside is propped up with rubble. With the many small vibrations of regular mini earthquakes, the supporting rubble wall comes loose from the cut-face façade. With a slightly larger earthquake, the façade bulges first outwards and then falls off. With a heavy earthquake, the entire building collapses.

The flowing two photographs illustrate the issue explained above.

= All thick and dry stone walls (no cement masonry) are to be avoided because these have no internal bonding.

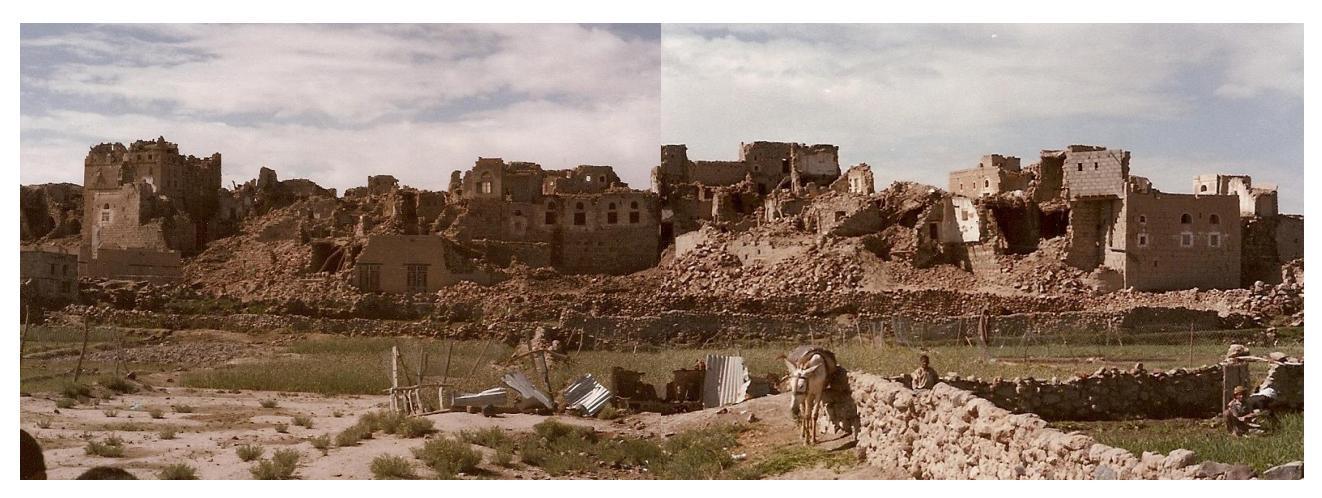
TOTALLY DESTROYED STONE-BUILT VILLAGE ON A ROCK OUTCROP

The above means that for small buildings built on soft soil or rocks, no large difference in calculations exist according to the ACI and Uniform Building Code. On the other hand, we saw considerably more damage in the houses which were built directly on the rock. Observations in the two different parts of the earthquake-affected area (the plateau and the mountains) showed that many of the mud wall or adobe constructions had less damage than the dry piled cut-face stone structures.
