Dhamar Aided Self-Help Reconstruction Project

Post 1982 Earthquake Reconstruction: Building Technique

By: Sjoerd Nienhuys
Earthquake Engineer, Programme Architect and Trainer
Hilversum, The Netherlands

March 1984 (Reprint and Photo Update 2009)

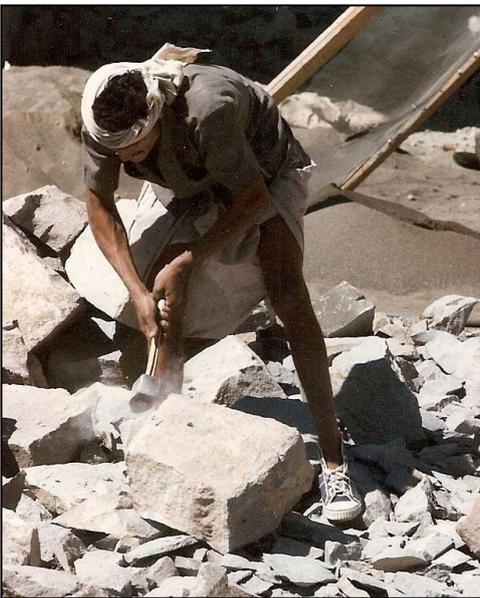
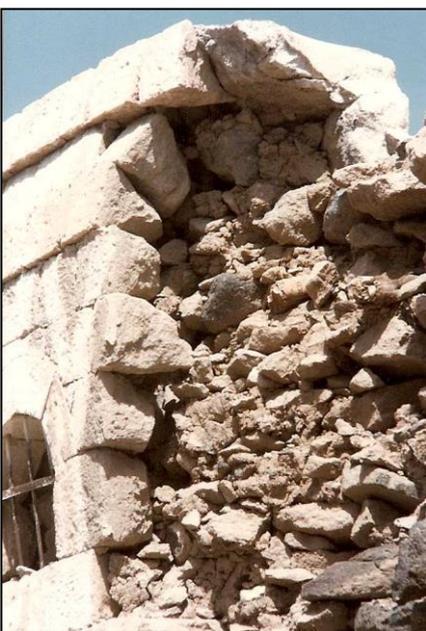
The volcanic stones can be finely shaped with enough time and skill (costs), but many masons apply the cut-back technique.

When mainly the face of the stone is tailored with straight sides, the rear sides are cut back to minimize the joint in the façade of the building. The inside is supported with rubble.

With the many vibrations, like the small and large earthquakes, this allows the cut-face stones to bulge outwards and come loose from the rubble masonry of the inside of the walls.

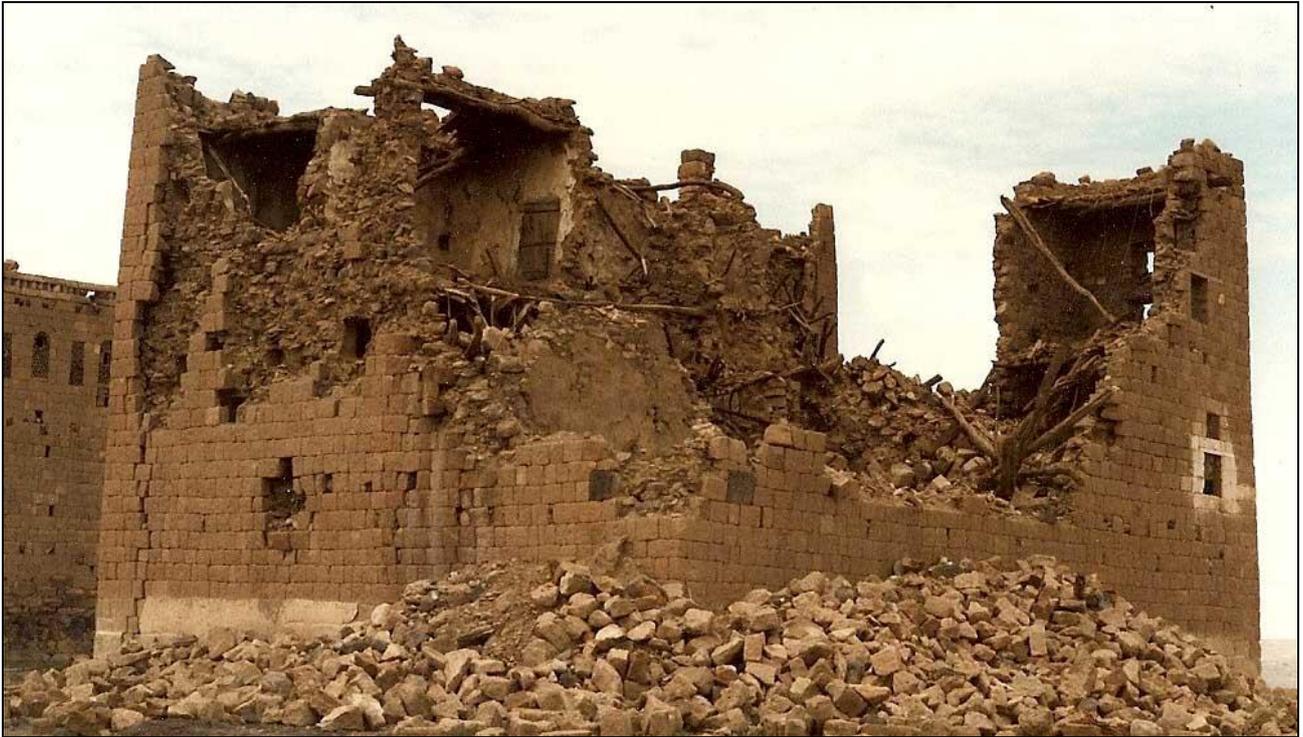
When the outside face falls off the walls, only the mud masoned inside wall may sometimes keep up the construction, but in most cases the entire wall collapses. On the picture below one can notice that left the cut-face walls have peeled off, and on the right side and the rear the entire wall is collapsed.

The stone mass of the above building is considerable, causing large earthquake forces. The collapse of the above building is also caused by lack of tie-beams, floor or roof diaphragms and adherence between floor beams and the walls.

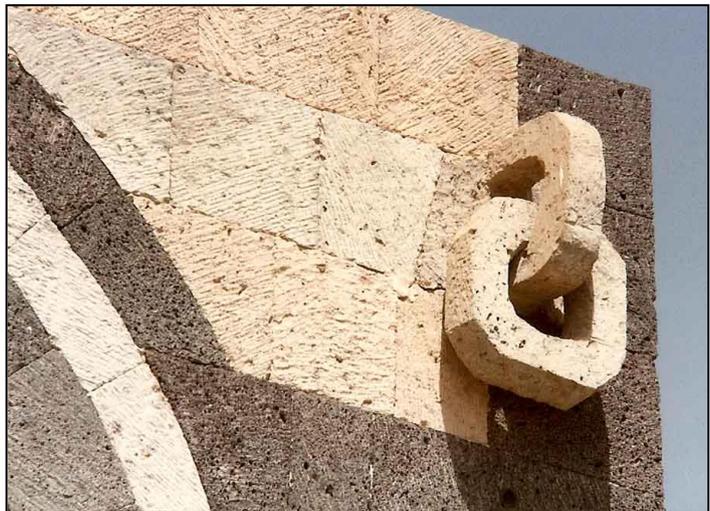
The stone material found in the Dhamar and Mahgrib Ans regions is mainly from volcanic origin. The black basalt is used for foundation, is heavy and difficult to work, and therefore expensive.

The light coloured (yellowish, pinkish and grey) Tuff stone is light weight ($< 1800 \text{ kg/m}^3$), is easy to work and has a very porous structure.

For the outside walls various ways are used for shaping the stone to obtain either a smooth surface or a rough finish.

Because it is porous, it allows high water absorption, a factor to be considered when masoned in cement mortar. Like burned brick, the stones must be soaked before being masoned with cement mortar.
