# CORDIA MEDAN

## Project Site Visits ~ Aceh

### Leprosy Communities at Trienggadeng and Po Diamat Villages

Indonesia  
March 2007

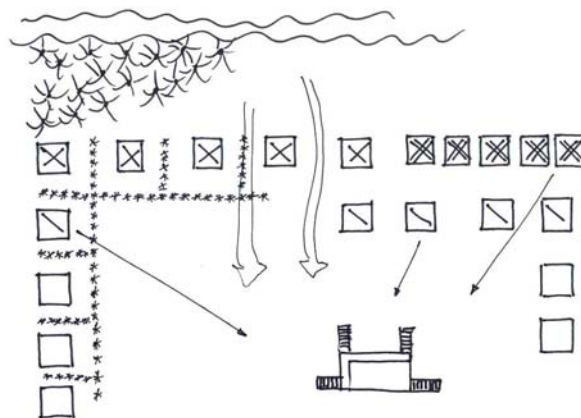
The houses of Trienggadeng village are situated in a U-shape around a central park area with coconut trees (left in photo above). The total land area is four hectares, with the individual plots measuring about 10 m x 20 m. The distance from the sea of the line of houses shown in the middle of the photo above is not very great. The house on the far right is located in the second row of houses. The houses seen behind the coconut trees (left) are in a line perpendicular to the coast. The possible recurrence of a similar, large-size tsunami has not really been considered as the land is only slightly above the high seawater line. Along the coastline, a small dike has been created to protect the village from small tsunamis.

*Apart from the small dike on the coast, four other measurements can be taken to improve disaster preparedness for this site.*

- 1) Dense plantations should be realised between the shoreline and the houses.*
- 2) No extensions should be built between the houses, obstructing the flow of onrushing seawater.*
- 3) No fences or barbed wire barriers should be erected in between the houses, blocking escape routes towards safer locations.*
- 4) An elevated construction or communal building on columns should be erected in a central location with easy access from all sides. The ground floor columns of that building should be self-supporting and have no infill walls.*

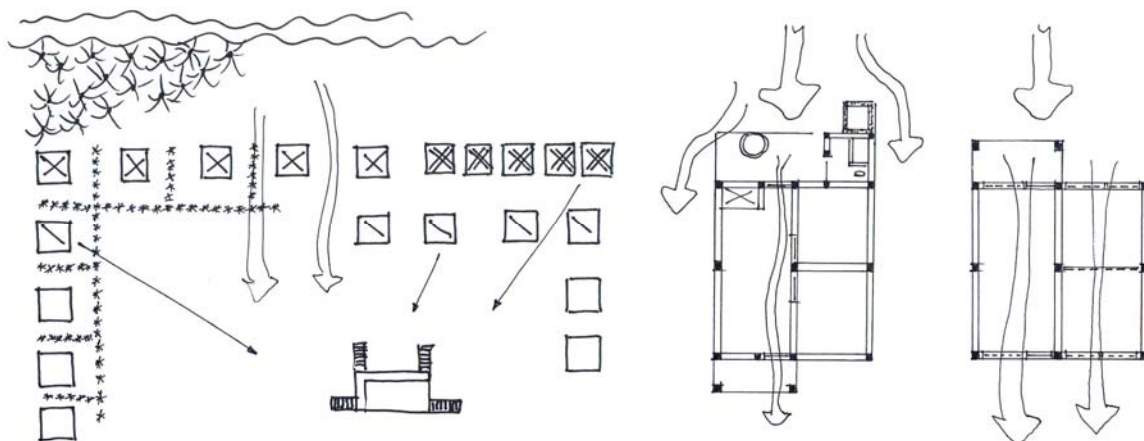
Most of the houses in Trienggadeng village have the back entrance facing towards the shore, providing a perfect opportunity to reinforce that side. In the sketch below, the houses with a double cross are the most vulnerable in the event of another large tsunami, those with a single cross less vulnerable, and the houses with a diagonal the least vulnerable.

No one can predict the size of the next tsunami or how much advance warning there will be, but the additional reinforcement to the rear of the house is a simple option that might give the house enough strength to withstand a small tsunami and save the lives of the occupants if they cannot escape in time.

The toilet extension with the water basin is actually a very strong construction because of the cross walls supporting the front-facing wall. This may deflect the water flow. To enhance the strength of the kitchen wall, a cross wall should be made, reinforced with a concrete tabletop. This can be made in the existing house or in the new kitchen extension.

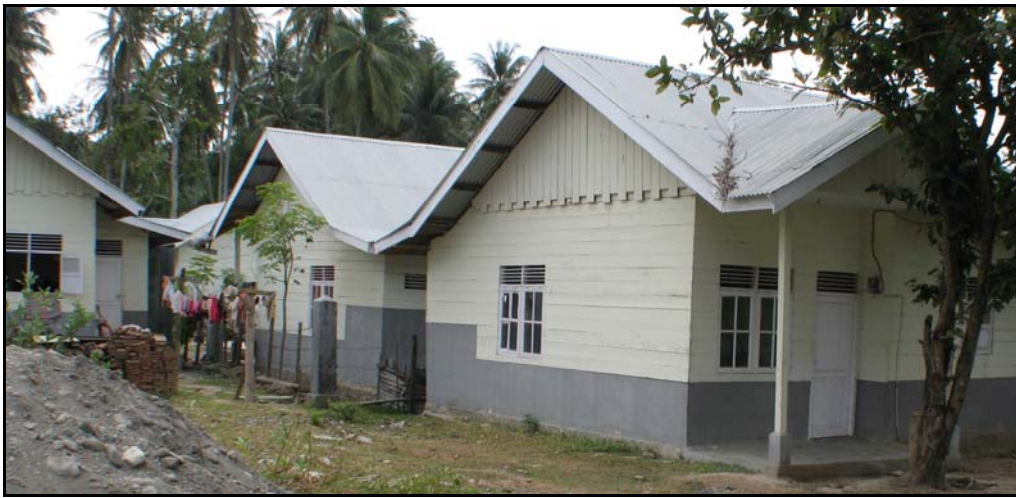
First semi-permanent house designs realised by NGOs along the north and east coast of Aceh.

These houses are well designed – structurally and climatically.

However, in a tsunami-risk area, houses should not be built too close together nor should the spaces between the houses be clogged up with structures that will obstruct water flow.

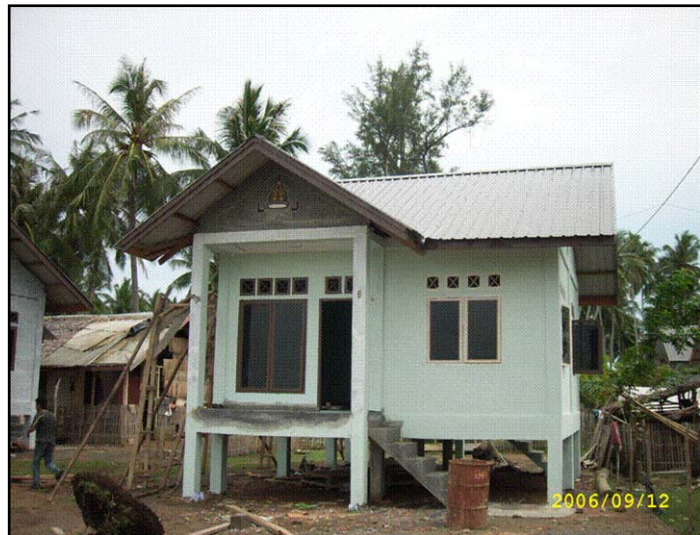
The photo right is a Cordia Medan house in Kuala Keureuto Barat village. The same type house is planned for Po Diamat. The elevated house has nine columns under the central section and four under the landings, in total thirteen supporting columns and two staircases.

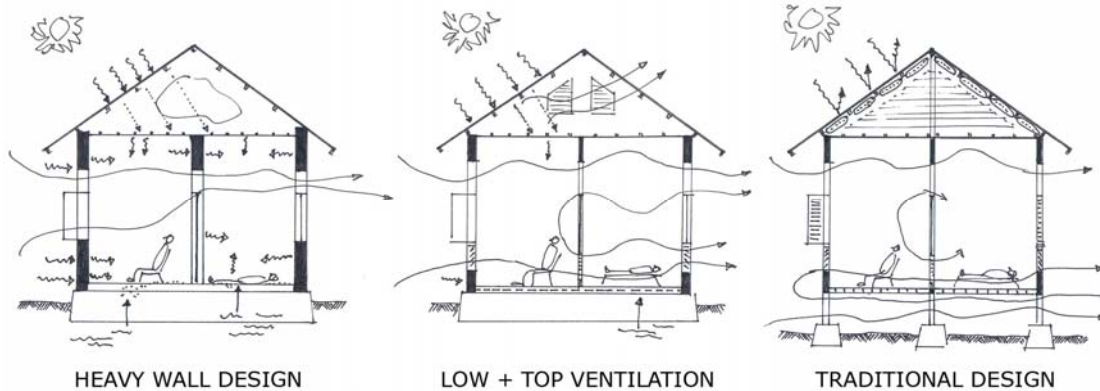
Heavy Wall Design has large heat accumulation during the day and requires good ventilation to cool off the walls. Because there are no low ventilation openings, warm air is removed only from under the ceiling. With lack of ventilation under the roof, the ceiling gets very warm and heats the rooms. The cement floor does not stop rising moisture from the ground, making the rooms moist.

Low + Top Ventilation is introduced. Plastic foil is placed under the floor before casting, keeping the cement floor dry. The walls are less heavy and the internal wall is lightweight for rapid cooling in the evening.

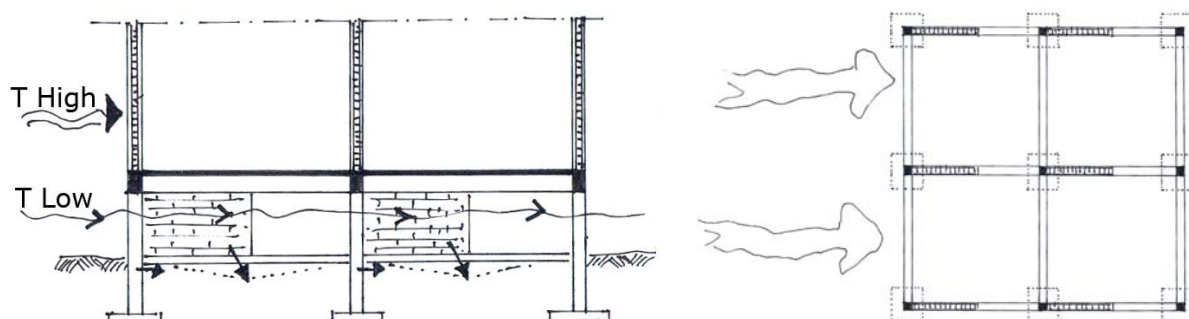
The above sketch illustrates an additional support wall built under the floor and against the columns, in the direction of the land. The foundations of these bracing walls need to be adequate to receive a vertical load without the risk of settling.

*To resist another high tsunami that reaches above the elevated floor level, bracing walls or supporting diagonals should be placed between the stilt columns.*

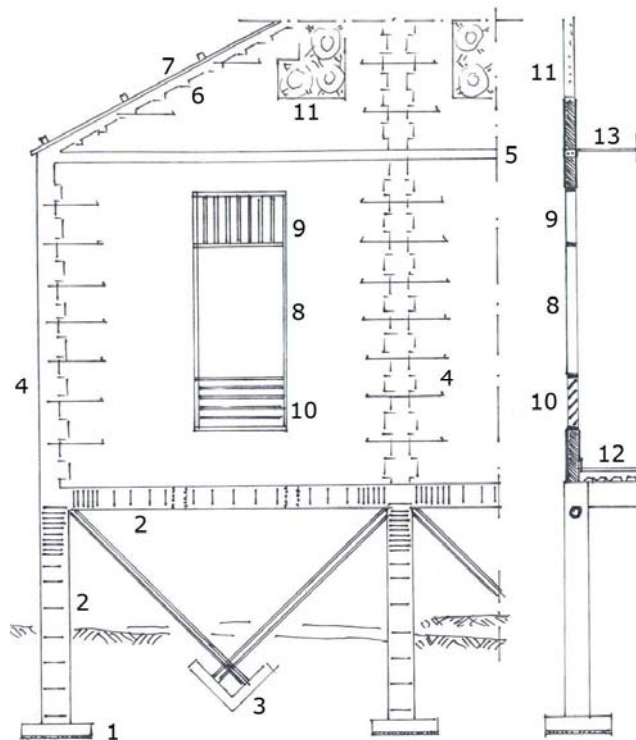
The sketch below illustrates supporting diagonals using three-inch heavy-duty GI water pipes anchored into a sub-surface foundation. These supporting diagonals block and resist a diagonal load. The pipes need to be well anchored into the column-floor junctions.

In addition, the diagram illustrates some elements of an alternative construction design using stiffer columns cast after the masonry of the brick walls and elements to improve ventilation:

- 1) Wider support columns and footings, reducing the possibility of settlement.
- 2) Increased number of stirrups in columns and beams where maximum moments will occur. The floor beam is not thicker/heavier than the column. The columns are stiffer than the floor construction.

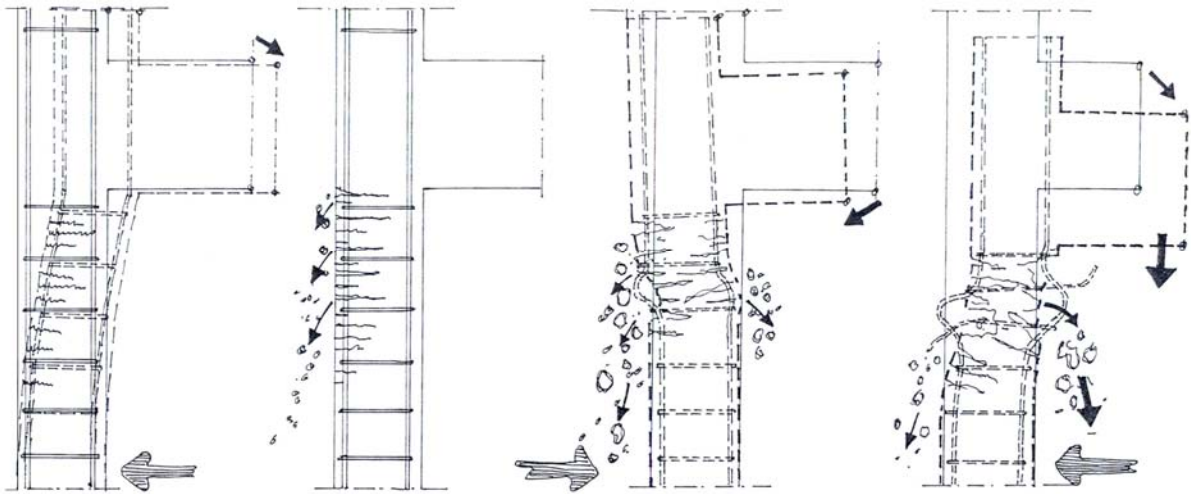
Observation on photo – page 12 (bottom right): At the vital maximum moment zone, there were insufficient stirrups. As a result, the concrete crumbled and fell out during an earthquake. The sketches below explain the process of failure during one shock. In reality, a series of shocks occur during an earthquake, continuing the described process and resulting in the column collapsing and with that bringing the house down.

Each column end should be reinforced with a cage of stirrups at its maximum moment zone to avoid broken concrete from falling out of the construction when earthquake forces exceed the design forces. This is especially the case when the floor beams are stronger than the columns. The column ends should therefore have 6 mm stirrups every 5 cm over a length of minimal 1.5 times the column width under the floor beam, followed by two stirrups 10 cm apart and then continuing with stirrups every 20 cm for the rest of the column.

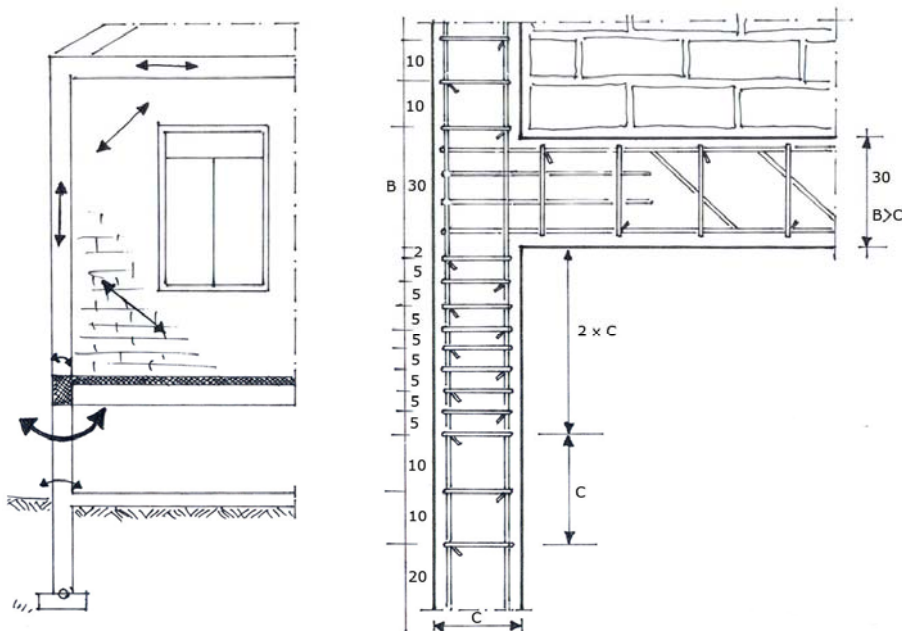
The sketch on the left shows the forces that occur in the current structural design. Only the stilt column is subject to a strong bending moment, while the upper column and tie-beam only receive compression and stress forces when the infill wall remains intact. In such a case, the reinforcement pattern sketched on the right is recommended. Better still is when the floor beam is lighter or thinner than the column, shifting the possible failure area to the beam.

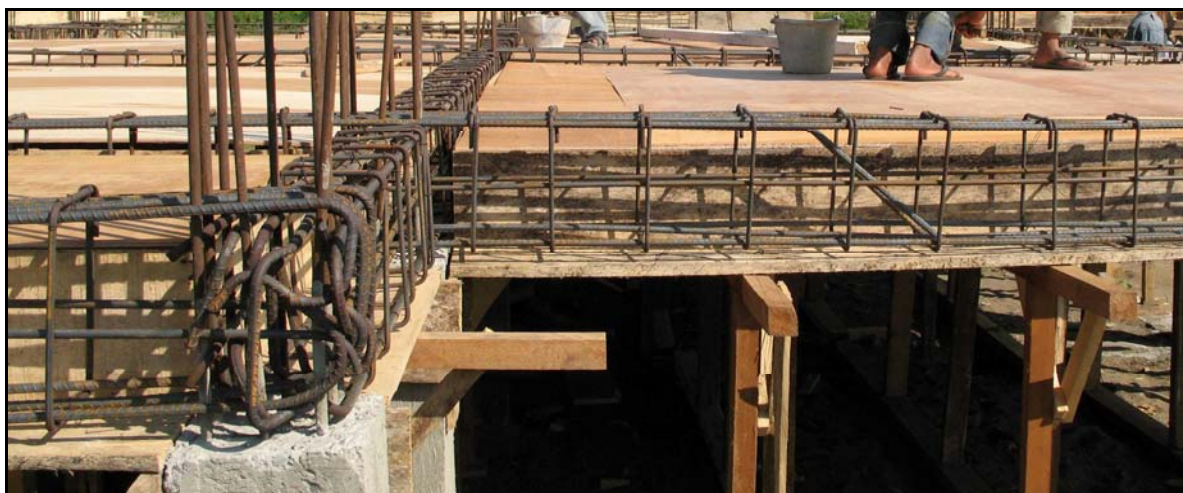
Observation: The eight reinforcement bars in the beam are not going around the 90° corner into the other horizontal beam section, but instead end with hooks inside the column. The eight hooks in the column, coming from two directions, totally congest the space inside the column. When casting the column with concrete, air pockets will be created. Because of the inadequate length of the hooks, the junction will be far below the required structural strength. The situation is aggravated in two other corners because two additional bars were added.

The Po Diamat house design has 13 support columns – nine columns under the main house and four under the front and rear side terraces. The four terrace columns and two other corner columns all have the above-mentioned anchoring failure of the beam-column junction. The result is that possibly only the seven central columns will be able to withstand an earthquake load. Recalculation of the strength of the central seven columns, having additional reinforcements, needs to be undertaken to determine if they are adequate to withstand an earthquake load. If the building is fitted with lightweight inside walls, this may be the case.

The strength of the beam-column junction depends on the continuity of the bars from one beam into the other and their adequate anchoring length in the concrete, not on hooks in the junction. The error in these junctions is based on the following issues:

- The design drawings were not specific enough in the reinforcement bar design.
- When the BRR recommended additional bars, the modified design was not reviewed.
- There were no calculations provided with the reinforcement design.
- The design drawings did not have a reinforcement bar cutting-folding schedule.
- The contractor does not have the required experience in reinforcement design.
- The site supervisor does not have the required experience in reinforcement design.

The reinforcement design of the ring beams should be detailed showing the reinforcement bars going around the corner, instead of ending with hooks inside the columns.

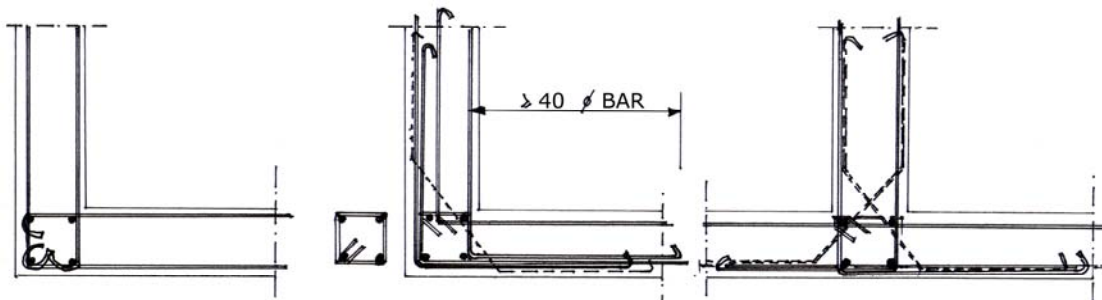
Left Sketch: Illustrates the applied reinforcement. In reality, four bars were applied in both the upper layer and bottom layer of the beam.

Middle Sketch: Illustrates the correct application of the beam reinforcements. These go through the column, around the corner and end in a hook, providing minimal a 40 bar diameter overlap. The possibility exists to add another diagonal bar (dotted line) depending on the force calculations. In the areas of the maximum moment, in the beam as well as in the column, additional stirrups should be placed with 5-6 cm spacing.
