Dhamar Aided Self-Help Reconstruction Project

Post 1982 Earthquake Reconstruction: Site Selection

By: Sjoerd Nienhuys April 1984 (Reprint and Photo Update 2008)

BUILDING TECHNIQUE REPORT, BUILDING SITE SELECTION PLANNING ACTIVITY NO 33

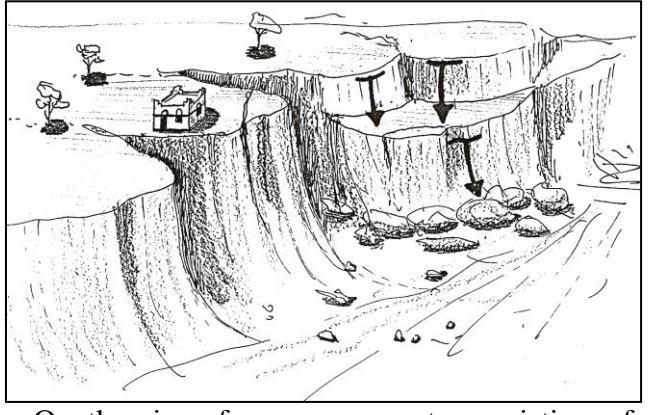
= On the rim of an escarpment, consisting of alluvial soil or moderately compacted conglomerates.

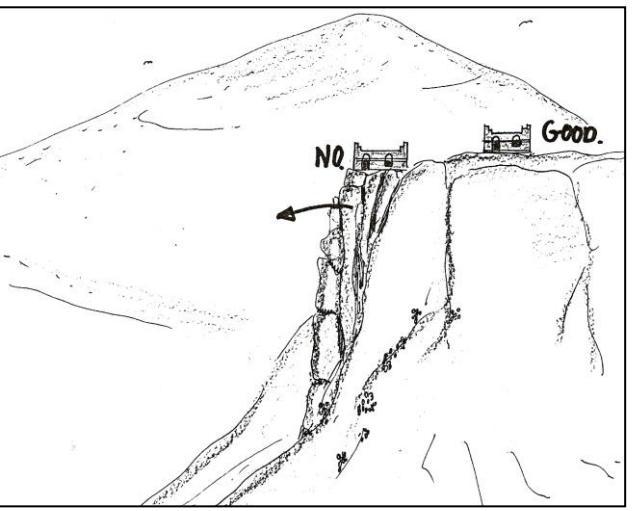
= On the rim of fractured rock outcrops.

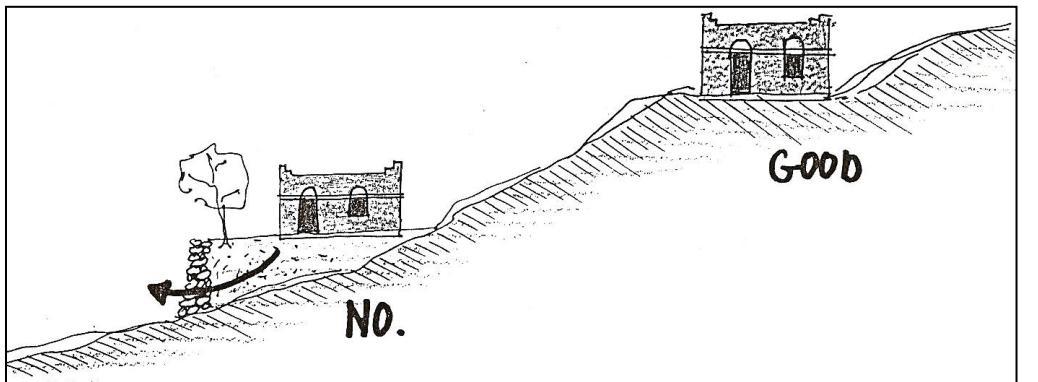
= On rock soil or gravel which has been filled in, even if it has been later compacted.

When infill soil cannot be avoided, such as when there is no level rock available, the retaining walls should be very stable, such as post-masoned gabion constructions. Additional soil stability can be created with horizontal anchorage from the retaining gabion wall going under through the building; a solution used in road construction. Drainage of rainwater must be assured on the high side.

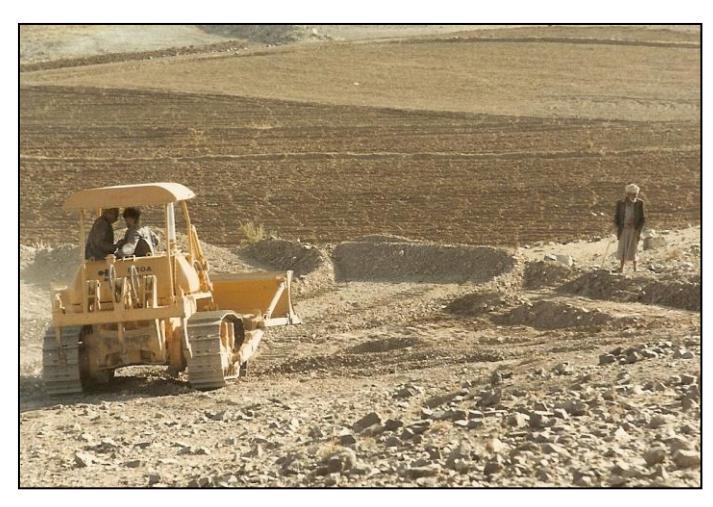
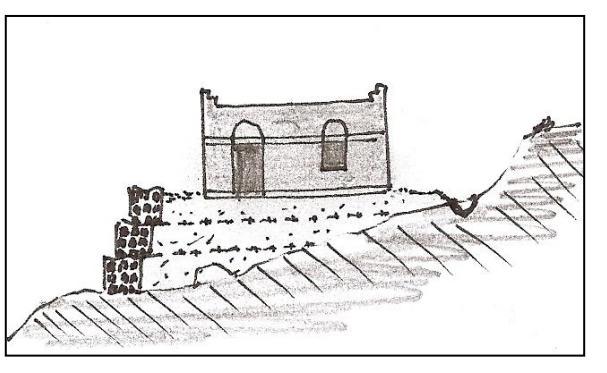
ANCHOR WIRE OR CLOTH CAST INTO THE GRAVEL

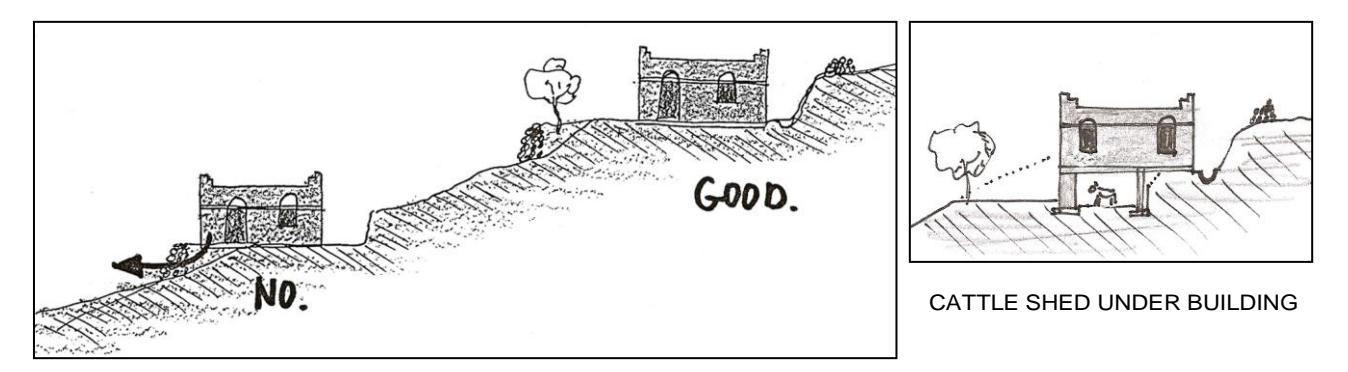
= On soil that is a partial area of terraces. Differences in soil density will cause cracking from the foundation upwards. Very strong foundation beams will be required.

As an alternative to the above situation, the foundation of the lower side of the hill can be excavated deeper, creating storage areas or cattle sheds.

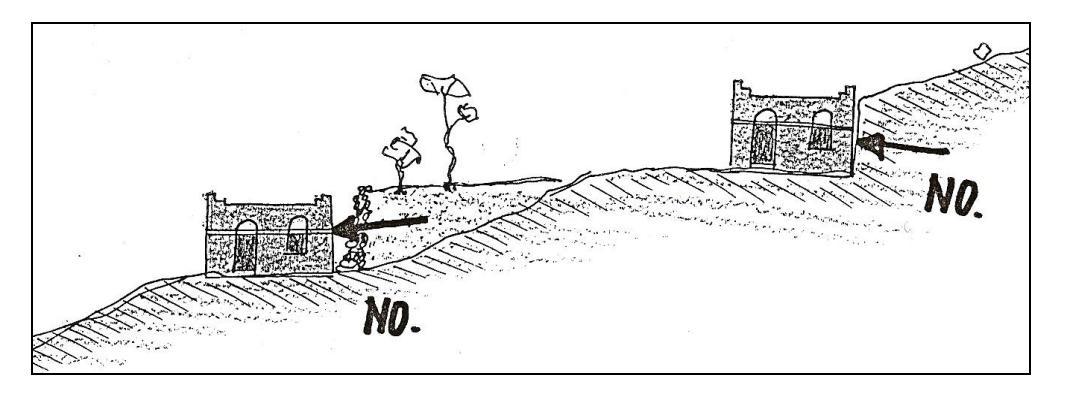
= With the back of the building against a loose stone wall with an in-filled terrace. This terrace wall can collapse and crush the sides of the house. In the case of countries with more rainfall, the walls of the house may block the evacuation of water, and water soaked soil may give the same effect.

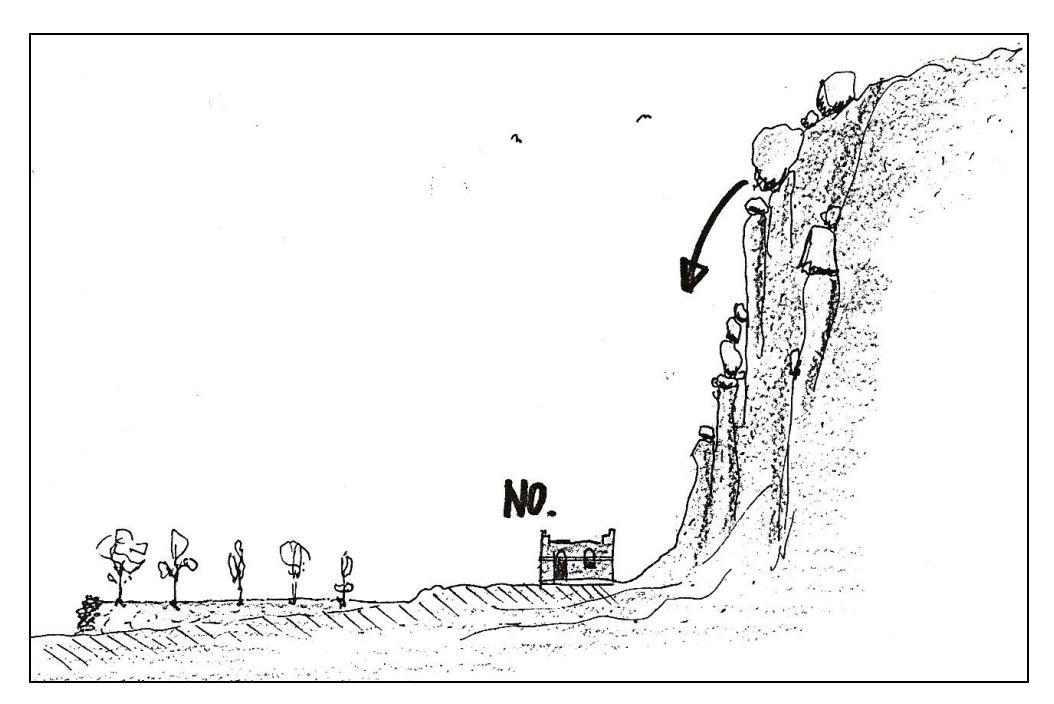
= Too close to high mountain sides having loose or many fractured outcrops. A 1 m^3 size boulder falling or rolling from a great height will destroy any type of building.

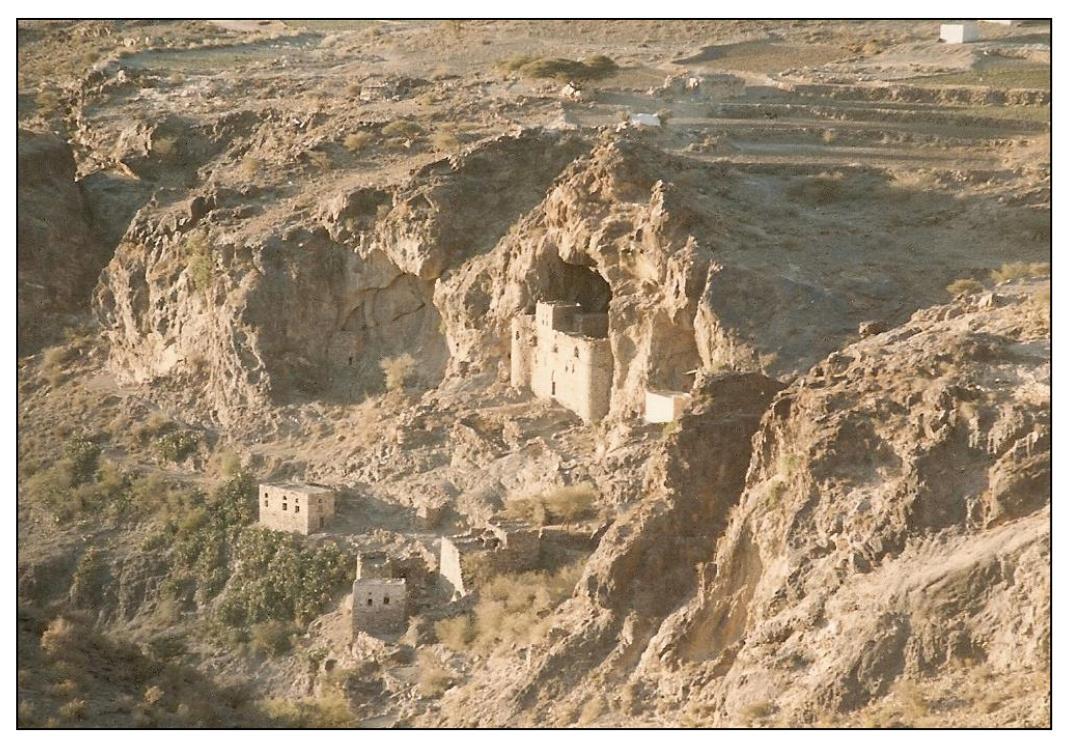
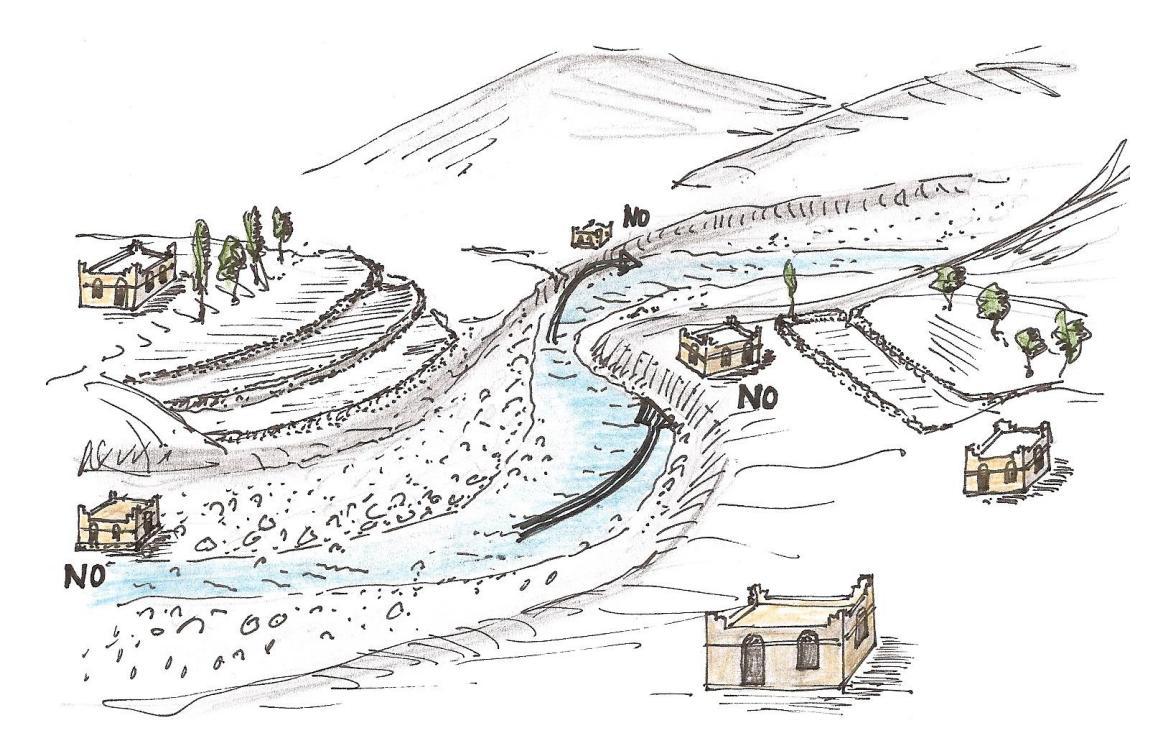
= Deposition sites of stones on the "Point Bars" (being on or alongside the inside bend of a river) should not be used for housing. "Cut Bank" sites (being the sites directly above the outward bend of the riverbed) should also be avoided. Although many riverbeds may be dry, such as is the case in many Yemeni rivers in the Maghrib Ans, occasional floods may occur, destroying everything in its wake. This is also the case when a dam bursts following an earthquake.

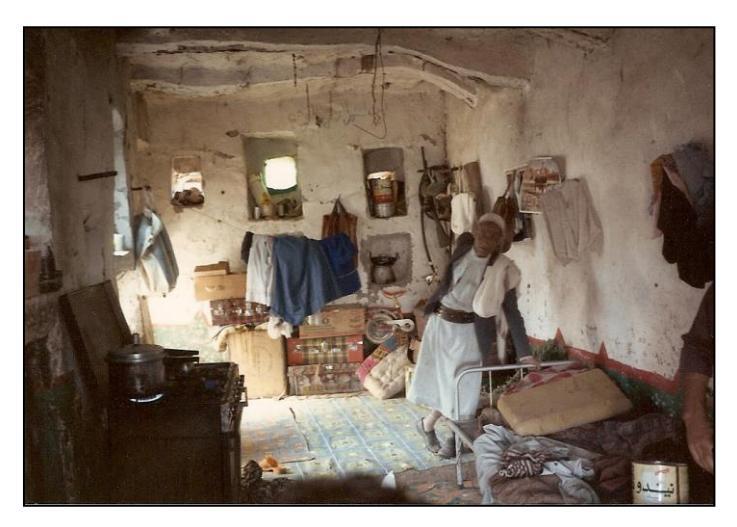
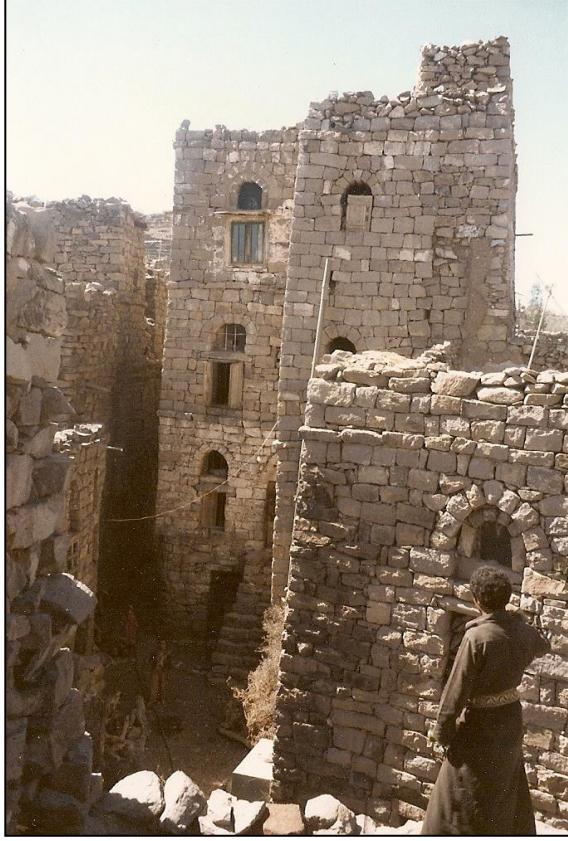
= The building height for so called non-engineered constructions should never be more than three storeys. The building on the right, photographed outside the 1982 Dhamar earthquake area, would have certainly collapsed in an earthquake.

= It is recommended that above the 10 m height, engineering calculations are made and strict control on the use of the building materials and the quality of the construction is applied according to the code.

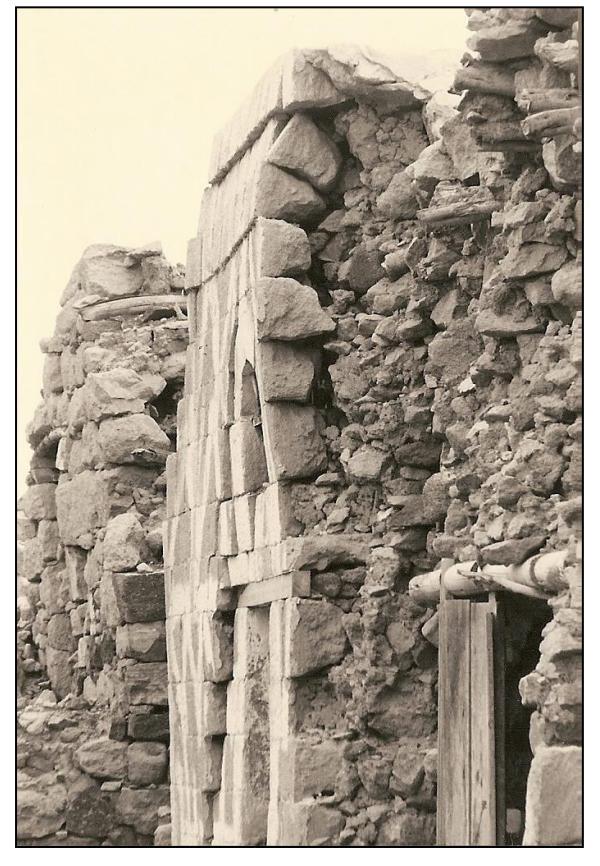
= All thick and dry stone walls (no cement masonry) are to be avoided because these have no internal bonding.

The cut-face façade stone assures that the outside face of the stone looks nice and flat with straight edges. To achieve this at minimum labour cost, the back of the stone is cut back inwards. This way the outside edges of the stones support, but the inside is propped up with rubble. With the many small vibrations of regular mini earthquakes, the supporting rubble wall comes loose from the cut-face façade. With a slightly larger earthquake, the façade bulges first outwards and then falls off. With a heavy earthquake, the entire building collapses.

The other result of the cut-face dressed stone façade is that very heavy, two-foot thick inside walls are necessary to keep the structure up. These inside walls are made in dry soil mortar, commonly without cement or lime bonding. The two to three-foot thick walls and small rooms require large construction sites.
