# Chapter 1 Alphabetic listing of terminology and abbreviations related to the induced earthquakes

in Groningen from Accelerometer to Zechstein.

Explanation of terminology, concepts, and abbreviations, related to the Groningen Induced Earthquakes that occurred since 2000 and culminated in 2012, with comments and sketches.

By: Sjoerd Nienhuys  
Construction, seismic engineer  
April 2023

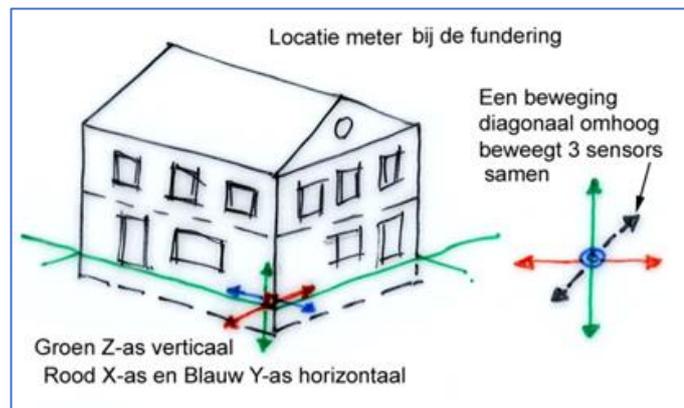
Rood X-as en Blauw Y-as horizontaal = Red X-vector and Blue Y-vector horizontal

*Figure 1. An oblique movement in a horizontal plane gives a deflection in the x and y coordinates. An oblique movement upwards therefore gives a deflection in all three x, y and z coordinates. The degree of deflection is also determined by the direction of the earthquake, the mass and height of the building, the location of the vibration meter and the elastic structure of the building.*

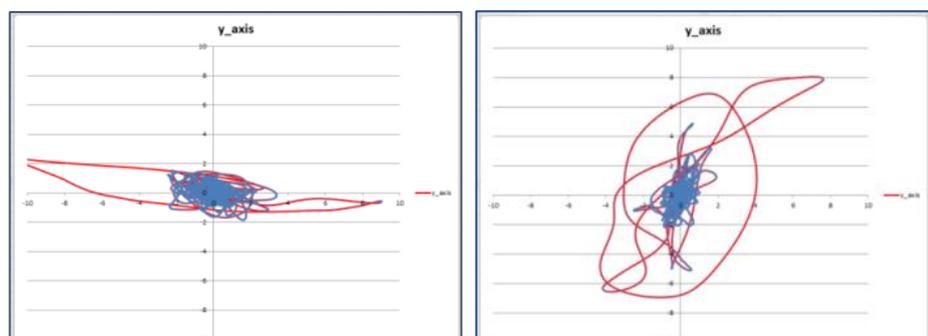
The coloured graph below represents a vibration from a meter bolted to a foundation. After the high peak (red), the continuing smaller vibrations (blue) are the movements of the building that return to the foundation (response) through the elasticity of the building.

*Figures 2. Left: a single back-and-forth pulse from a foundation vibration meter. Right: a more complex movement of a building that also gives a different elastic (response) back to the foundation.*

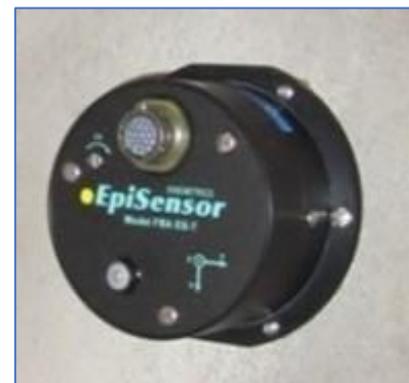
*Figure 3. In the province of Groningen, hundreds of accelerometers have been attached to the foundations of buildings since 2014, which send signals of the three types of vibration (X and Y = 2 horizontally perpendicular to each other and 1 vertically = P) that are transmitted via a network with a central measurement room are connected.*

Each quake is mapped precisely with direction and strength. The accelerometer measures the three PGAs (two horizontal X and Y and one vertical Z) as the most important values for determining earthquake strength<sup>7</sup>. They only register when several meters go off at the same time, so not when someone slams the door in a home. To prevent a vibration meter from also registering the slamming of a heavy door, a vibration is not transmitted until it is detected by three meters. NAM has also installed several pairs of depth geophones (borehole gauges) that measure ground acceleration at depths of up to 2 km.

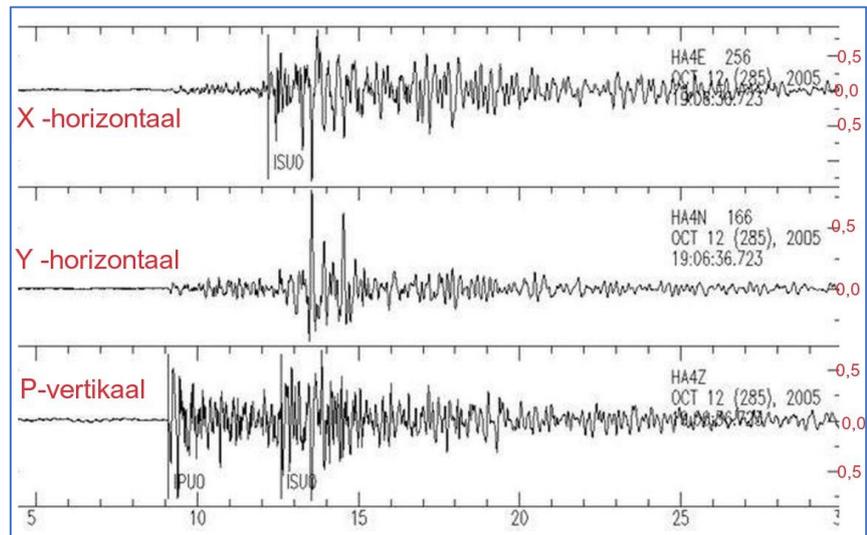
They sensed a big bang at which the building crunched. Date 12 October 2005 at Smilde near Assen. Mw 2,5 and  $PGA_g \approx 0,06$ .

The P shock comes up first, then the horizontal shocks. Depending on the distance between the epicentre and the meter, the registration is different.

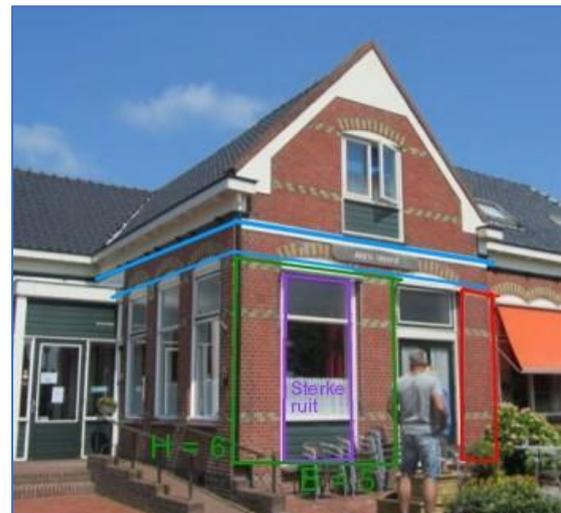
In the assessment of chimneys that stand on the roof base, a ratio of  $w/h = 0.5$  is already risky because there is no connection to the underlying masonry due to the lead flashing.

For example: a window pier  $w:h < 0.25$  is already a risk at  $PGA_g > 0.1$ . A free-standing (loose standing) brick chimney measuring  $w:h < 0.1$  can already pose a risk at  $PGA_g > 0.1$ .

Ratio (number) between the length and the height of, for example, a shear wall. Length-to-width ratio or the ratio between a span and the thickness of a structure. The ratio is used in a RVS inspection to quickly estimate the proportions of structures such as window piers, free wall lengths and heights of chimneys. If these parts fall outside the recommended ratio, their strength must be calculated, and the structure possibly reinforced.

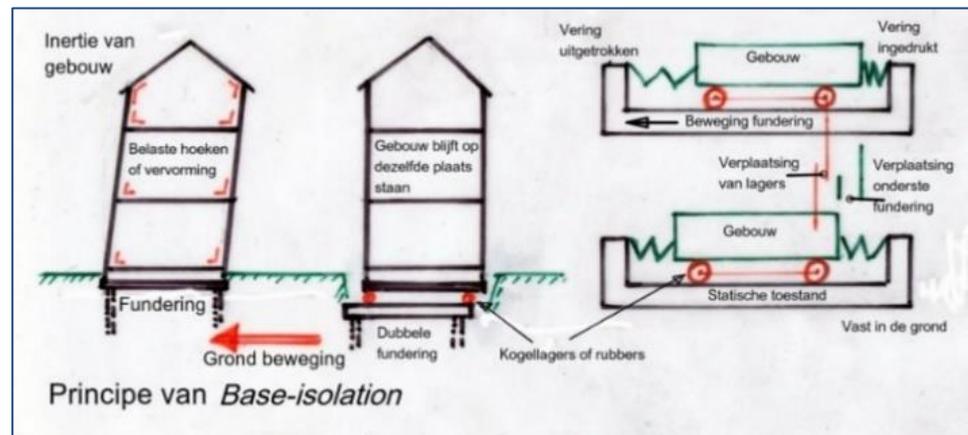
Intertie van gebouw = Inertia of building. Belaste hoeken of vervorming = Loaded corners or deformation  
 Gebouw blijft op dezelfde plek staan = Building remains standing on the same location  
 Fundering = Foundation Grond beweging = Ground movement. Dubbele fundering = Double foundation  
 Vering uitgetrokke = Spring extended Vering ingedrukt = Spring compressed  
 Beweging fundering = Movement foundation Verplaatsing van lagers = Displacement of rolbearings  
 Verplaatsing onderste fundering = Displacement of lower foundation Gebouw = Building  
 Kogellagers of rubbers = Ball bearings or rubbers Statische toestand = Static position  
 Vast in de grond = Firm in the ground Principe van Base-isolation = Principle of Base-isolation

Figure 6. The rollers with springs, rollers in a bowl or rubbers ensure that the building returns to the center of the support.

Because the building mass has an inertia, the ground moves together with the lower foundation separately from the building above.

The building experiences only a small lateral load due to the spring action and will have no tilting effect. It therefore receives very little stress forces on the connections between walls and floors or roofs. The type of Base-isolation depends on the building mass and the maximum horizontal displacement of the maximum earthquake. In the induced earthquakes of Groningen, the horizontal displacement is very small (at PGA 0.1 about 1 cm) compared to tectonic earthquakes, which sometimes are decimetres.

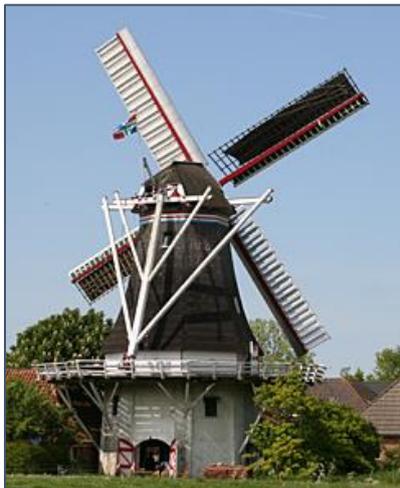
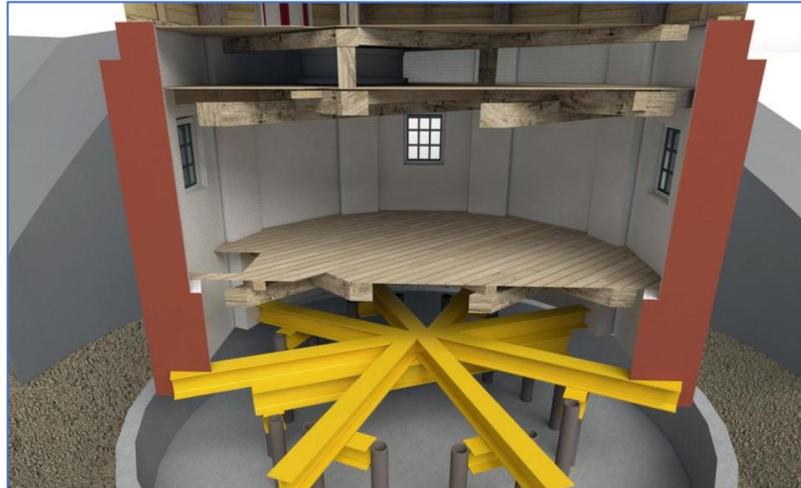
Figures 7. Left: Government monument Zeldenrust windmill (Internet photo by R. Bakker)<sup>10</sup> at Westerwijtwerd. A windmill is well constructed to withstand vibrations from all wind directions and has a flexible timber upper structure that is not affected by small earthquakes. Right: design of the Base-isolation under the windmill.

The early (2014) construction of this Base-isolation under the windmill was inspired by the panic of the extreme high PGAg as proposed by the KNMI. Placing the Base-isolation apparently was also a mere technical research exercise to determine the feasibility of the technology (interesting job for the engineers) and at the same time to placate the monuments organization.

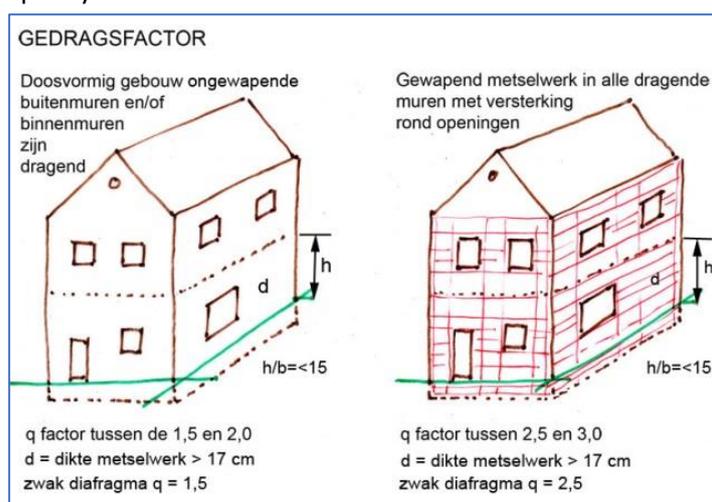
$d$  : dikte metselwerk =  $d$  : thickness masonry  
Zwak diafragma = Weak or not to the walls connected floor diafragma.

Gewapend metselwerk in alle dragende muren met versterking rond openingen = Reinforced masonry in all load bearing walls with reinforcements around openings.

Figures 8. Left. Box shape and non-reinforced masonry. **This is the Dutch standard method with  $q$  1.5 to 2.0.** Right. Reinforced masonry with  $q$  factor between 2.5 and 3.0. Reinforced masonry is mandatory with a  $PGA_g < 0.2$ . In a brittle and rigid construction, the  $q$ -factor is low. With a flexible construction, the  $q$ -factor is high. This flexible construction method for housing does not occur or rarely occurs in the Netherlands.

Unreinforced masonry has a  $q = 1.5$ . This factor is applied below the fraction line in the calculation. The higher the  $q$ -factor, the greater the reduction and the stronger the building's resistance to earthquakes. **In the province of Groningen mainly the first type exists.** In areas with tectonic earthquakes with a  $PGA_g > 0,2$  reinforced masonry is mandatory (Eurocode)

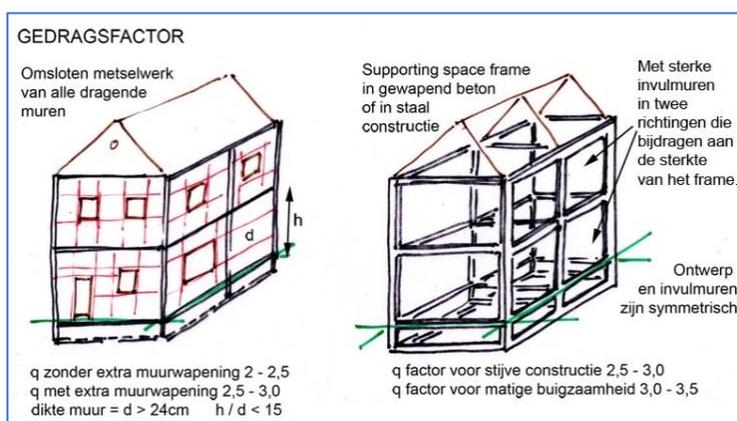
GEDRAGSFACOR = BEHAVIOUR FACTOR  
Omsloten metselwerk van alle dragende muren = Encased masonry for all load bearing walls  
q zonder extra muurwapening 2 - 2,5 =  
q without extra wall reinforcement 2.0 - 2.5  
q met extra muurwapening 2.5 - 3.0 =  
q with extra wall reinforcement 2.5 - 3.0  
dikte muur =  $d > 24$  cm  $h/d < 15$  = thickness wall =  $d > 24$  cm  $h/d < 15$   
Supporting space frame in gewapend beton of in staal constructie = Reinforced concrete or steel construction space frame

Met sterke invulmuren in twee richtingen de bijdragen aan de sterkte van het frame = With strong infill walls in two perpendicular directions contribute to the strength of the frame.  
Ontwerp en invulmuren zijn symmetrisch = Design and fill-in walls are symmetrically positioned.  
q factor voor stijve constructie 2,5 - 3,0 = q factor for stiff construction 2.5 - 3.0  
Q factor voor matige buigzaamheid 3,0 - 3,5 = q factor for slight elastic deformation 3.0 to 3.5

Figures 9. Left. Buildings with enclosed masonry and/or a load-bearing frame construction such as a concrete frame. Right. Concrete and steel structures that can deform (ductile) without collapsing have an even higher  $q$ -factor. Load-bearing structures such as timber frame construction (HSB) also have a high  $q$ -factor.

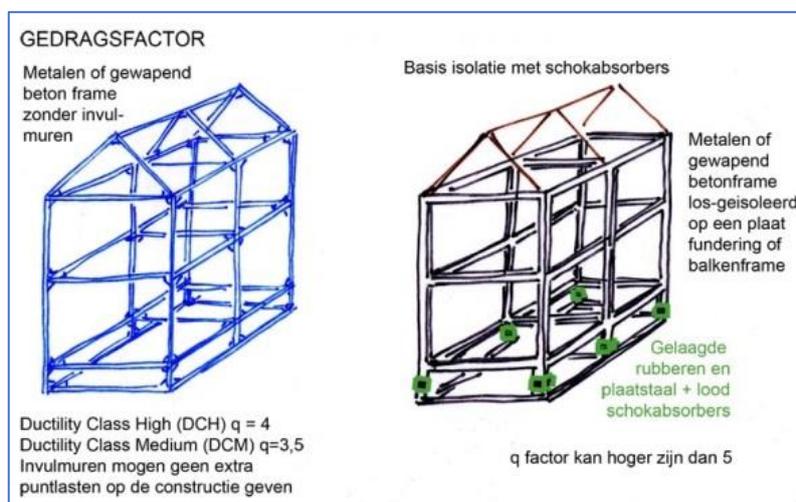
GEDRAGSFACOR = BEHAVIOUR FACTOR  
Metalen of gewapend beton frame zonder invulmuren = Metal or reinforced concrete frame without infill walls  
Invalmuren mogen geen extra puntlasten op de constructie geven = Infill walls may not cause additional loads on construction  
Basis-isolatie met schokabsorbers = Base-isolation with shock absorbers  
Metalen of gewapend betonframe los-geïsoleerd op een plaat fundering of balkenframe = Metal or reinforced concrete frame, separated by base-isolation and placed on a slab foundation of beam construction  
Gelaagde rubberen en plaatstaal + lood schokabsorbers = Layered rubber and steel plates with lead shock absorbers.  
q factor kan hoger zijn dan 5 = q factor can be higher than 5

Figures 10. *Left.* Metal frame or reinforced concrete buildings that do not have structural or rigid infill walls can be calculated with an even higher q-factor.

*Right.* A building on a base-insulation has the highest q-factor. With an easily moving roller construction it will score higher than with a stiffer rubber block or sliding construction.

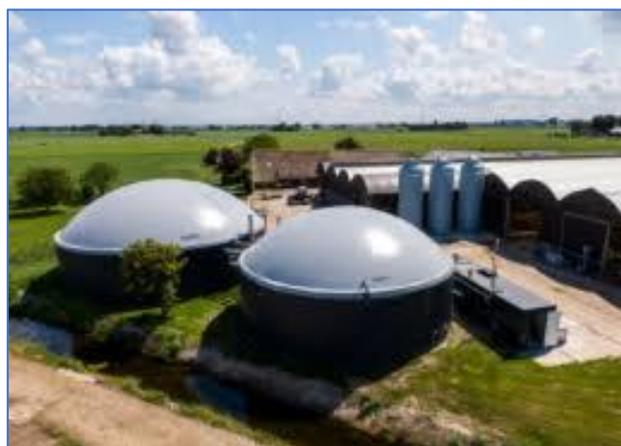
*Figure 12. Internet photo. Biogas installation from [www.Host.nl](http://www.Host.nl) with two large gas storage containers. The biogas must be purified and can be burned for energy (at night when there is no sun) or can be made into LNG for trucks.*

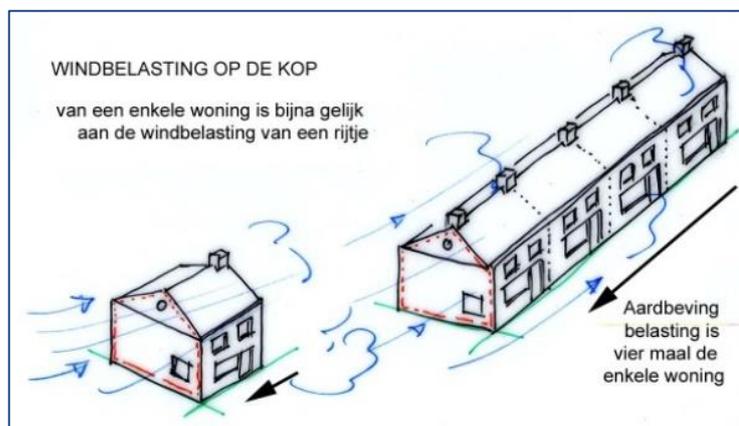
*Figure 14. The wind load at the head of a single house is approximately equal to the wind load at the head of a block of 5 to 7 terraced houses.*

*The earthquake load on the head of a block of four terraced houses is 4X that of a single house.*

A maximum storm load on a 50 m<sup>2</sup> head facade is approximately 50 tons. A cube-shaped terraced house weighs about 1500 tons. A PGA<sub>g</sub> 0.1 means an earthquake load of 0.1 x mass (1500 t) = 150 t, so approximately three times the storm load. According to the building standard, a block of 4 terraced houses is also designed for a storm resistance of 50 tons on the short end, but it will receive approximately 600 t perpendicular to the row of facades of the 4 houses. Because of the partition walls between these houses, these constructions can easily handle that load perpendicular to the long façade, but not to the short head. Although the storm load on the head is only 50 t, the earthquake load in the length direction is 0.1 x 4 x 1500 t = 600 t.

These houses have large windows front and rear, without internal walls on the ground floor. These are not designed for this earthquake load and therefore run a high risk of damage and falling over (like a card house). Thousands of such houses exist in the Groningen province.

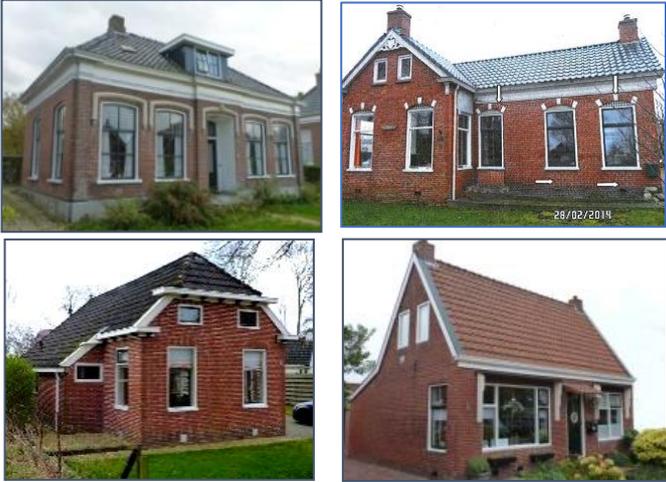
URM	Building description	Period	Floors	Image of frequent present Groningen housing. The oldest houses have the most damage.
1	<p>Standing free. Flexible timber floors, half-brick (12 cm) inside walls. Exterior whole brick walls 22 cm.</p> <p>About 10% of the housing and with most of the earthquake damage</p>	< 1920	1-2

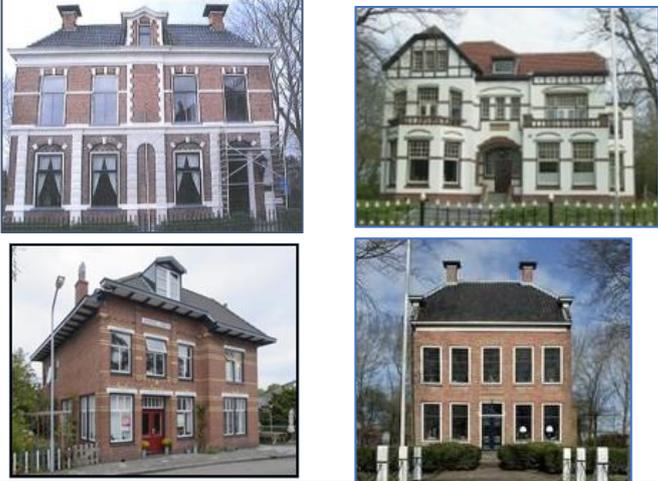
2	<p>As URM 1 . "Mansion". Attic in use</p> <p>Flexible timber floors, half-brick (12 cm) inside walls. Exterior whole brick walls 22 cm.</p> <p>About 5% of the housing and with most of the</p>	< 1920	≥ 3

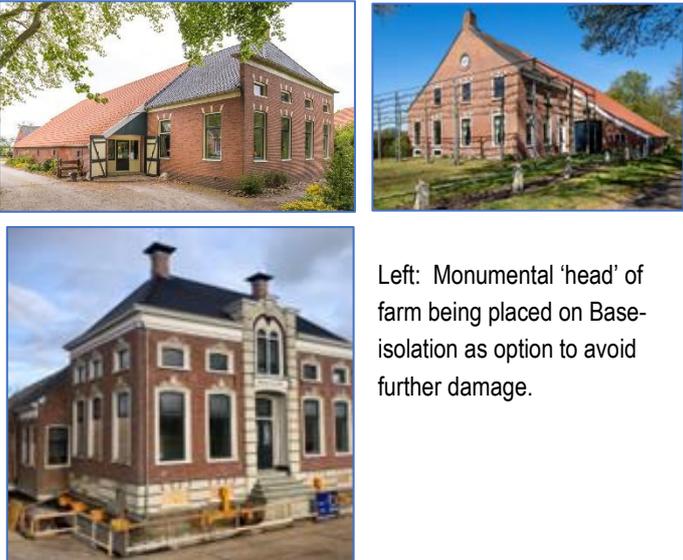
2a	<p>As URM 1 . "Mansion".</p> <p>As 2, but often classified as monuments.</p> <p>Including the 'head' sections of the large truss farms. Some of these are masoned with clay making them extremely vulnerable.</p>

<p>Left: Monumental 'head' of farm being placed on Base-isolation as option to avoid further damage.</p>

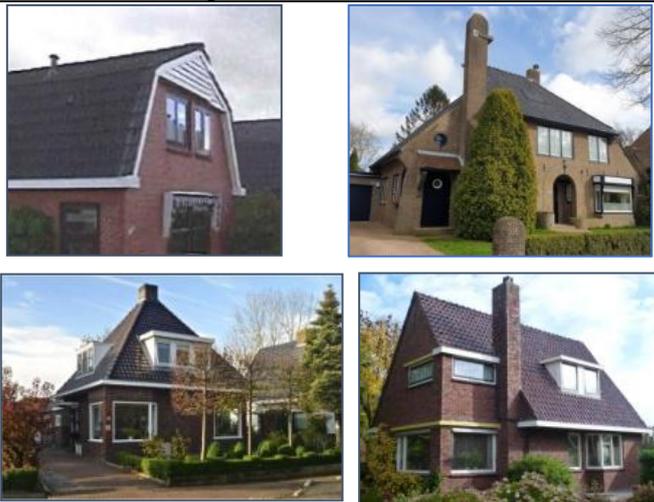
URM	Building description	Period	Floors	Image of frequent present Groningen housing. The oldest houses have the most damage.
3-4	Free standing or two-under-one-roof. Flexible timber floors, half brick (12 cm) inside walls and whole brick (22 cm) exterior walls.  High chimneys from period 1930 are an additional high risk objects.	1920-1960/70	1-2 and $\geq 3$

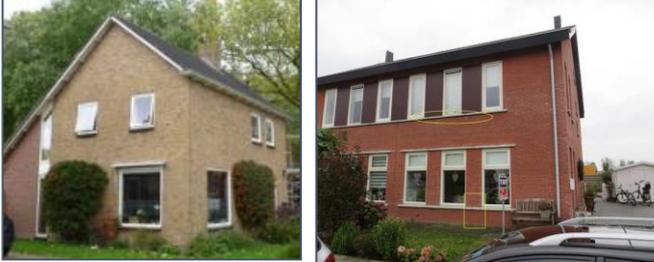
5-6	Free standing or two-under-one-roof. Reinforced concrete floor stiff diaphragm. Less damage, but large building mass.	>1960/70	1-2 and $\geq 3$

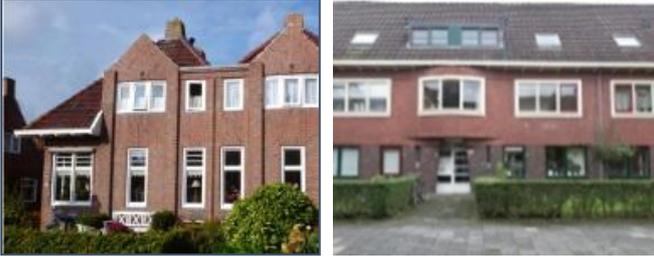
9-10	Terraced houses, Timber floors, half brick (12 cm) inside walls. Whole brick (22 cm) or cavity outside walls.	1920-1960/70	1-2 and $\geq 3$

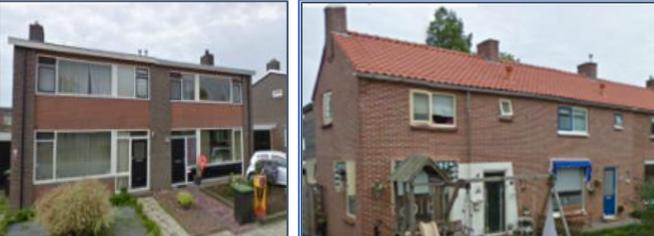
11	Terraced houses with large windows front and rear. Few or no inside cross walls. Reinforced	>1960/70	1-2

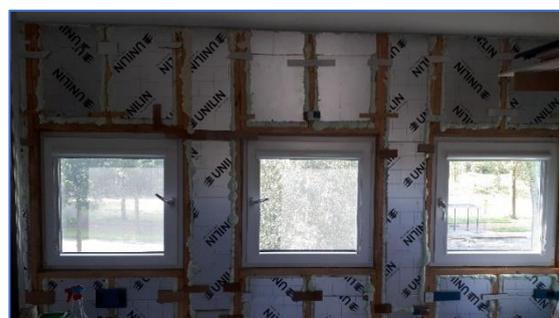
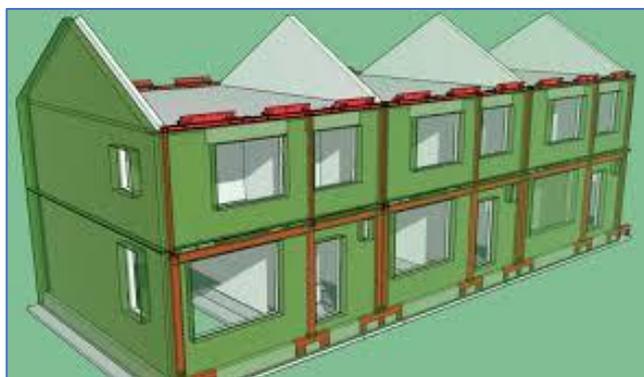
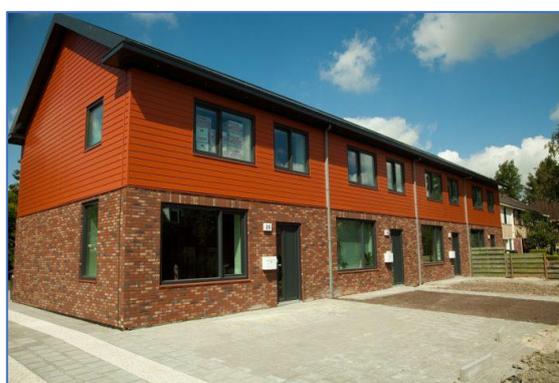
*Figures 15. When internally reinforcing an exterior wall with a timber frame construction (with tensile joints on the inner cavity wall), thermal insulation in accordance with the latest building standard (BENG 4.7 m<sup>2</sup>.K/W) is also required. The thermal insulation will hide the reinforcement construction, but the rooms become a little smaller.*

*With external reinforcement, for example when placing steel portals in the location of the outer cavity wall, thick thermal insulation and brick slips can then be applied, whereby the upper storey can have a more flexible plastic or wooden facade cladding. This way the houses do not become smaller inside, exterior finish is more expensive than interior finishings.*

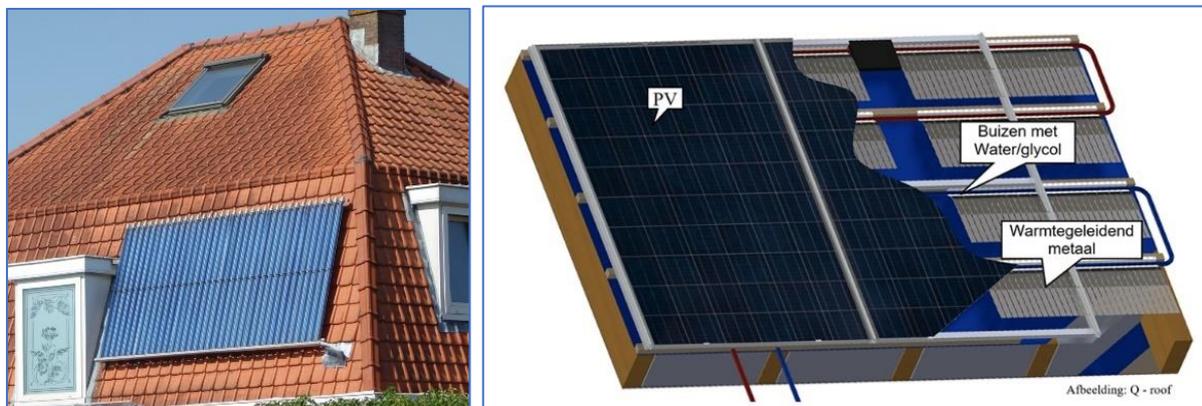
Figures 16. In addition to PV panels, there are also solar water heaters. *Photo left.* These supply approximately 50% of the domestic hot water requirement but may not be very effective during the clouded winter.

*Right.* Thermal PV panels (PVT) are connected to the heat pump. Under the PVT panels are radiators that absorb the air temperature and use that to upgrade the inside temperature.

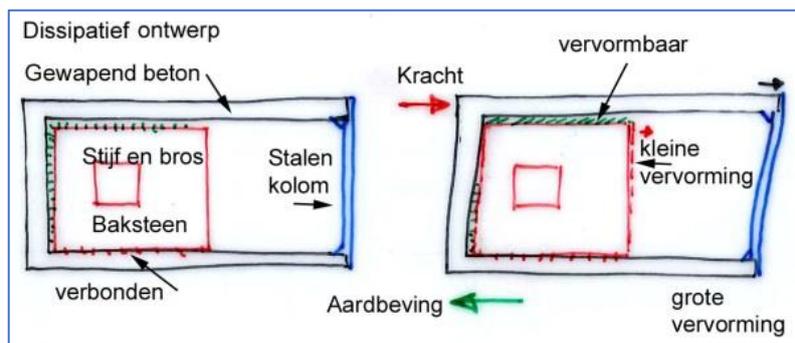
*Figure 17. Sketch of a facade. The rigid brick wall has only half the ductility of the reinforced concrete column.*

*The steel column can deform twice as much as the concrete column. When calculating the maximum permissible horizontal earthquake force, the loads must be distributed in accordance with the stiffnesses. The stiffest elements receive the largest loads. In the above case, the masonry should be connected in a flexible way to the reinforced concrete construction.*

This is important when reinforcing brick facades with metal portals. A building may be strong enough against collapsing, but the brick walls can still crack at maximum load if the stiffnesses and dilatations have not been considered. In a facade with wide and narrow window piers, the widest piers will absorb the most forces. This phenomenon is further explained in Chapter 6.

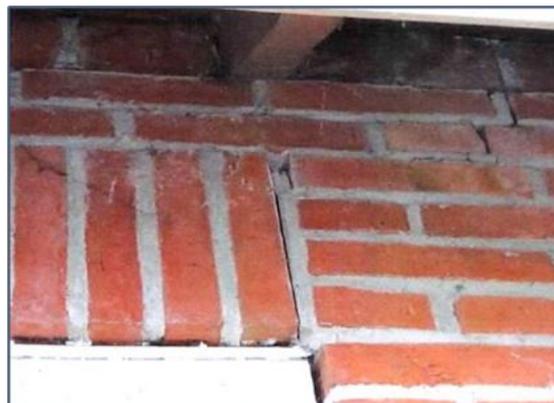
*Figure 18. Crack at the support/connection of a lintel that is supported on the inside wall of the cavity wall construction. Most cracks around window and door openings are building related and the cause of poor construction details, often combined with light settlement in the foundation. Vibration from heavy traffic or an earthquake can make them wors.*

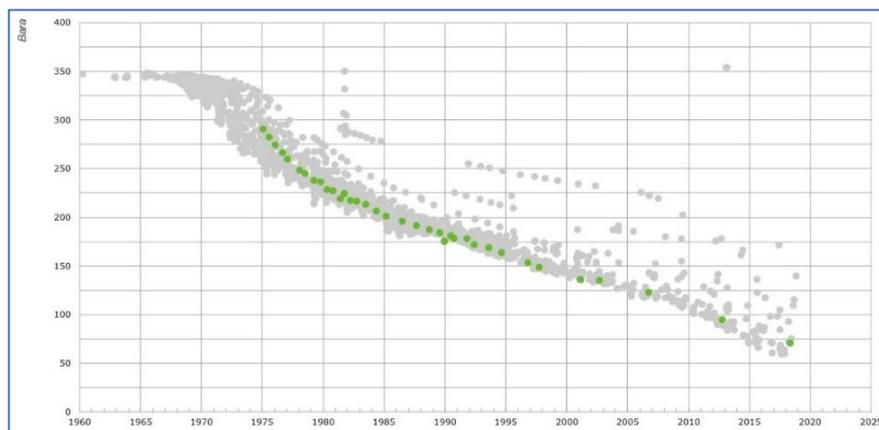
Figure 19. In this graph of the internal gas pressure from 2019 the pressure per measuring point (grey or green dot) is indicated. <sup>28</sup> Measured since 1965

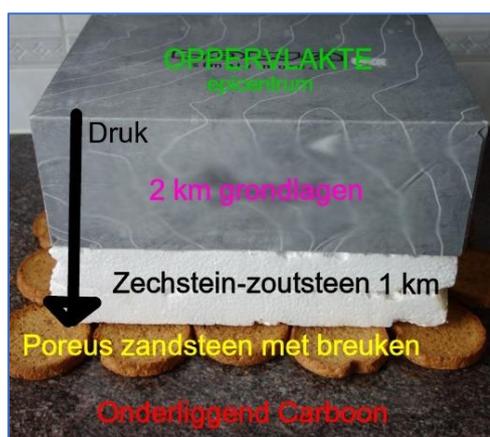
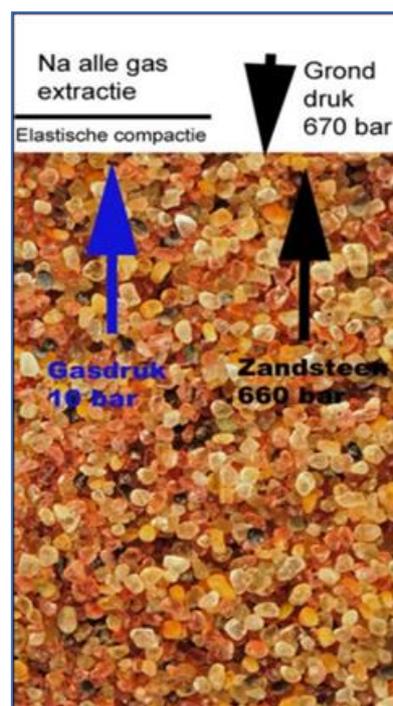
Oppervlakte = surface    Druk = pressure    2 km grondlagen = 2 km soil layers    Zechstein zoutsteen = Zechstein salt rock  
 Onderliggend Carboon = underlying Carboniferous    Na alle gas extractie = after all gas extraction,  
 Elastische compactie = Elastic compaction    Grond druk 670 bar = soil pressure 670 bar

Figures 20. To make a comparison, you can load rusks/biscuits under two masses more heavily. A reduction in pressure in the sandstone corresponds to a greater load from above. With extra pressure, the rusks are slightly compressed until they crush.

Impression of the grain structure in the sand layer that is compressible. By compressing the cores in a laboratory, as was done in the sandstone layer, one gets an impression of the elasticity of the sandstone layer and at what pressure it will be crushed (causing an earthquake shock).

In August 2015 rock samples were taken from the 3 km deep gaseous sandstone layer. These samples have a length of 30 m with a total length of 180 m. Drilling to these cores is done with a derrick and a hollow drill head, like the functioning of an “apple drill”. These nuclei were analysed for their possible compaction.

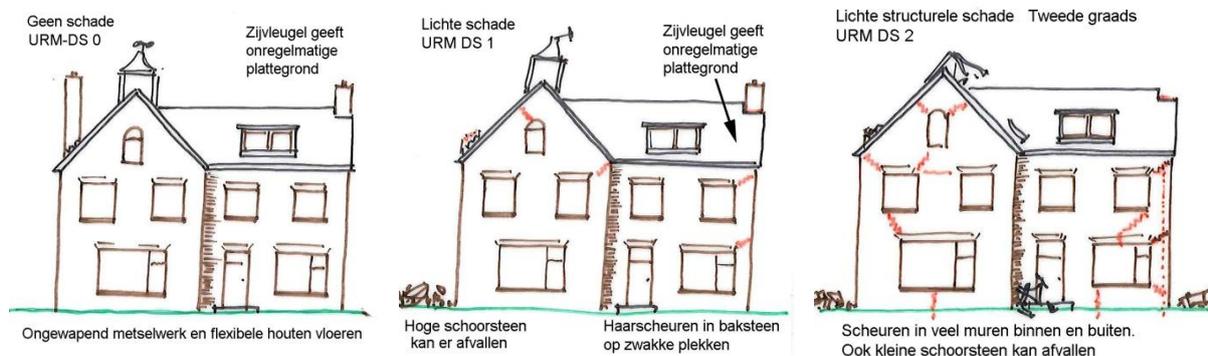
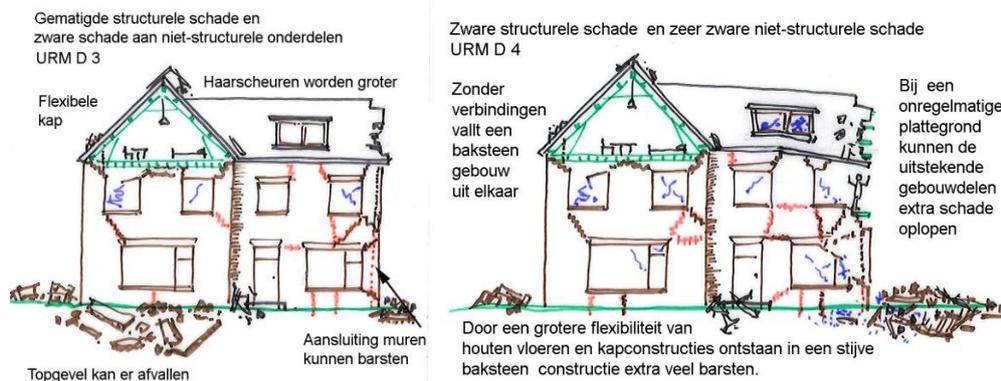
Scheuren in veel muren binnen en buiten = Cracks in many walls inside and outside.

Ook kleine schoorsteen kan afvallen = Also a small chimney can drop down.

Figures 22. These three: DS1, DS2 and DS3 are in the NPR. Mainly DS1 has been shown in the province Groningen. The necessary seismic strengthening according to the NPR is to prevent D4 (partial collapse).

Left below. Gematigde structurele schade en zware schade aan niet-structurele onderdelen = Moderate structural damage and large damage to non-structural elements. Flexibele kap = Flexible roof construction.

Door een grotere flexibiliteit van houten vloeren en kapconstructies ontstaan in een stijve baksteen constructie extra veel barsten = Because of the larger flexibility of timber floors and roof construction, an additional number of cracks will appear in the ridged brick masonry.

*DS2 only exists in Groningen when the building has been erected according to old standards or if serious construction errors were made.*

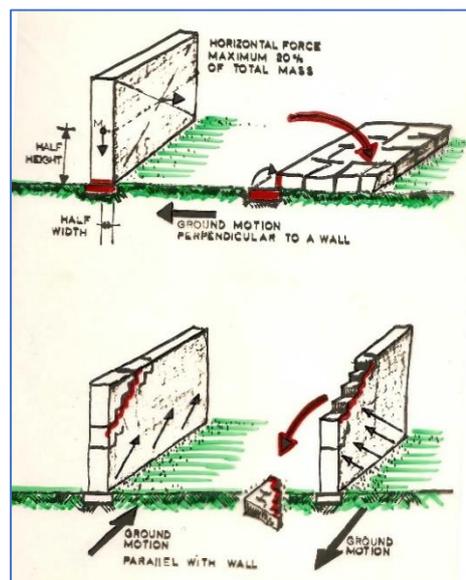
Left sketch. Lack of a diaphragm will cause the topside of unsupported wall to break outside their plane.

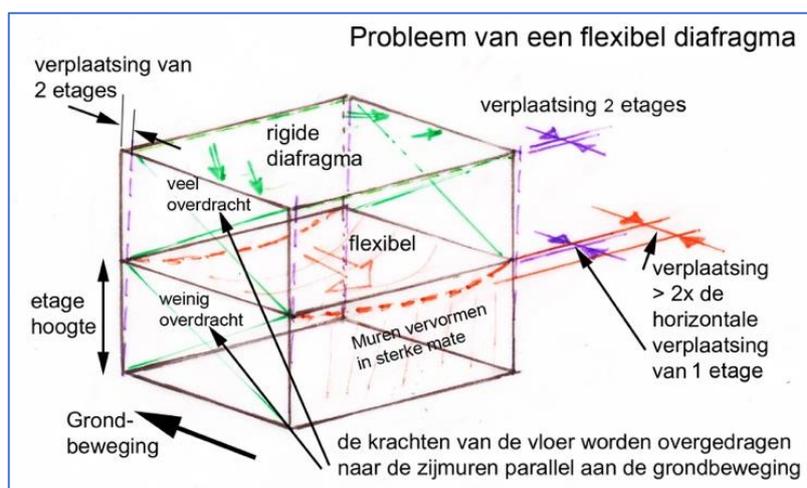
Verplaatsing van 2 etages = Displacement of two storeys. Etage hoogte = height of storey.

Veel overdracht = large transfer (of forces). Weinig overdracht = Little transfer. Grond beweging = ground movement.

Figure 24. A rigid diaphragm will transfer maximally the forces from the floor to the side walls that are parallel to the ground movement and strong in their plane.

A flexible diaphragm will deform strongly in its own plane and will greatly stress and deform (crack) the front and rear wall.

A **flexible** diaphragm is a (floor) plate or disc that has a horizontal deformation over its length that is twice the horizontal displacement per storey height (orange).

A **ridged** diaphragm is a very ridged (floor) plate or disc that has a horizontal deformation over its length that is at most half the horizontal displacement per storey height (for example, a reinforced concrete floor).

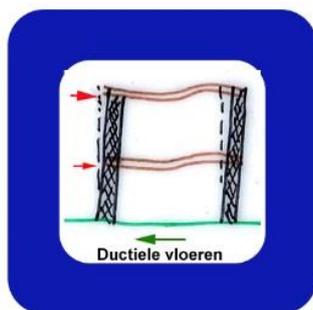
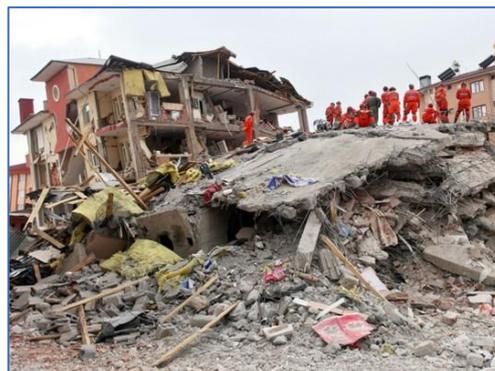
Te stijve vloeren = Too rigid floors    Ductiele vloeren = Ductile floors

Figures 25. Left. The wrong design/situation with ridged floors and flexible columns (red.)  
Middle. Good design/situation with strong columns and flexible floors (blue).  
Right photo. With the failure of columns, the entire building will collapse, and the building will pancake.

In the vertical plane, the floors must NOT be stiffer than the connections to the load-bearing walls or columns. If the floors or diaphragms are stiffer/stronger than the columns, this will result in an increased load on the columns in the event of an earthquake, just below and above the ridged floor, where the maximum moment zone already exists. This can endanger the columns if the load is too great. When the walls or columns give way, a building will collapse, not when floors collapse.

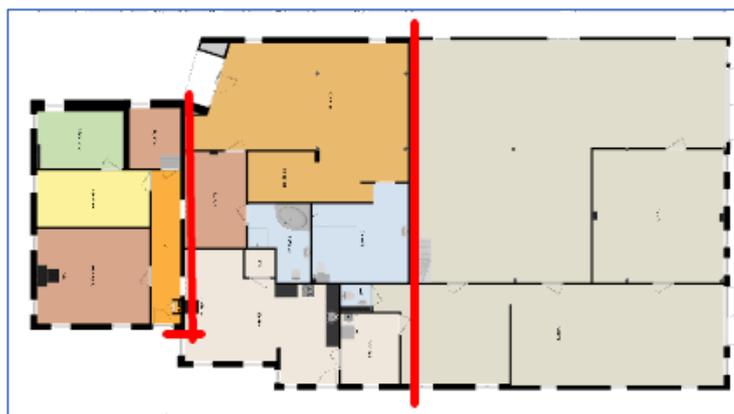
Figures 34. Large timber truss farms have stiff masoned front buildings and must be dilated between the different masses and flexibilities of those masses. Lack of dilatations between building parts caused a lot of building damage in the province of Groningen.

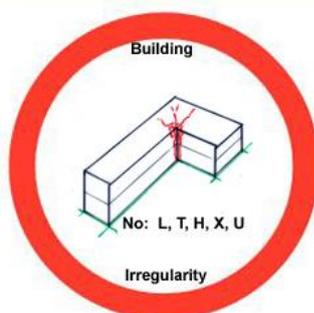
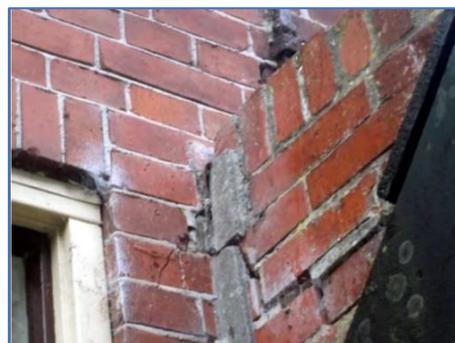
Left. Elongated buildings or buildings with side wings without dilatations can suffer major damage at their inside corners in the event of tremors. Dilating extensions or side wings prevents such damage.  
Right. Example of cracks in the inside corner of an L shaped building.

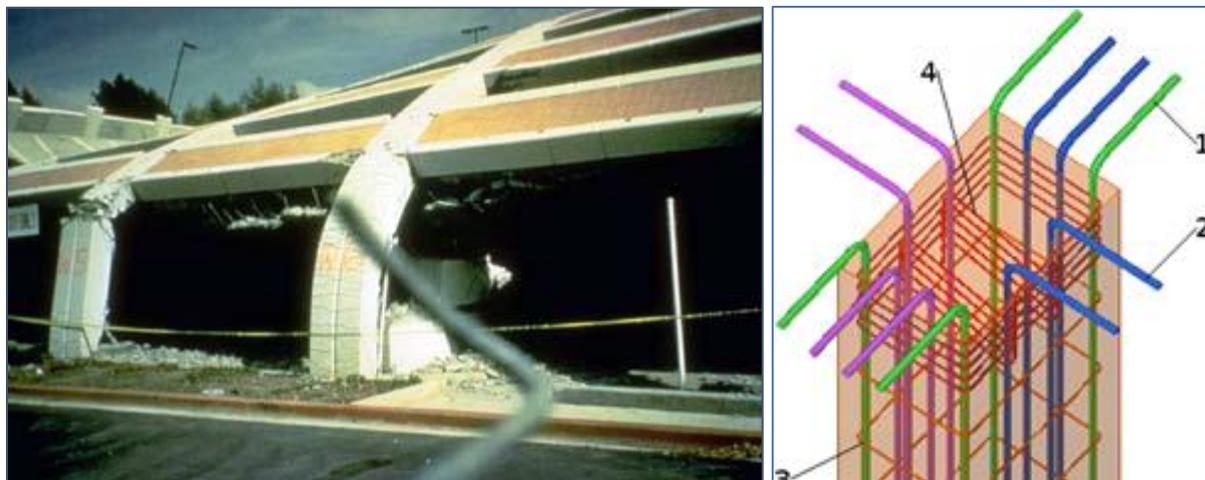
Figures 35. (Internet photo) Ductile columns of a parking garage. The earthquake load on these columns was much higher than the calculated strength. Ductility is achieved by both the material used (bendable steel) and the way in which the reinforcement forms a basket in the maximum moment zones, so that the concrete remains within the basket and does not lose its compressive function.

Designing buildings in tectonic earthquake zones continues to pose unknown risks. By designing the structures ductile, total collapse will not occur in the event of too heavy load (than the design) or repeated shocks and failure. The basket construction in the maximum moment areas keeps the broken concrete in place so that it can still absorb pressure.

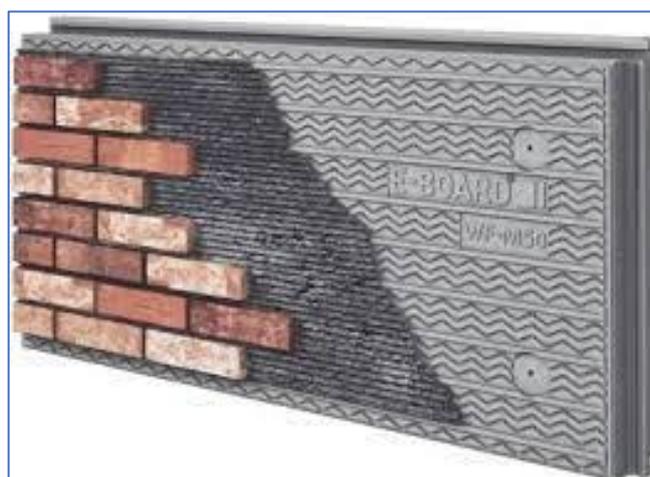
Figure 36. Brick slips can be produced in many (including classic) designs and glued to thermal insulation boards. By adding them with a slightly flexible component adhesive, the load-bearing construction can move slightly without this being visible by cracks in the outer facade. Retrofitted houses will be well insulated and show no more cracks in their facades.

Brick is a brittle or non-ductile material and will crack if overloaded. This is especially the case with the sudden short shocks of the Groningen earthquakes, but this has no constructive consequences when for cracks  $< 2$  mm. To prevent this kind of damage, only Base-isolation or excessive reinforcement is an option. Alternatively, the damaged brick wall can be insulated and re-clad with a slightly flexible material such as wood or glued brick slips.

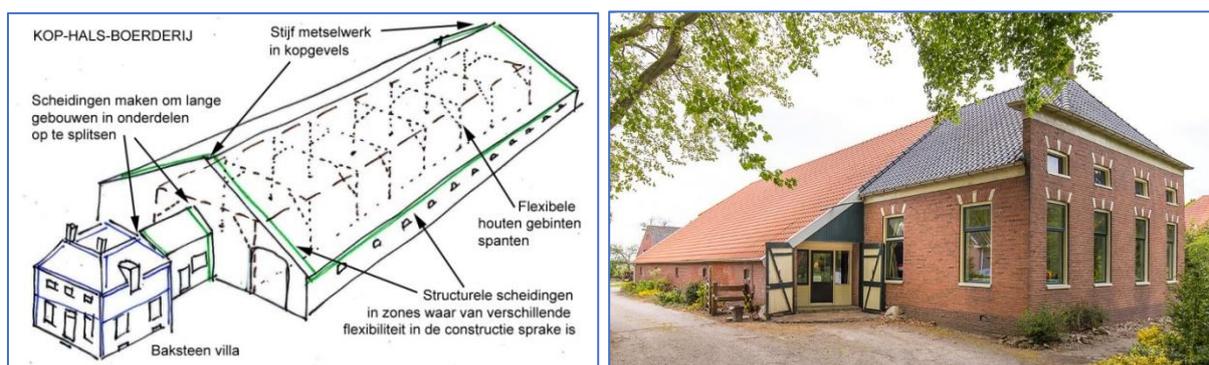
*Figures 37. Left:* By dividing a traditional head-neck-trunk farm building into three parts: the house, the intermediate piece and the barn, each part has its own dynamic independence. In this way, damage between the differently shaking building components is prevented. The different parts with their different stiffness can be calculated as independent units and each reinforced in its own way.

*Right:* This traditional head-trunk farm built as fully connected must be disconnected behind the head of the more flexible large-truss barn to prevent damage to both buildings.

The (old) brick head-house (*Figure 37 right*) has a different height, mass, rigidity, and function from the large timber truss barn which is a very flexible and hollow construction. This shed will therefore move differently from the main head building during an earthquake. The old house can eventually be placed on Base-isolation when it is a monument, or it must be considerably reinforced throughout. Chapter 2. Shape of buildings.

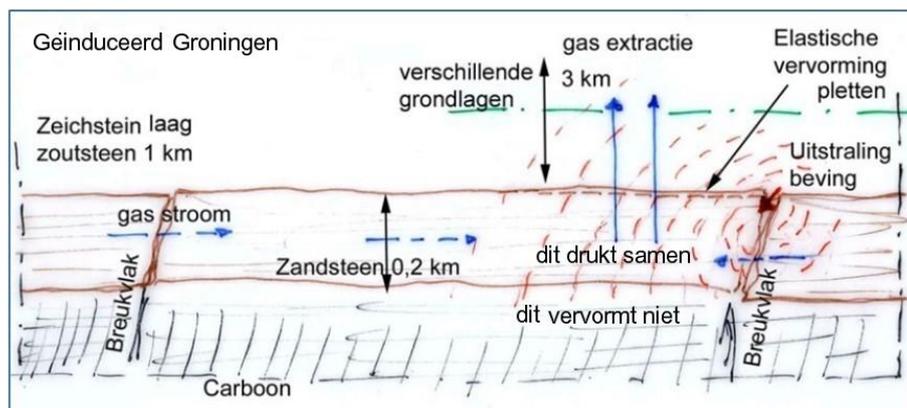
Zoutsteen = saltstone  
 Zandsteen = sandstone  
 Grondlagen = soil layers  
 Breukvlak = fault  
 Elastische vervorming pletten = elastic deformation compaction  
 Vervorming = deformation  
 Drukt samen = compression  
 Vervormt niet = does not change in shape  
 Uitstraling beving = progression of shock

Figure 38. Induced earthquake. The rapid extraction of natural gas from the porous sandstone causes a local pressure reduction inside that sandstone layer on one side of a fracture or fault line. The upper pressure remains the same and causes elastic compaction of the sandstone. The carrying capacity of the sandstone layer is reduced because of the lesser internal gas pressure. Due to the constant weight of the 3 km soil layers, the sandstone is suddenly crushed when the combined carrying capacity is exceeded (stone + pressure), causing a short shock wave. The same will lead to small soil settlements above the tough salt rock layer of the Zechstein.

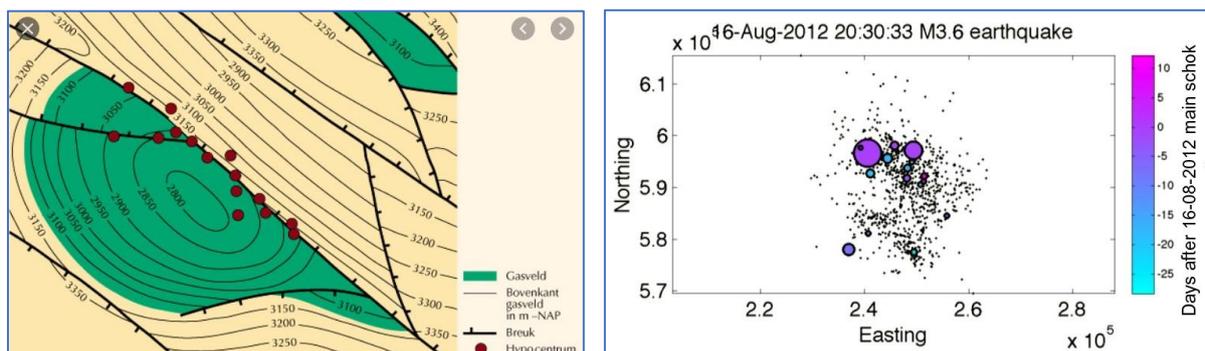
Figures 39. Left: Depth lines/contours and measured locations of the shocks (Hypocenters) along a fault line<sup>38</sup>. Right: The main and aftershocks of the Huizinge 16-08-2012 earthquake. These show that in the next four days many small extra shocks/settlements occur all around the main shock. These small settlements (shocks that cannot be felt by people) also occur above the tough salt rock layer (about 1 km thick) and affect the ground level. These smaller shocks/vibrations, however, do have an impact on the soil surface and can negatively affect the build environment, causing cracks in brittle masonry.

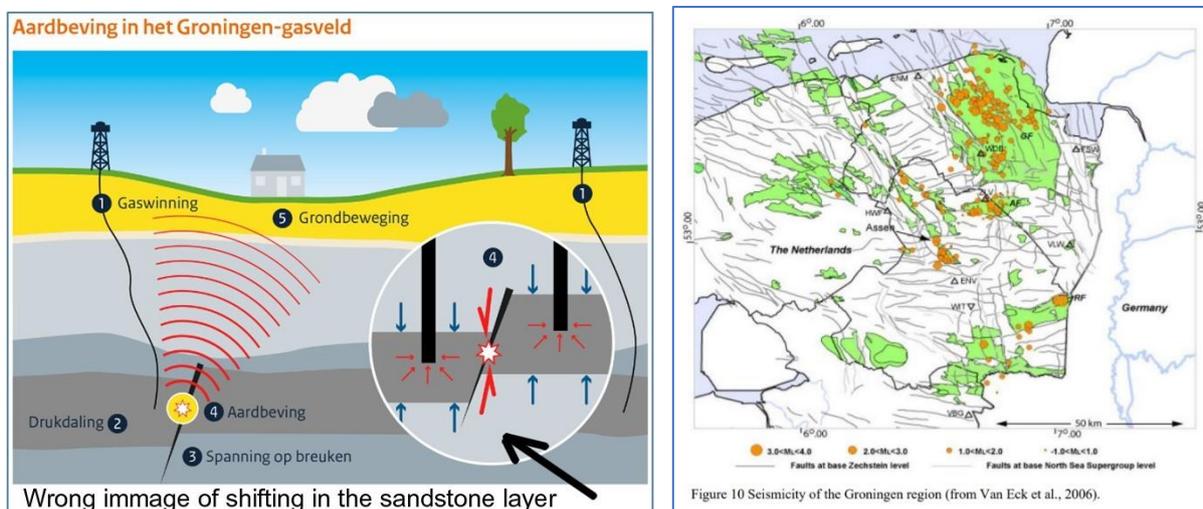
Aardbevingen in het Groningen gasveld = Earthquakes in the Groningen gasfield

Figures 40. *Left:* Example of a misrepresentation of the fault shifting process as presented in various publications and by the KNMI about the origin of the induced earthquakes. This image is copied from tectonic earthquakes. This image suggests that the underlying Carboniferous layer is pushing up along the fault lines. This is not the case, only the gas containing sandstone layer is compacted/crushed.

The image also suggests that there is subduction over the area the sandstone is pressed upwards.

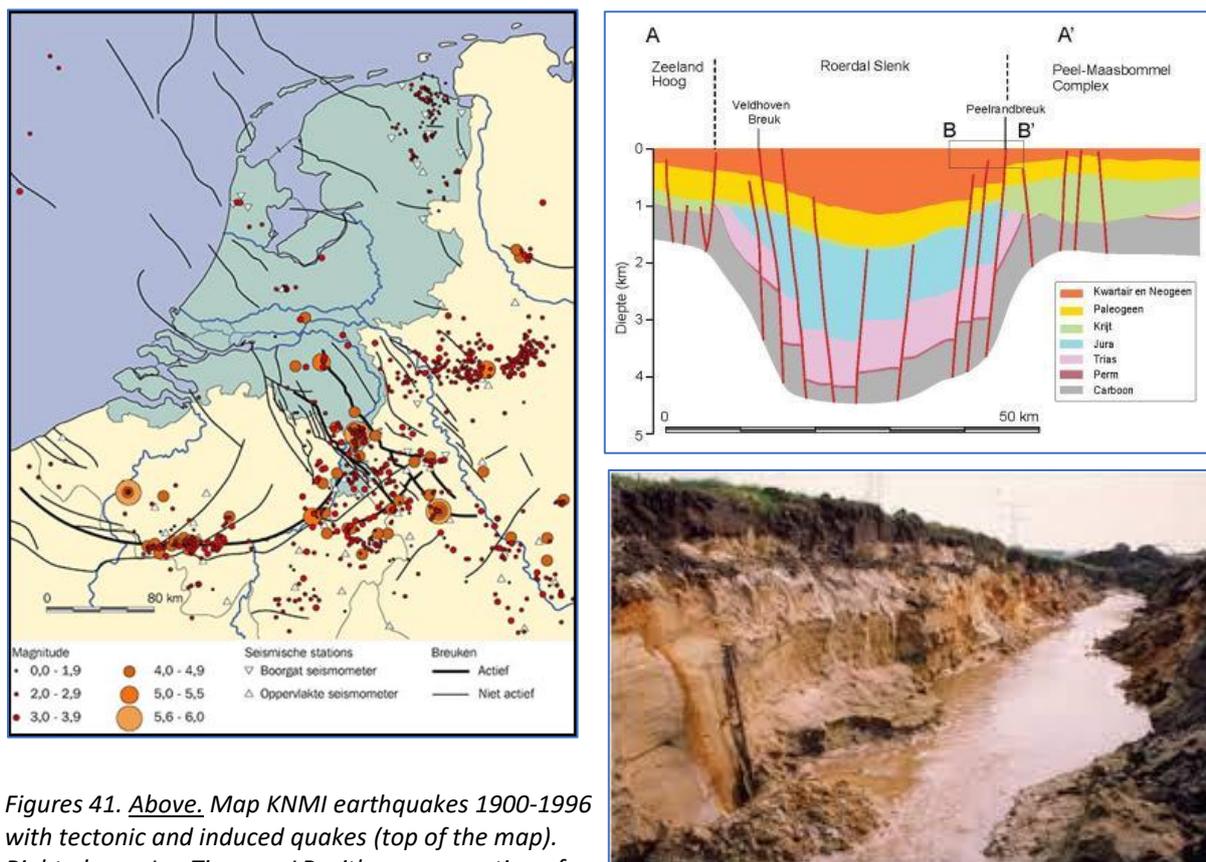
Figures 41. Above. Map KNMI earthquakes 1900-1996 with tectonic and induced quakes (top of the map).

Right above: Jan Timmers LR with a cross-section of the Peel edge fracture below the main rivers in the map. Tectonic earthquake Roermond.

*Photo from after the earthquake 13-04-1992 in Roermond where the ground sank locally by 60 cm. Despite their relatively low magnitude, on the Richter scale of up to 3.6 (PGAg < 0.1), the gas-induced earthquakes are strongly felt. This is due to their shallow hypocentres. These induced earthquakes rarely last more than a fraction of a second, but buildings on the surface vibrate because of the clay and peat soil layers and their own elasticity. In fractures that are mainly in the sandstone layer, such as in the province of Groningen, the subsidence differences at the earth's surface will be small, only millimetres. When in a brick masoned building one part of the foundation settles 2 mm, then a 2 mm crack will occur in the brick wall, being very visible in plasterwork.*

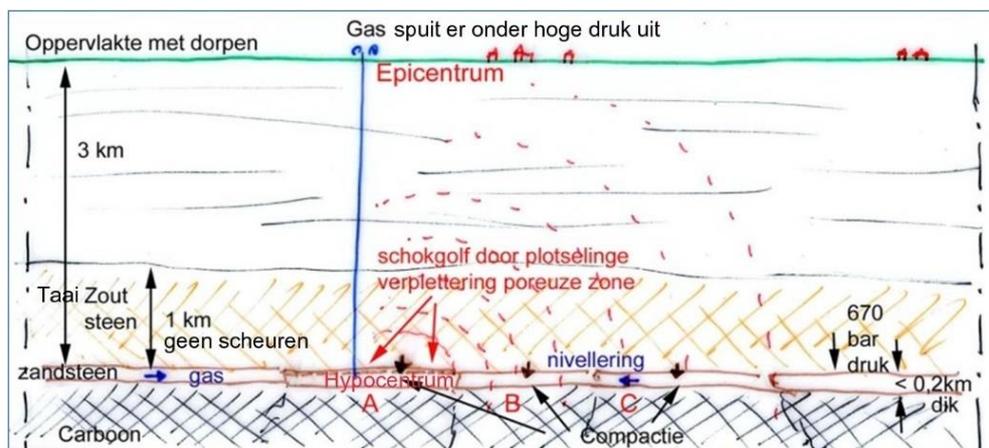
Oppervlakte met dorpen = Surface with villages. Gas spuit er onder hoge druk uit = Gas is expelled under high pressure. Geen scheuren = No cracks. Schokgolf door plotselinge verpletting poreuze zone = Shock wave by sudden crushing of the porous layer. 670 bar druk = 670 bar pressure.

Figure 42.  
The sketch has been drawn in the correct height ratio for the sandstone layer.

Buildings at the epicentre experience most the vertical shock impact.

Buildings that are more than 3 km horizontally from the epicentre experience more the horizontal impact from the shocks. The tough salt stone layer levels out the settlement over a wider area. A settlement of  $\approx 60$  cm takes place over the entire area over the 50 years, corresponding to the compaction in the sandstone.
