# Chapter 1 Alphabetic listing of terminology and abbreviations related to the induced earthquakes

in Groningen from Accelerometer to Zechstein.

Explanation of terminology, concepts, and abbreviations, related to the Groningen Induced Earthquakes that occurred since 2000 and culminated in 2012, with comments and sketches.

By: Sjoerd Nienhuys  
Construction, seismic engineer  
April 2023

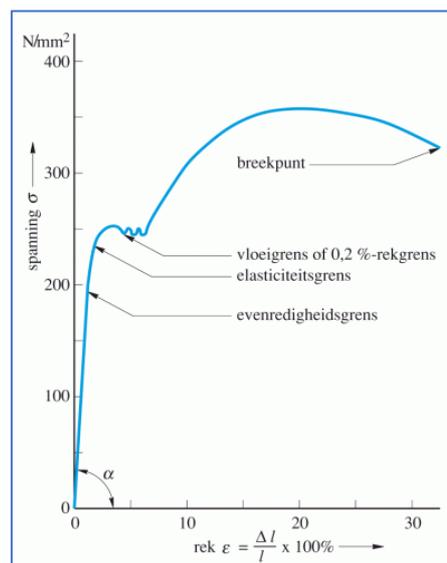
Evenredigheidsgrens = proportional limit

Breekpunt = point of separation

Figure 44. Tension diagram of steel. From architecture book. The calculation standard is the proportional limit of the steel, where the elongation has the same % as the increase in tensile force. This proportional limit of  $200 \text{ N/mm}^2$  is used in the calculations, while the elastic limit is up to  $230 \text{ N/mm}^2$ . However, after deformation, the steel can still withstand a load of up to approximately  $350 \text{ N/mm}^2$ , almost twice the calculation standard. To a lesser extent, this phenomenon also occurs with other building materials.

A new-build home built in accordance with the 2012 Building Decree can withstand 30% to 50% higher loads than for which it was designed. This is because most construction standards for materials have a margin of safety built into them. The material standard often corresponds to the lowest value of a large series of tests, not the average. When calculating reinforced concrete structures, there is an extra safety margin on top of the material strength. Metal construction parts and the reinforcement in reinforced concrete are ductile (tough), so that they can still absorb high loads after deformation.

Each material has a certain elasticity that is expressed by the elasticity module or the Young module (within the elastic zone). When the maximum elasticity of a material is exceeded, permanent deformation will occur. In the tensile diagram of steel reinforcement bars, the elastic limit is 200 N/mm<sup>2</sup> and the very high modulus of elasticity is 220 kN/mm<sup>2</sup>. *Figure 44.*

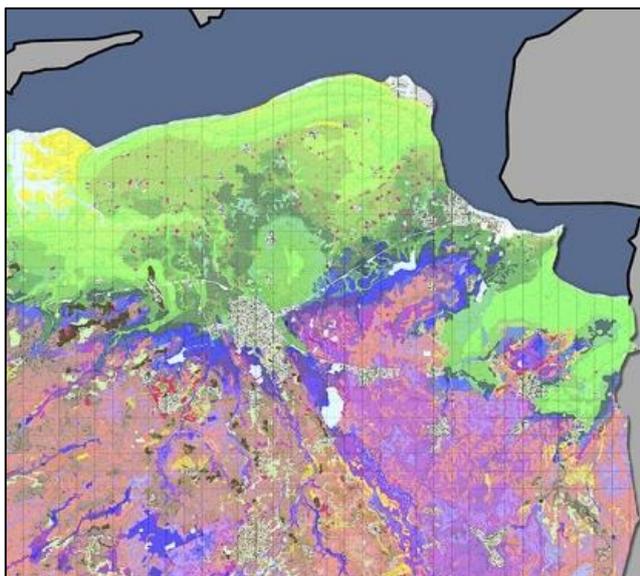
Figure 46. The accompanying soil map of the province of Groningen and the surrounding area indicates the most important soil types.

The green and light green areas (clay soils) in the NPR map give the highest values for  $V_{s;30}$  and therefore also for the PGA<sub>g</sub>.

The purple, firmer soils give a lower value for the  $V_{s;30}$ , which means that the quakes are also less strong and can last shorter.

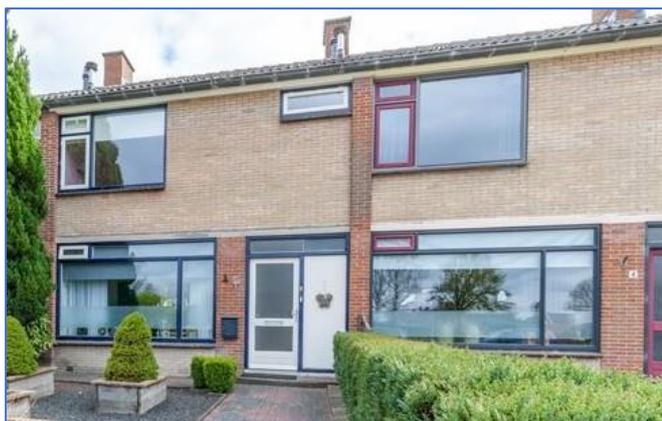
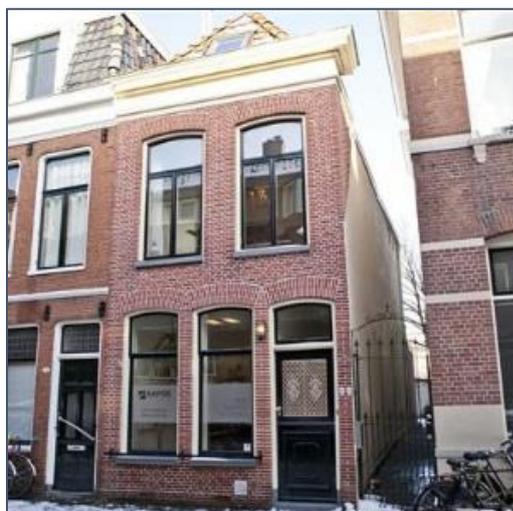
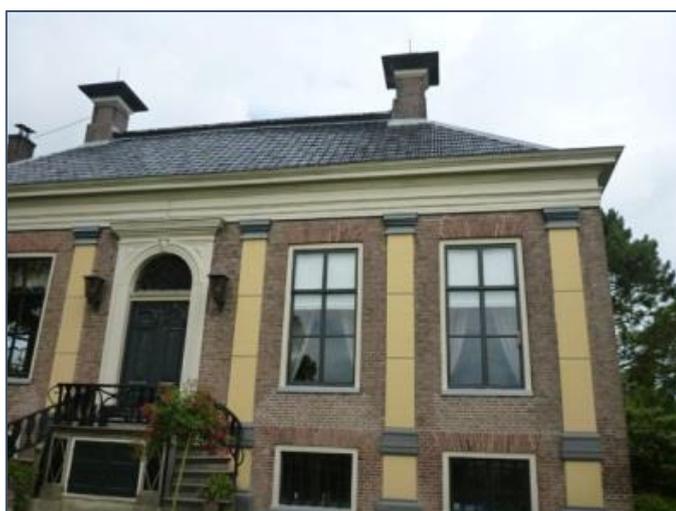
*Figures 46. Common terraced houses with and without wide windows and small piers in the lower facades and without moment-resistant floor-wall connections in the longitudinal direction of the building block, belong to the weakest building categories. Good reinforcement methods are available for all types of buildings, but economic factors play a major role in the decision-making.*

*These two older buildings (period 1800) are seismically among the weakest construction types.*

*Left. The ground floor has very narrow window piers and high windows. This type of town building has no interior cross walls for stability that can absorb the transverse seismic load.*

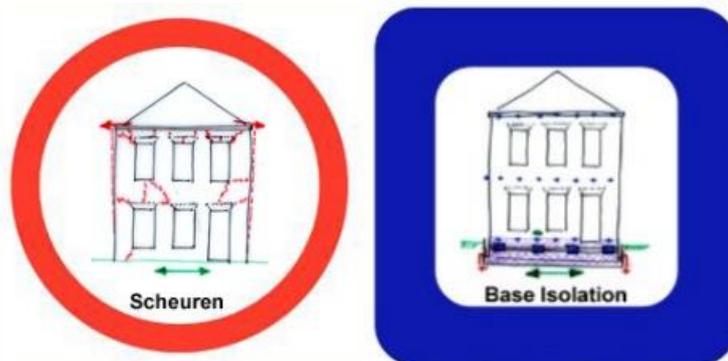
Scheuren = cracks

*The whole building is cracking around all openings (danger).*

*Due to the Base isolation, only light forces are exerted on the structure above (safe).*

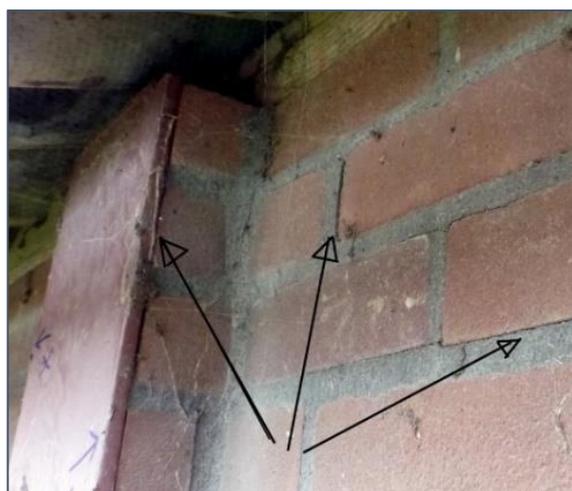
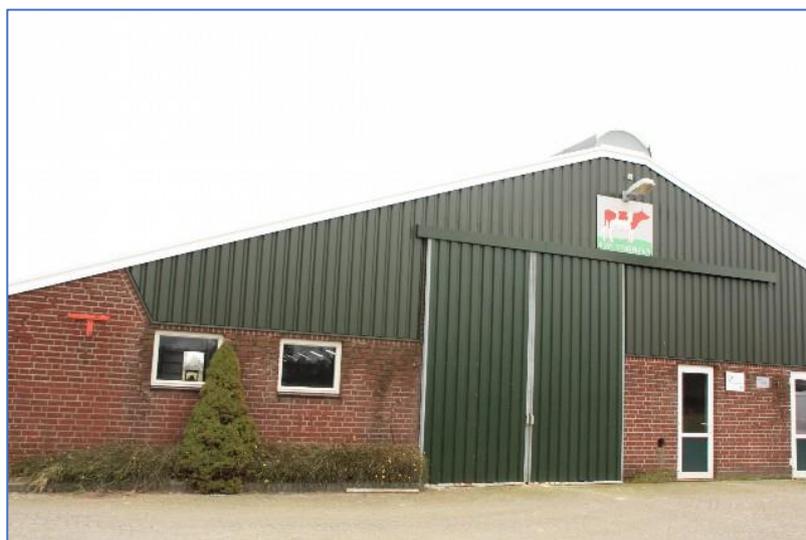
*Figures 49. Along the steel columns of this steel truss chicken shed, the joints in the brick have cracked because of different elasticities between the steel frame and the rigid brick infill wall.*

*In such a construction, the different materials must be dilated from each other. This "damage" has no negative constructive effect whatsoever.*

*By dividing up the very large end facades of old farm barns (separation at the stable doors) and making the tops of those facades in flexible sheet material, cracks due to settlement or movement of the flexible roof construction are prevented.*

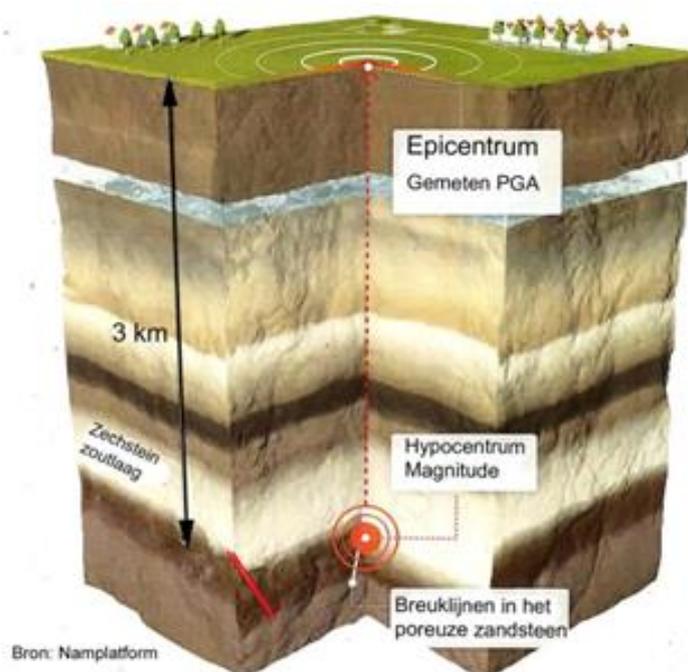
*Figure 50. The 0.5 km to 2 km (average 1 km) thick Zechstein salt layer is too tough to undergo fractures.*

*The Carboniferous layer below the sandstone reservoir does have fractures, but the rock layer does not move along those fractures during a displacement or an earthquake in the sandstone layer.*

*In the province of Groningen, the epicentre is about 3 km above the hypocentre. An earthquake takes about one second to travel this distance.*

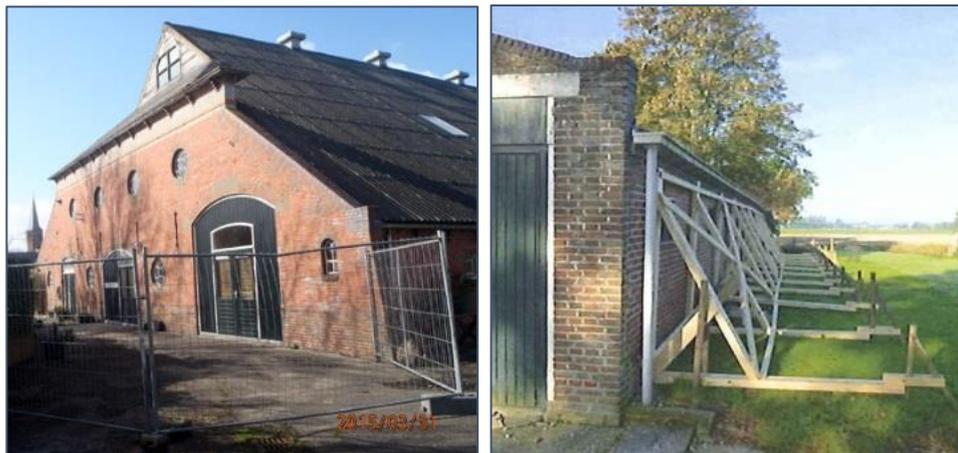
Figures 51. *Left.* Barrier around a high-risk facade construction. The flexible roof provides no support (but does provide additional load) on the already large mass of the high-top facade. *Right:* Struts of an old bad side wall.

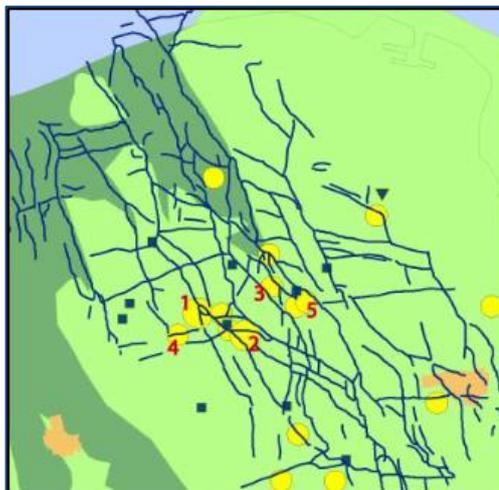
Figure 52. The 2014 KNMI-NAM map shows the largest fault areas in the gaseous sandstone layer. Outside the Groningen gas field there are many other small gas containing areas, about 1700 in total. The red numbers are the locations of the largest shocks up to 2012. In the above the sandstone reservoir positioned (sealing) Zechstein salt-rock there are no fracture planes or faults, and no shocks occur there.

Recent maps are much more accurate and show many more fracture planes in the sandstone layer.

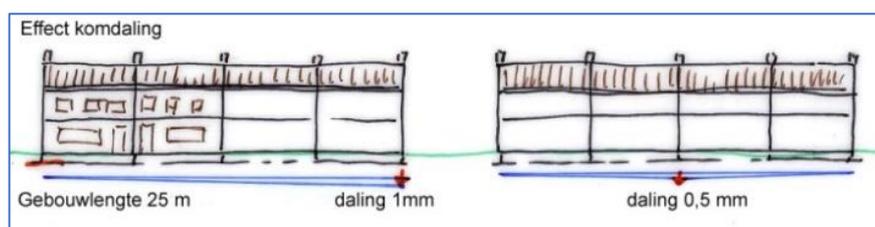
Figure 53. A building that is perpendicular to the contour lines of the subsidence will sink more on one side than on the other.

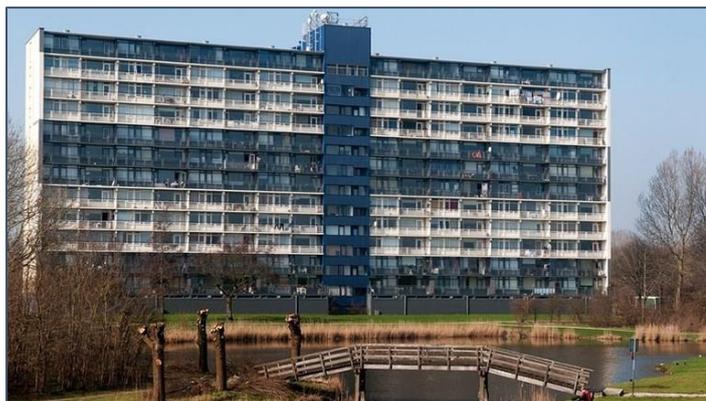
*A detailed NLTHA survey was done on the seismic strength of this and other apartment buildings. Due to the assumption of somewhat flexible connections between the elements, the building turned out to have a reasonable strength.*

*This is a consequence class CC3 building.*

An interesting example of a building with rigid reinforced concrete construction elements and somewhat ductile or loose connections is the Dijkzicht flat in Delfzijl (photo above). After detailed NLTHA measurements of the actual structure and very detailed calculations (assuming possible movement in the joints), the building's resistance to earthquakes was estimated to be greater than the simple static calculation indicated.

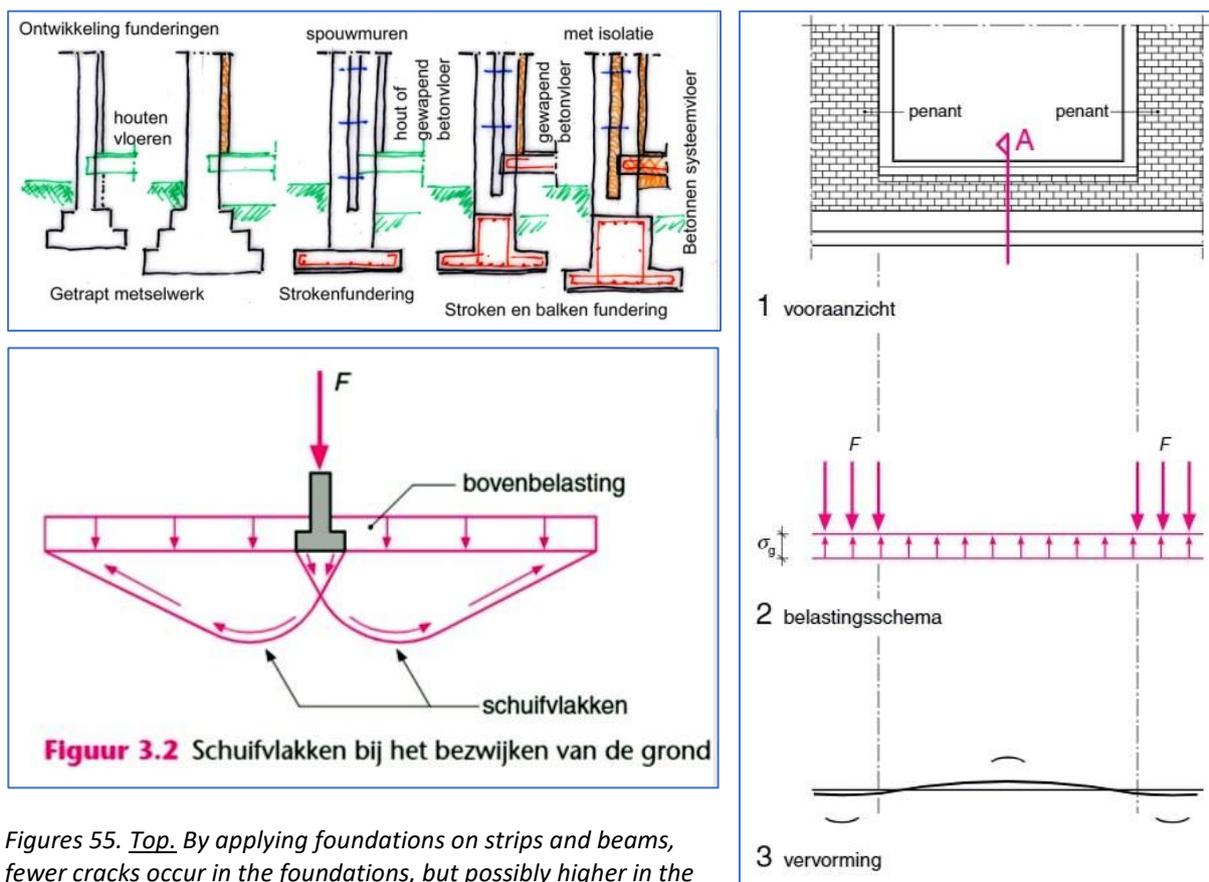
Figures 55. Top. By applying foundations on strips and beams, fewer cracks occur in the foundations, but possibly higher in the building (construction periods 1970s and 1980s).

Above. Calculations involve the mass of the soil besides the foundation. Foundations on undisturbed soils must be laid wider with higher building loads.

Right. With a smaller load under windows, foundations are subject to negative moment forces.

Ontwikkeling funderingen = Development of foundations

Strokenfundering = Continuous slab foundation    hout of gewapend betonvloer = Timber or reinforced concrete floor

Betonnen systeemvloer = concrete prefabricated floor    Stroken en balken foudation = slab/strip and beam foundation

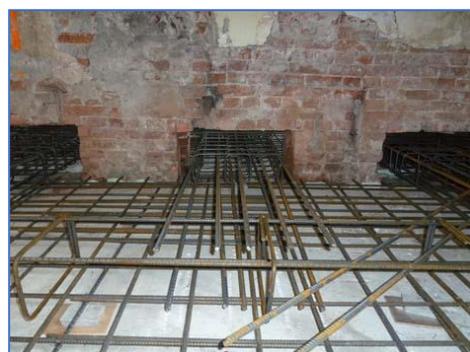
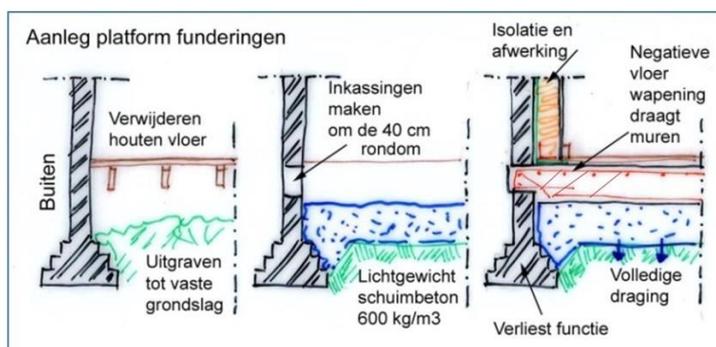
Figures 56. Photo and sketch of the construction of a platform foundation in an existing building. By making a fully load-bearing plate under the entire building, the ground pressure is reduced even more. See also Chapter 4.

Due to this design, the building mass causes a low, fully distributed pressure on the ground and the risk of settlement is greatly reduced or avoided, and thus also crack formation because of any settlement. This slab foundation (sometimes on foam concrete) can be added to existing buildings by constructing it with encasement into the walls at regular intervals and installing a load-bearing concrete floor with negative reinforcement in the concrete floor along all walls.

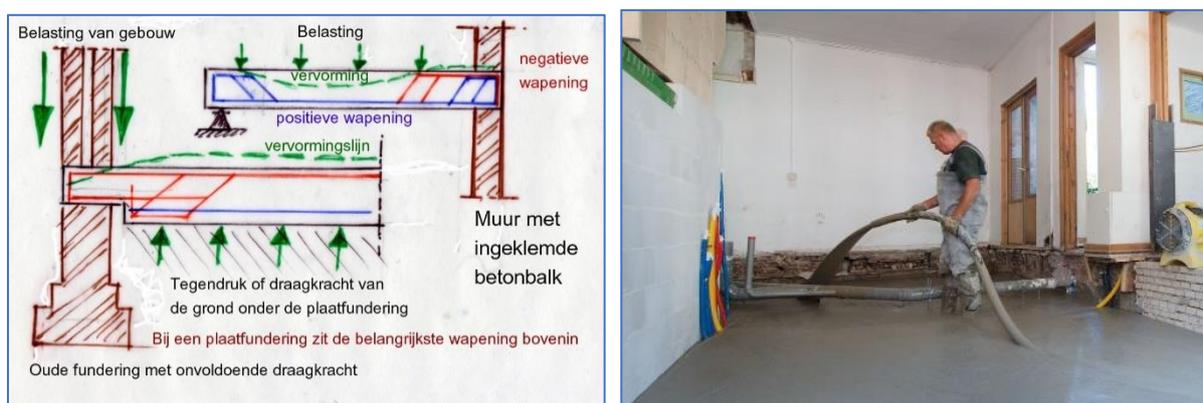
Figures 57. *Left.* With a concrete beam, a negative moment is created when loaded and clamped in a wall. Here, 'negative' reinforcement is applied (red). With a slab foundation, the load on the building is all around along the edges of the floor, meaning the reverse load of an elevated self-supporting concrete floor. Negative reinforcement must then be placed in the entire top of the slab foundation. *Right.* Application of foam concrete after foundation repair. <https://vandijkmaasland.nl/expertises/schuimbeton/woningbouw/>

Belasting van gebouw = Load of the building    Belasting = load    Negatieve wapening = negative reinforcement  
 Vervorming = deformation    Positieve wapening = positive reinforcement    vervormingslijn = deformation line  
 Tegendruk of draagkracht van de grond onder de plaatfundering = reactive pressure by the soil under the platform  
 Bij een plaatfundering zit de belangrijkste wapening bovenin = with a platform foundation the most important reinforcement is in the upper part of the plate.  
 Oude fundering heeft onvoldoende draagkracht = Old foundation has insufficient bearing capacity  
 Muur met ingeklemde betonbalk = Wall with sandwiched reinforced concrete beam.

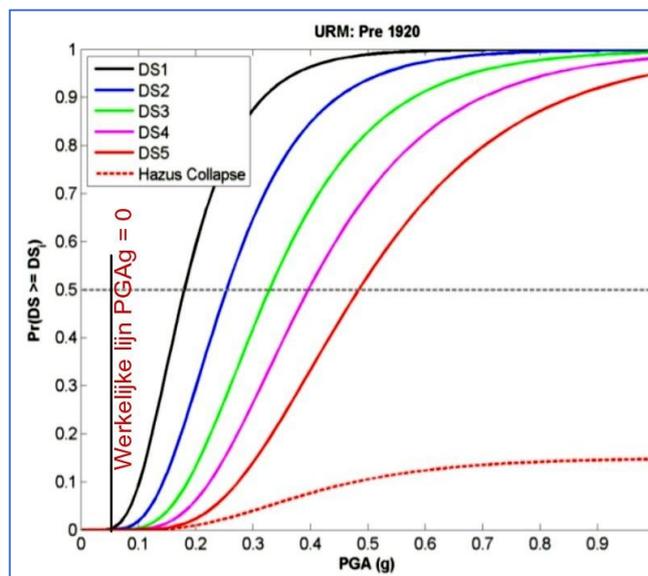
Figure 58. Arup 2013 vulnerability diagram of pre-1920 on firm soil -built dwellings with whole brick walls and large windows or narrow piers and wooden floors without diaphragm function. The left grading scale is the portion that is damaged at the PGAg value below.

The black line of DS1 (light damage) in this diagram already rises at PGAg 0.05 and is about 10% at PGAg 0.1. However, this does not correspond to reality, with >50% of the pre-1920 homes in Huizinge having damage at PGAg 0.085.

The vertical PGAg 0 line should therefore already start at the beginning of the black line AND the black line should be slightly steeper.

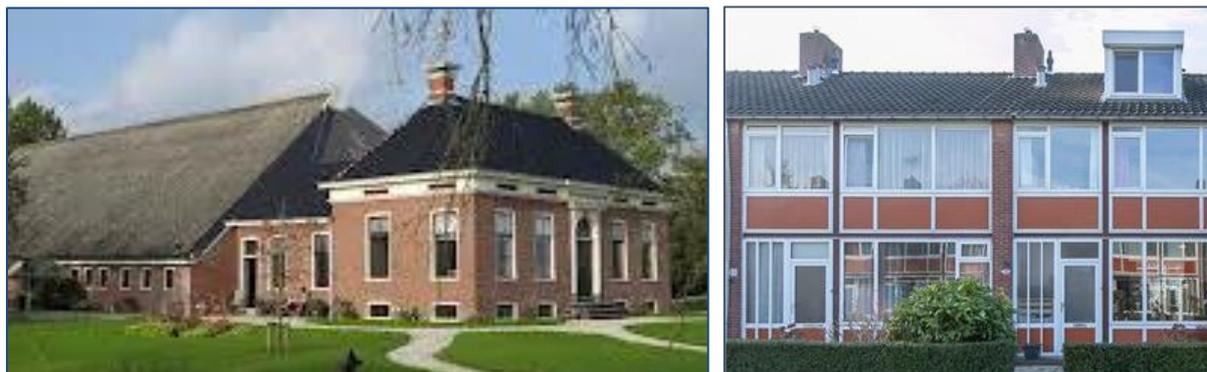
Figures 59. Left. (Photo Internet, by Funda) Old farmhouses are among the most vulnerable buildings in the province of Groningen, because they are often built with loam and lime mortar, have high windows, lack of floor-wall connections, high heavy chimneys on a flexible wooden roof construction. They are connected to the large and flexible timber truss shed. In addition, some of the buildings have a partial basement, which results in differences in foundation settlement. Because no dilations have been made between the head building and the so called 'neck' or between the 'neck' and the 'trunk' (large shed), they will tear apart at those connections. The large barn shed has its own seismic characteristics and problems.

Right. Terraced houses with all-window façade. Without internal structural walls, these types of buildings will collapse during an left-right direction earthquake.

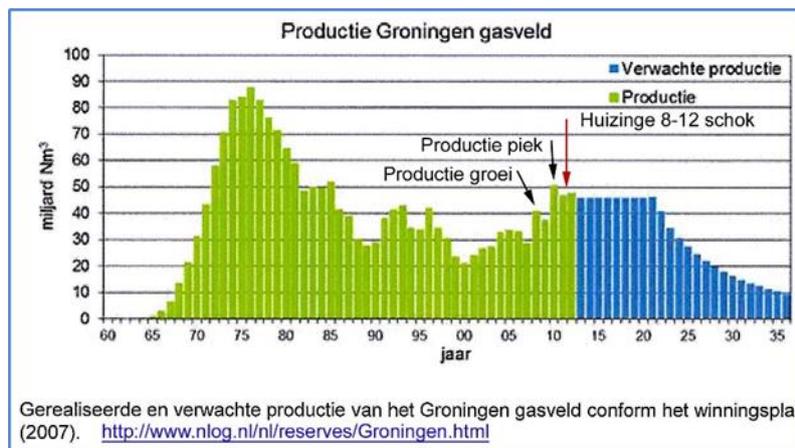
Figure 60. The 2007 extraction plan in which the planning of natural gas production is indicated up to 2040, with a possible extension to 2050. From 2022 it would no longer be possible to run at maximum capacity due to the pressure reduction.<sup>72</sup>

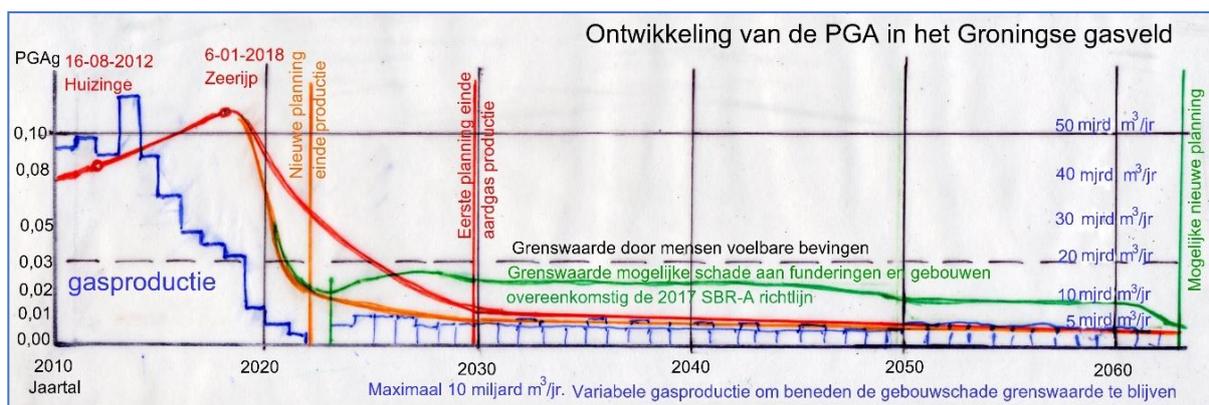
Figure 61. With the year 2021 knowledge of the subsurface and the relationship between gas extraction and earthquakes, it is possible to extract the remaining natural gas from the Groningen field with sufficient length of time without causing earthquake damage.

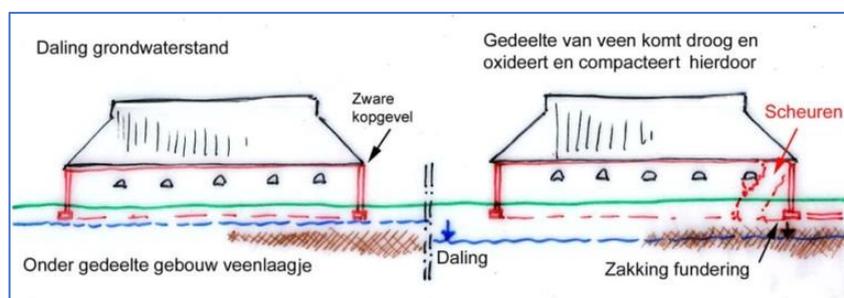
*Figure 62. Example of partial subsidence of a long building because one side of the building rests on a dried-out peat layer.*

*The massive end wall of this type of shed causes great pressure on the ground and will then sag in relation to the (poorly) founded low side wall.*

Daling grondwaterstand = Lowering of ground water level      Zware kopgevel = Heavy head façade  
 Onder gedeelte gebouw veenlaag = Under part of the building a peat layer      Zakken fundering = subsidence foundation  
 Gedeelte van veen komt droog en oxideert en compacteert hierdoor = Part of the peat falls dry, oxidises and compacts  
 Daling = lowering      Scheuren = cracks

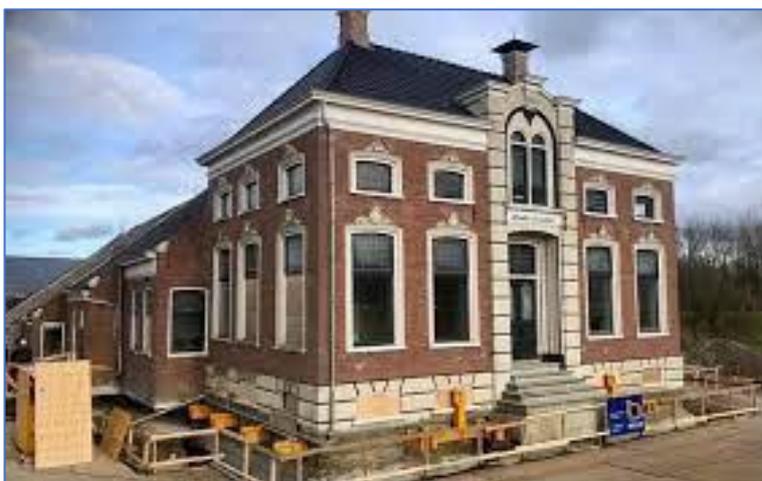
*Figure 63. At this historic end house of this farm in Garrelsweer, cracks appeared in the foundation and basement in 2006 and 2012 due to the earthquakes. In combination with the already occurring land subsidence and the resulting increased groundwater level, the groundwater ran into the basement.*

*Finally, in 2020, this old building was placed on Base-insolation, a job that was not completed until the end of 2021.*

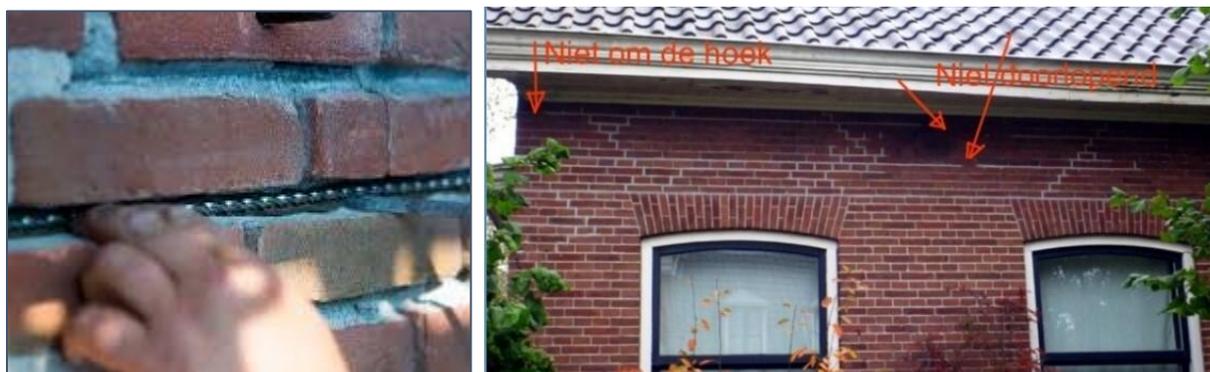
Figures 64. A stainless-steel spiral-shaped (helical) wall reinforcement is glued into a deeply milled horizontal masonry joint. The horizontal joint is then fully glued and finished. Given the light tremors in the province of Groningen, this is the most relevant and important method for wall repair and strengthening.

*Right:* The longitudinal reinforcement above the lintels is interrupted here. This means that with a new earthquake there will be a new crack between the ends of the reinforcement. In the early period after 2012, the method was often incorrectly applied.

For seismic reinforcement it is necessary that this horizontal joint reinforcement continues all around the building, and not just a small piece to the right and left of the crack. In the initial phase of building repairs in the province of Groningen, short pieces of spiral (helical) reinforcement were often used to keep costs low. By consistently connecting all inner and outer walls together and connecting the floor joists to the walls (making diaphragms), many buildings can be made sufficiently seismic resistant, and large cracking can be prevented.

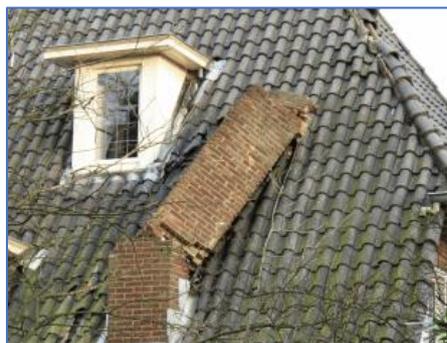
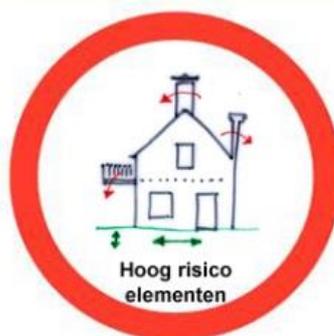
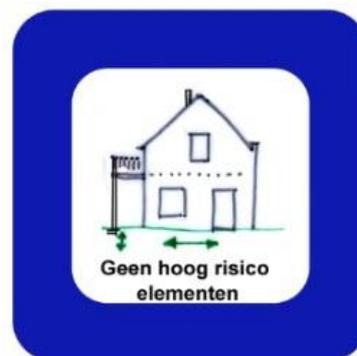
Figures 59. High-risk elements include heavy chimneys on a flexible timber roof structure, balconies wedged into brick walls, and spandrels or free-standing gable ends that sit on buildings and above sidewalks. While falling, they can cause casualties in the public space. *Middle and right.* Building with high-risk elements: heavy chimney on a weak roof, wedged cantilevered balcony (red), and a building without these high-risk elements (blue).<sup>81</sup>

The removal of high-risk elements from a building, or from building components is important. Securing these elements prevents them from falling off the building in the event of an earthquake and cause damage. An initial identification of these high-risk components is done by means of Rapid Visual Screening, (RVS)<sup>80</sup>. When a potential problem is observed during a superficial examination, a further analysis follows by means an Extensive Visual Screening (EVS).<sup>90</sup>

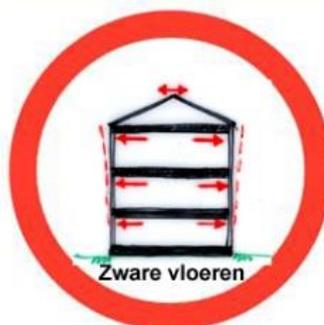
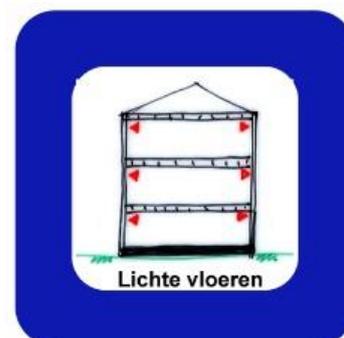
Figures 60. *Left.* Heavy concrete floors (high risk, red) and *Right.* light wood floors (low risk, blue).

Wooden floors in combination with narrow window piers can pose a high risk if they do not have an especially strong reinforced aperture.

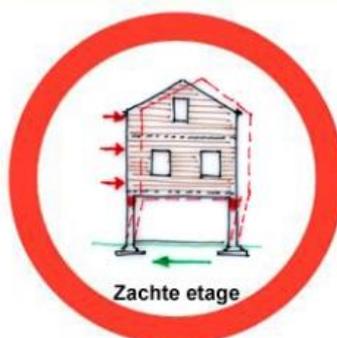
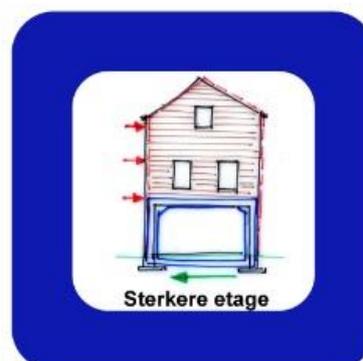
Figures 61. *Left:* Soft/weak ground floor (shops, terraced houses) with a lot of deformation (high risk).

*Right:* Strong ground floor due to a reinforced portal with less horizontal displacement (low risk).

As one of the riskiest buildings, the terraced houses (stacked construction method) with large window frames in the facades and heavy concrete floors can be regarded as one of the riskiest buildings. The ground floors with large window openings are considered weak floors. If there are no transverse walls inside terraced houses that can absorb the earthquake loads in the longitudinal direction of the building block, these are very risky. Strengthening these buildings can be done, for example, by adding strong portals, strong constructive glass panels that sit tightly in the window frames and transfer the floor load from the storey in the plane of the facade walls to the foundation.

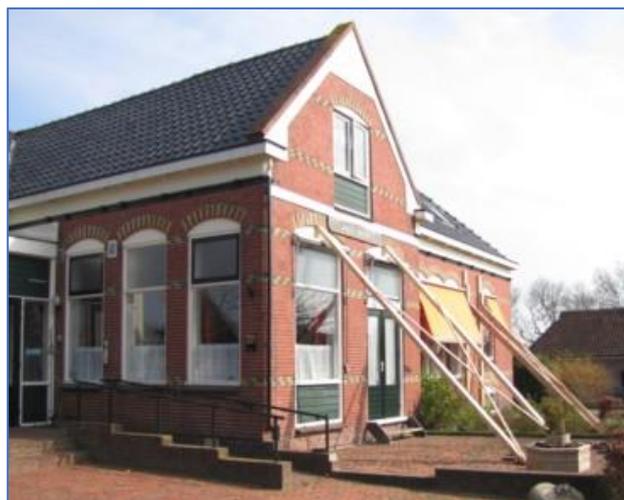
Figure 62. The town hall in Leermens is a high-risk building because of the extra narrow window piers (width/ height =  $< 1/7$ ) and the lack of lintels over the full length of the façade, or the presence of a connecting floor diaphragm.

By replacing at least one window in each side with a structurally strong glass panel, the piers are structurally widened.

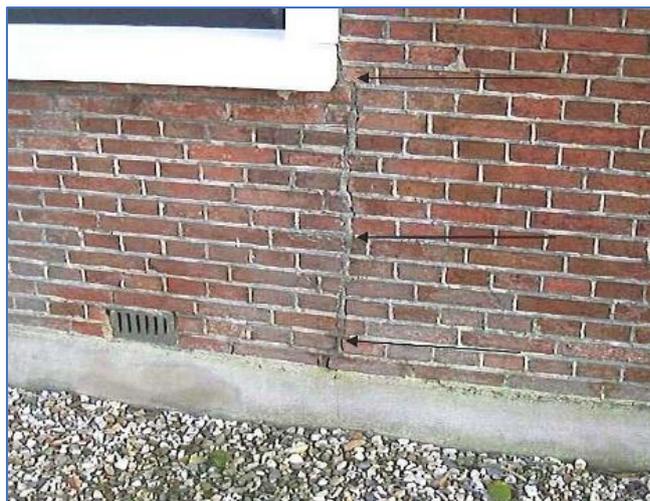
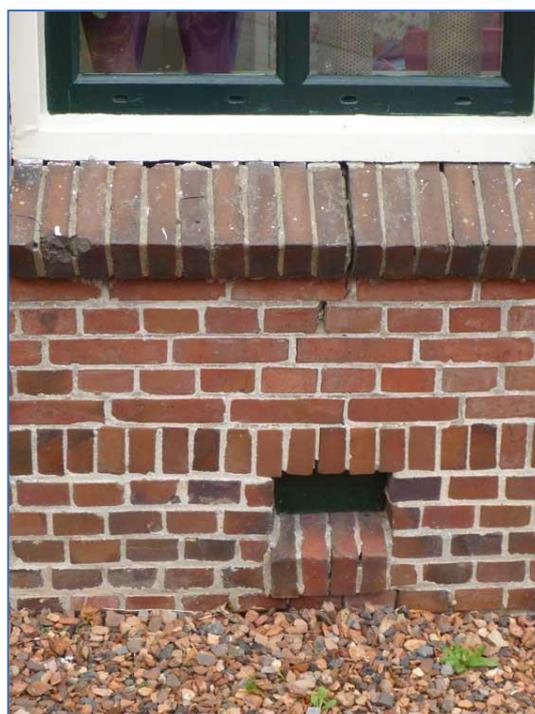
Figures 63. Numerous cracks arise from the foundation due to small settlements in foundations on solid ground. These cracks extend to the window openings on the ground floor. These are very common even without earthquakes, especially in brick buildings with cellars. These cracks are aggravated by (earthquake, traffic) vibrations.

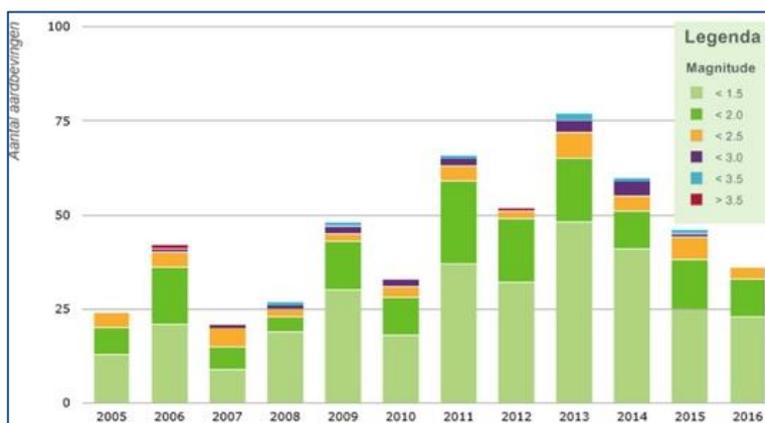
Figures 64. These NAM-platform graphs<sup>84</sup> about the number of quakes < Richter 1,5 shows a reduction of shocks per 2014, both in number and strength. This decline has continued.

After the bang on 16 August 2012 Huizinge (Richter 3.6) the NAM increased gas production, resulting in a larger number of shocks in 2013/2014.

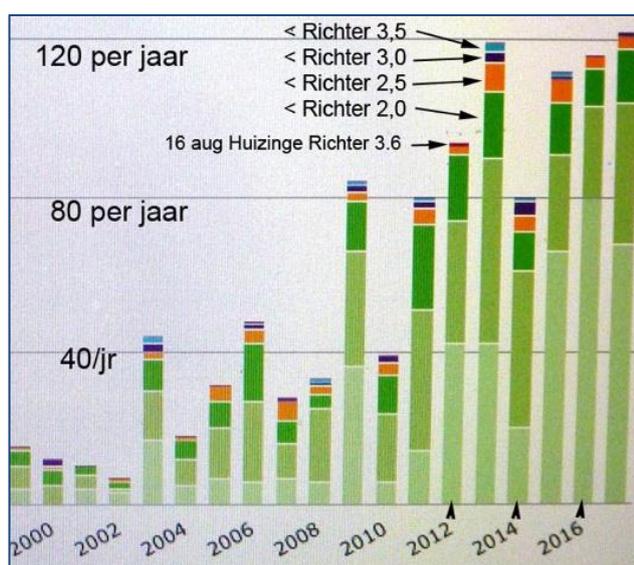
This NAM-graph is until 2017. In the 2012 column the Huizinge shock is indicated<sup>85</sup>.

After 2013, a sharp reduction in production was introduced, from 54 billion m<sup>3</sup>/year to 24 billion m<sup>3</sup>/year in 2017, which greatly reduced the number of shocks in 2014.

In the years 2015 to 2017, the total number of earthquakes will again increase due to the lower pressure in the gas field, while 2017 also indicates an increase in the number of Richter earthquakes < 1.5.

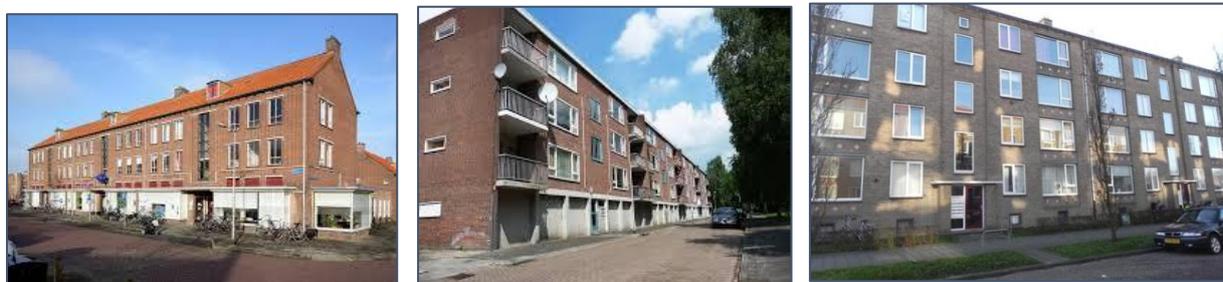
Figures 65. *Left: CC1B, three floors. Middle: CC1B three floors. Right: CC2, four floors*  
*In the middle picture there are four floors, but the bottom floor is not inhabited (garage boxes), therefor only three floors apply with CC1B qualification.*

Not only is the safety factor CC increased, but for many buildings the risk factor is also reduced from  $10^{-5}$  to  $10^{-6}$  (= safety factor increased), such as for chemical companies and sea dikes. Large residential buildings, according to the list above, also have an increased factor, which means that they must be made stronger.

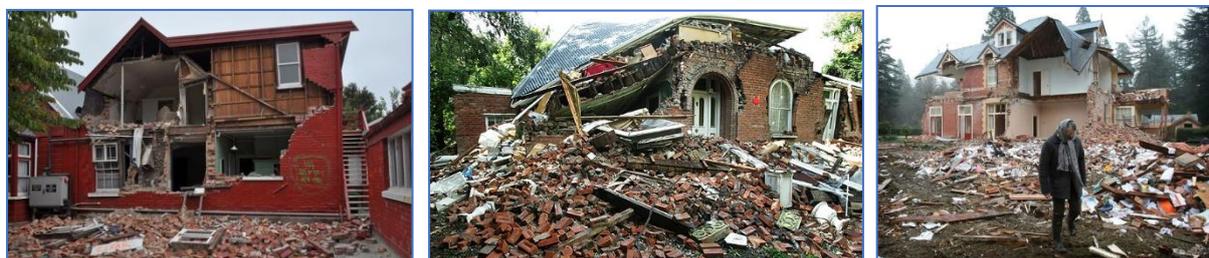
*Figures 67. Left. This building is in the DS4 (just failed to collapse completely). Middle. This building is in the DS5 (collapsed) phase, while they were built seismically resistant according to the code. This earthquake was Mw 6.2 and depth of only 5 km and for a 15 km long zone with  $PGAg \approx 0.22$  vertically and  $PGAg 0.17$  horizontally at the epicentre. In the city itself, the  $PGAg 0.08$  vertical and  $PGAg 0.07$  horizontal, comparable to the 16-08-2012 Huizinge earthquake, but much longer in duration.*

This 2011 Christchurch quake lasted only 10 seconds and caused soil softening (liquifying) in some locations. The total economic damage was estimated at >20 billion euros. Buildings that are very similar to those in the province of Groningen but complied with the seismic code; 20,000 buildings damaged and 10,000 beyond repair; 50,000 people moved. Almost half of the 186 victims were caused by falling debris from gable ends in the shopping streets.

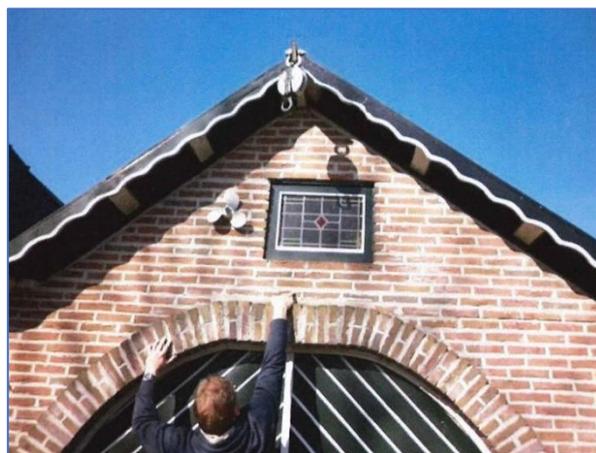
*Figure 68. In this converted garage, the contractor has removed the tie rods from the trusses to create more space inside (own construction error). The roof load and the arch push the side walls outward causing the arch to split and sag in the middle. If the arch is already under tension, an extra vibration from an earthquake can cause a larger crack. The primary cause of the crack is the construction defect (inherent defect).*

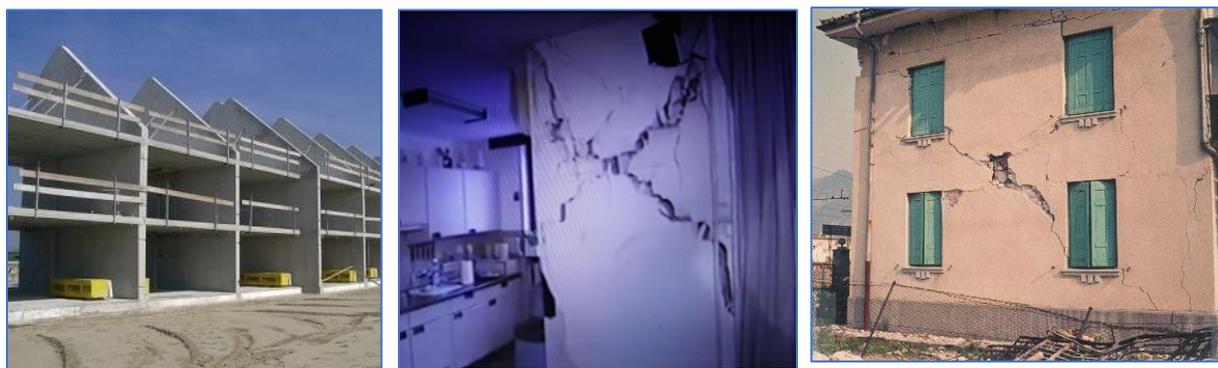
Figure 69. *Left: If the floor-wall connections of the storey floors are not moment-strong enough to withstand an earthquake load in the longitudinal direction of the building block, and there are no internal transverse walls that can withstand loads, the block can collapse as a house of cards.*

*Middle: Small inside transverse wall of a house after the 1992 earthquake in Roermond. When this wall would have been removed by the creation of an open kitchen, probably the house would have collapsed. The X crack formation is typical of an in-plane wall overload (shear).*

*Right: House after an earthquake in Italy. Earth movement to the right causes the // cracks, earth movement to the left causes the \ \ cracks.*

In terraced houses (with large windows front and rear), the front and rear facades on the ground floor have windows without any shear strength in the plane of that long façade of the building block. Only short inside cross walls may provide some resistance. Someone who has removed a small inner load-bearing cross wall between the living room and kitchen in such a terraced house to create an open kitchen, weakens the horizontal longitudinal resistance of the entire building block. Without an earthquake, the building will remain standing, but an earthquake in the longitudinal direction of the block can cause significant cracks; even collapse risk of the entire row. See 'Building Directive'.

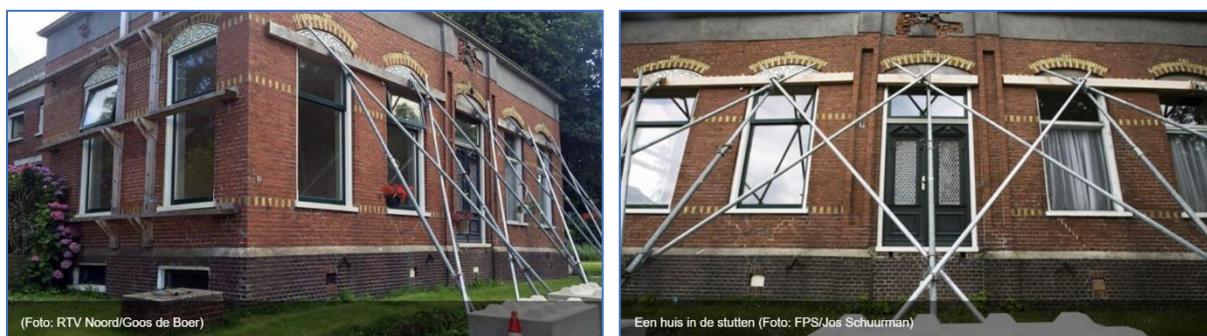
*Figures 70. House in the struts/props with side view and front view. The large damage above the double door in the middle indicates a structural problem related to the high windows, narrow piers between the window frames and the distribution of the inner walls, with a lack of a continuous connecting diaphragm under the roof. These are architectural aspects from before 1920 and have nothing to do with inherent defects, because that was how people built at the time.*

No financing structure was set up (not even in collaboration with the government)<sup>100</sup> for repairing the inherent defects or making the home more sustainable (insulating, generating energy). As a result, many buildings experienced scaffolding and props<sup>101</sup>. The images of the struts were widely used in the press as negative imagery and pointing out how important the damage was.

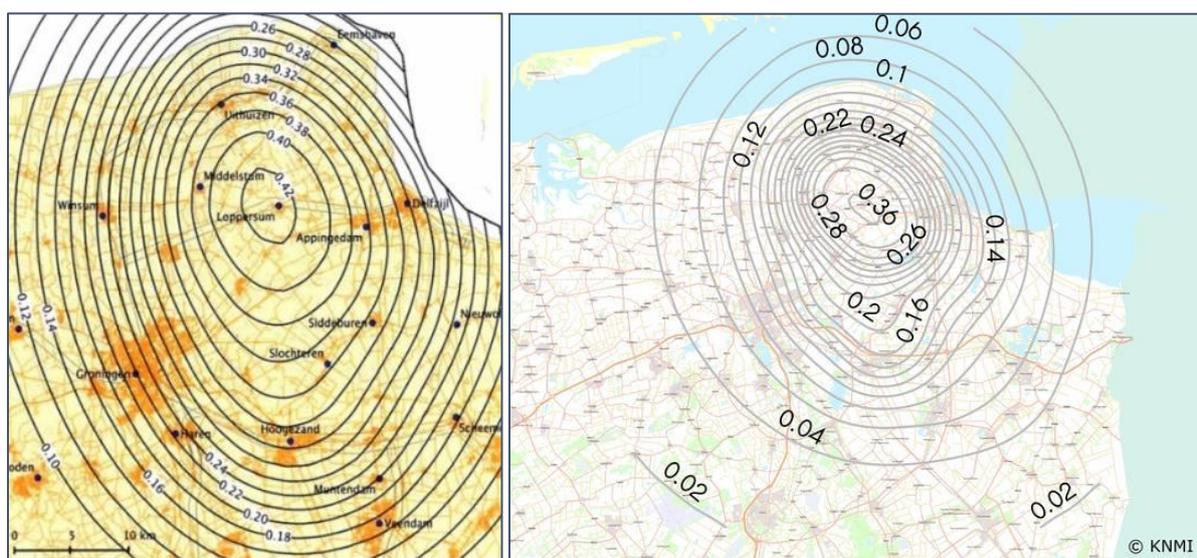
Figures 71. *Left*: The first KNMI PGA map from 2014 with a PGAg 0.42 in the epicentre. *Right*, the second map from 2015 with PGAg 0.36. These very high values were determined based on uncertainties and NAM's wish to continue large-scale gas extraction until the gas field is exhausted. The values of 2020 can now be found on a Home Webtool <https://seismischemacht.nen.nl/map.php> and is specified per one km location. The KNMI makes earthquake strength calculations according to the Richter scale based on its own data. From this the PGAg loads are calculated, which are then given an incremental factor for the uncertainty.

The KNMI is jointly responsible for determining the earthquake strength contour map associated with the Eurocode 8 and the Dutch translation, the NPR9998. Because the KNMI could only study past data regarding the determination of the PGAg threat map and the 2012 production information provided by the NAM about the planning of future gas exploitation, and because there were many uncertainties, the first PGA map can be called **extremely conservative** (i.e., with very high PGA value).

The largely exaggerated and not explained PGA values of the KNMI maps were the cause of increasing fear and stress among the population of Groningen and extensive research activities by the NAM that delayed the repair and strengthening activities.

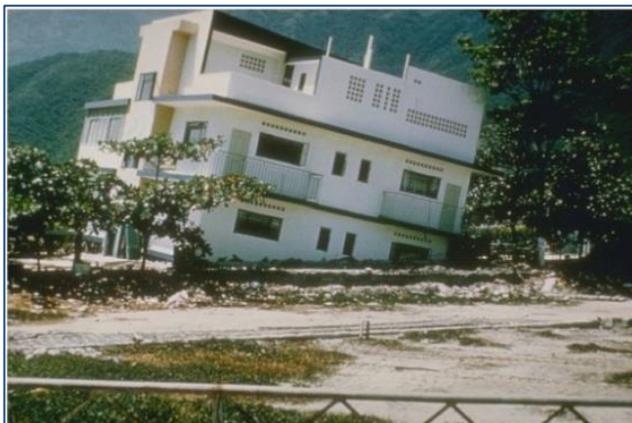
Figure 72. Example of softening of sandy soil causing the water to rise and lose the soil's carrying capacity. Protracted and severe 2011 New Zealand earthquake. Because the tremors in Groningen are only short, softening does not occur, but settlement does.

Liquefaction is the loss of strength and stiffness in moisture in non-compacted but saturated sandy soil, due to vibrations and the associated reduction of effective stress and bearing capacity of that soil. With partial softening, there is still part of the grain tension left (pressure on the sand grains).

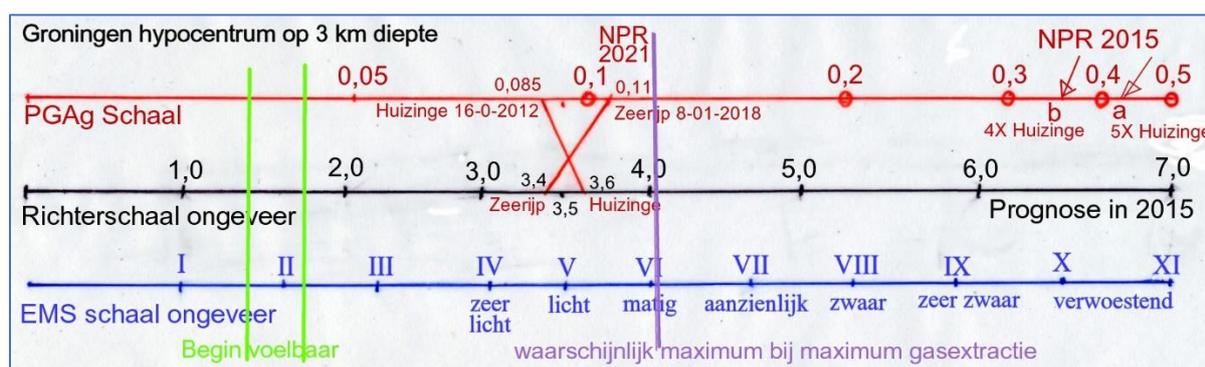
Groningen hypocentrum op 3 km diepte = Groningen Hypocentre at 3 km depth

Waarschijnlijk maximum bij maximum gasextractie = Likely maximum at maximum gas extraction

Figure 73. The PGA is strongly influenced by the depth of the hypocentre and the ground layers. The logarithmic Richter scale only has to do with the strength of the earthquake (+1 point = 10X as strong) and cannot get very large in Groningen due to the relatively thin sandstone layer (max 200 meters). The Richter scale has little to do with ground acceleration. The Zeerijp earthquake (8 January 2017, Richter 3.4) therefore had less force, but a larger PGA (0,116) than the Huizinge earthquake (0,085 Richter 3.6). The Mercalli and EMS scales are both based on feeling.

The different scales such as Richter (Energy, Mw), EMS (damage) with Mercalli (feeling and damage), and the PGA zoning of the Eurocode 8 do not coincide. All PGAs (acceleration) of tectonic and induced quakes can be compared, regardless of the depth of the hypocentre; that is why they are listed in the Eurocode 8 and the NPR9998.

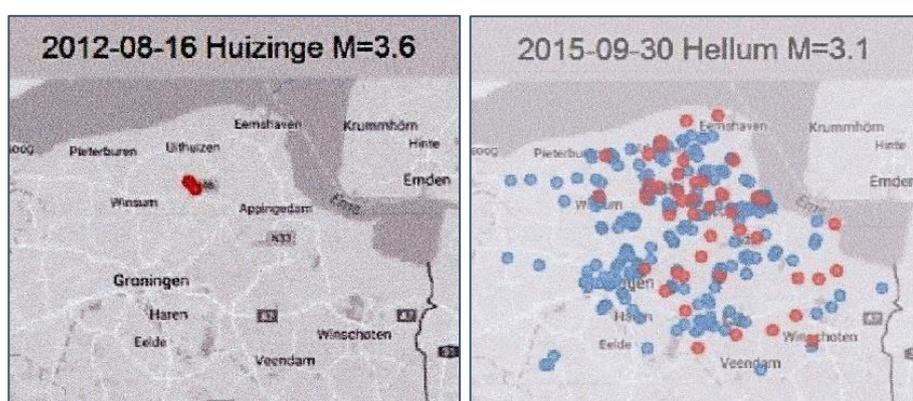
*Figures 74. Expansion of the measurement network of the KNMI (red) and TNO (blue) since 2012 up to and including 2015. Thanks to the large measurement network, better data can be collected, and accurate maps can be made.*

With the seismological measuring network of accelerometers and borehole seismometers, KNMI and TNO can register earthquakes for the NAM, both on the earth's surface and at great depths. A few hundred accelerometers have also been placed on the foundations of buildings in the province of Groningen. By linking the information from the deep measurements to the measurements at the earth's surface, it is possible to determine the relationship between these two. However, the seismographs on the foundations also show the building response (reverberation) for the different types of structures. The vibration characteristic of those buildings can therefore be determined.

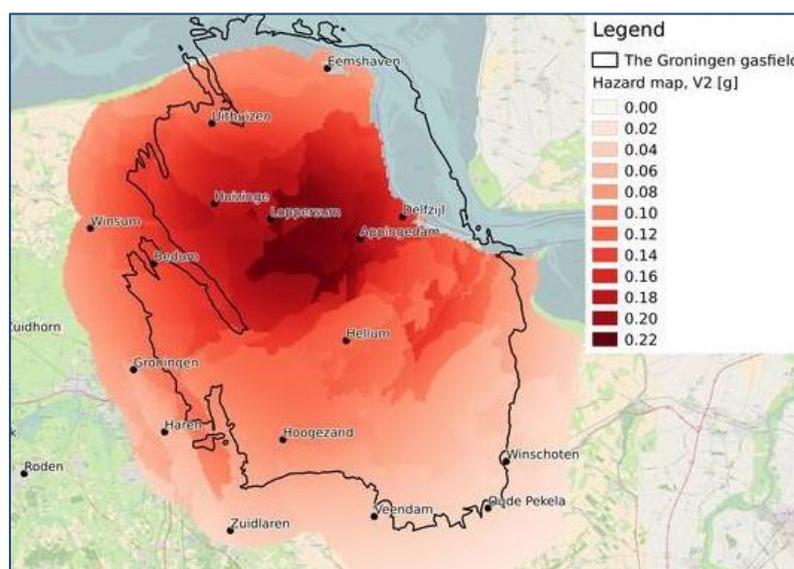
*Figure 76. This old 2014 Arup threat indicates their estimate of the maximum earthquake at 2.5 X the Huizinge earthquake with PGAg = 0.22 in the epicentre area between Ten Boer, Loppersum and Appingedam. At the same time the KNMI produced a map with about **double this value.***

*In 2018, when the KNMI lowered their PGA value for the third time, the maximum limit value of PGAg = 0.13 would only be reached in the core area of the region (municipality of Loppersum and south and southeast thereof).*

Realistically speaking, the special seismic calculation will no longer be required if the gas tap remains closed. The current KNMI threat map of the NPR9998:2021 is still about 2X higher than the actual occurring earthquake strength in connection with the regular safety factors <sup>111</sup>.
