# Chapter 1 Alphabetic listing of terminology and abbreviations related to the induced earthquakes

in Groningen from Accelerometer to Zechstein.

Explanation of terminology, concepts, and abbreviations, related to the Groningen Induced Earthquakes that occurred since 2000 and culminated in 2012, with comments and sketches.

By: Sjoerd Nienhuys  
Construction, seismic engineer  
April 2023

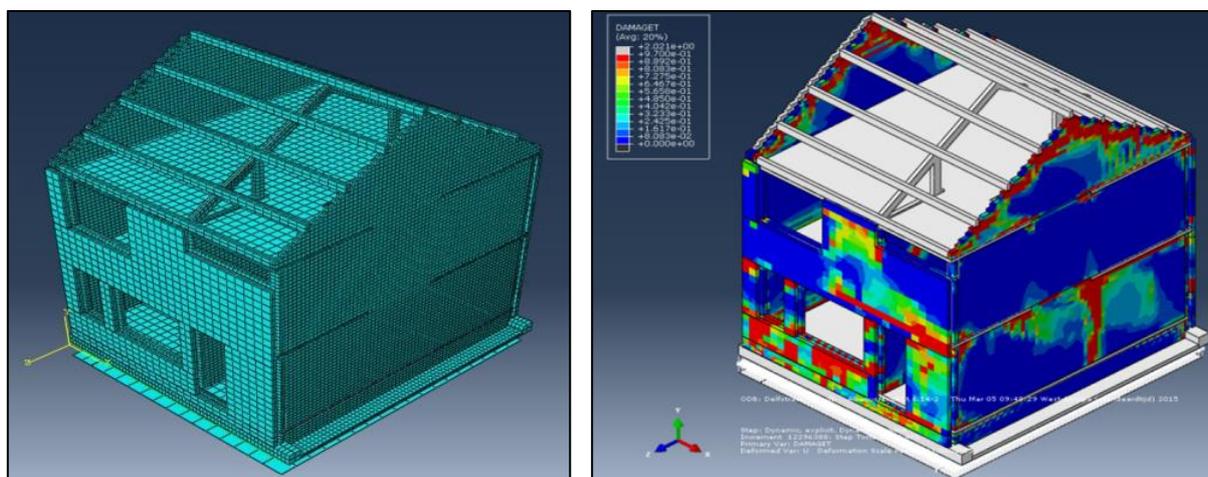
Figures 77. Example of dividing a terraced house into small pieces of 30 x 30 cm and the result of an NLTHA by Zonneveld Engineers. Red are damage zones such as cracks.

The (Non-Linear Time-History Analysis) calculation method is based on the time-dependent reaction of the building during an earthquake. The vertical and the two horizontal and ground signals of an earthquake are applied to the foundation. To be able to apply and calculate this method, the entire building is calculated in small pieces (for example 30 cm x 30 cm) where the elasticity and strength of each piece and its connections (strength, ductility, elasticity, flexibility) with the connecting piece are entered. This means that tens of thousands of pieces need to be entered; this is specialistic work and takes weeks (and is therefore very expensive).<sup>112</sup>

Specially designed computer programs perform the many calculations of each vibration and of all the pieces <sup>113</sup>. This makes it possible to theoretically see which points or zones in a building are the weakest and which are likely to fail. For new or existing buildings, these are the locations where the reinforcements must then be applied, or the design adjusted.

<sup>112</sup> The figures below give an example of the calculation of a simple building. It shows where the tensions will appear and the cracks (red). Similar building will have similar damage patterns. However, it is not necessary to use this calculation method instead of the simple Lateral Force Resisting System (LFRS). Both systems indicate at what PGA the building will fail. To analyse thousands of buildings with the NLTHA was good business for the engineering companies, made the reporting extremely expensive, and delayed the repair process. Moreover, with the use of exaggerated PGA values of the KNMI, the results are hardly representative for the reality.

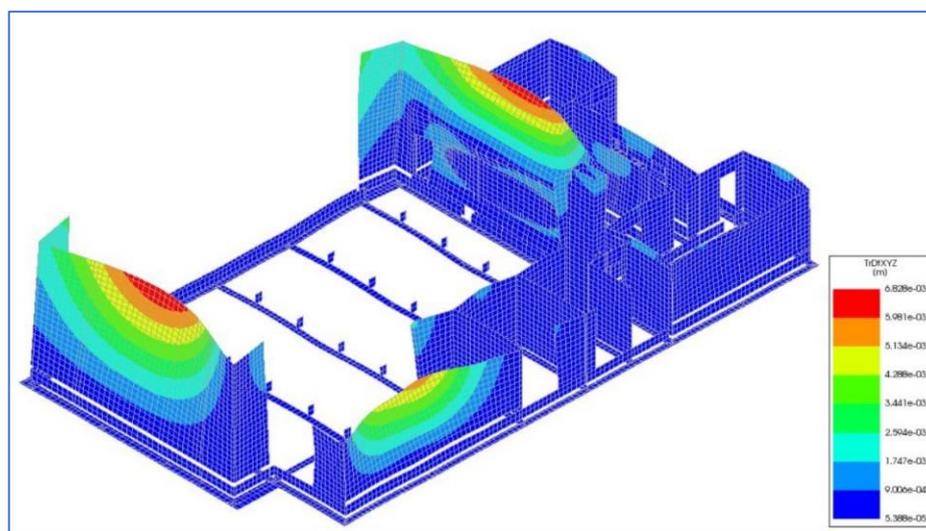
Figure 78. Image by AVECO of the NLTHA calculation of a school, in which the brick top facades show a lot of deformation and will therefore damage first.

The above is an analysis of a school building, but the top facades are not (in the calculation) connected to the roof construction. The effect is that these top facades start to sway and break off. A well-designed roof diaphragm can avoid this. The earthquake loads must also be applied in the perpendicular direction.

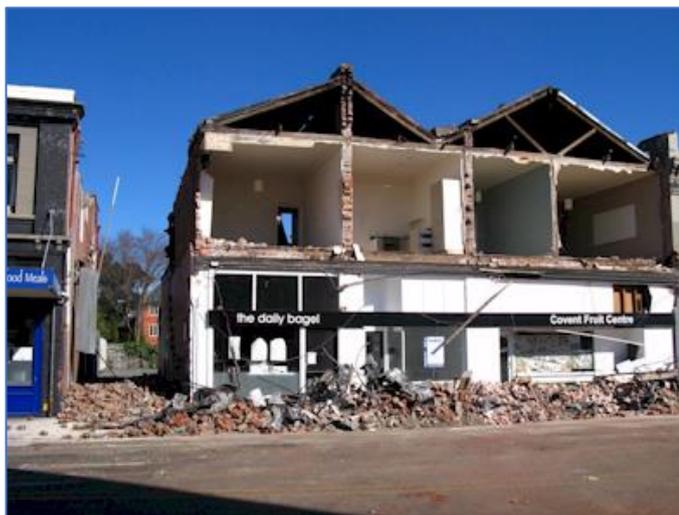
*Figure 79. (Internet photo) In Christchurch, New Zealand, the collapse of the non-structural elements of older buildings that were not built according to the seismic code, such as façades, gables over shopping arcades, was the leading cause of public deaths.*

*Particular attention should be paid to infill panels in space-frame buildings or reinforced concrete structures so that they are ductility connected to the main structure.*

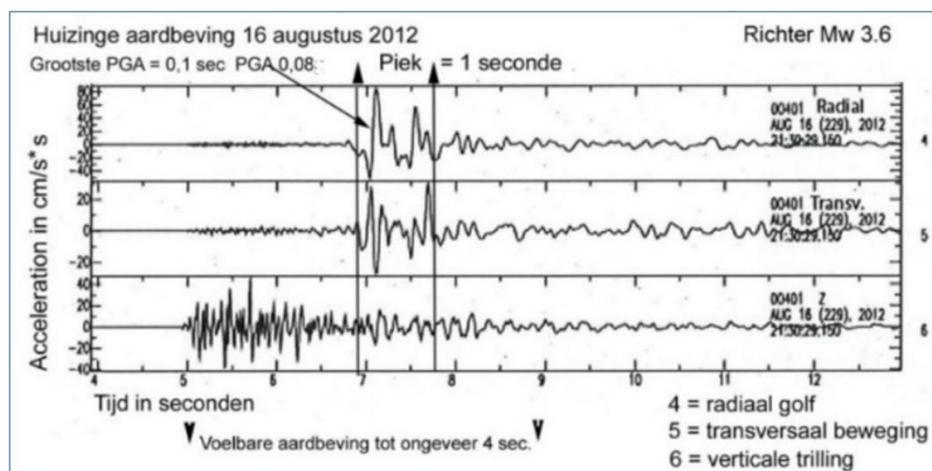
Voelbare aardbeving tot ongeveer 4 seconds = Noticeable earthquake up to about 4 seconds (at ground level)

Figure 80. The graph shows the three measurements made by a seismograph. Depending on the horizontal distance between the epicentre and the building, in combination with the subsurface, the duration of the earthquake can increase, but the intensity decreases.

The duration of this earthquake of August 16, 2012, in Huizinge starts at second 5 (in the graph), but it is not recorded when it ends. For people who only felt the horizontal movement, it may have lasted 1-5 seconds depending on their location and building post-shaking (low building).

In Nepal, Kathmandu earthquake (2015-04-25, Mw 7.9 and 15 km deep), there was up to 30 cm horizontal displacement. Because of the ground and building effect (reverberation), some people felt the quake in Huizinge for 10 seconds. The above graph only shows between the points of second 5 and second 8 only three seconds vibrations. After that, only the reverberation of the building is felt.

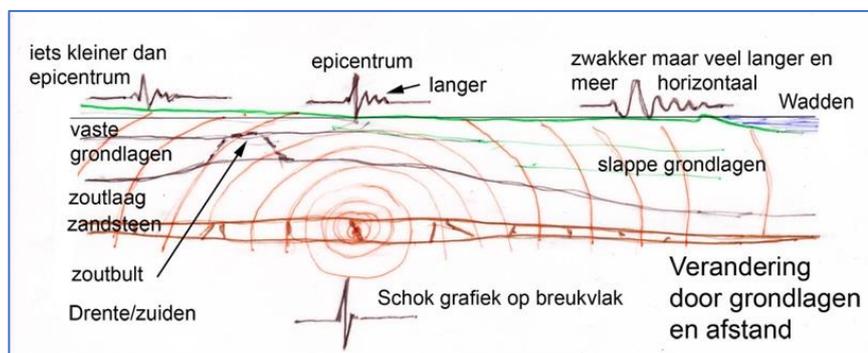
iets kleiner dan epicentrum = A little smaller than at the epicentre. Langer = Longer.

Verandering door grondlagen en afstand. = Changes caused by soil layers and distance.

Figure 81. With a high and hard salt bump, the shock can be felt more directly and strongly. With weak soil layers, the post-vibration will last longer. Farther from the epicentre than the depth to the hypocentre (3 km), the horizontal amplitude will be greater than the vertical.

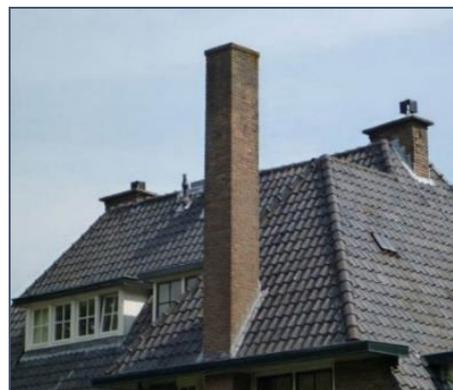
*Figure 85. A high chimney or detached top facades are high-risk elements anyway and are easy to detect from the outside. The 1930s chimneys are an extreme example of this. At the base, the masonry is also interrupted by the lead flashing. Reinforcement is very expensive and replacement with a lightweight model is then preferred. Open fireplaces are not desirable in energy-efficient buildings or for the environment (poor energy efficiency and high particulate matter emissions). It is therefore preferable to completely remove the masonry chimney unless it is an important architectural element.*

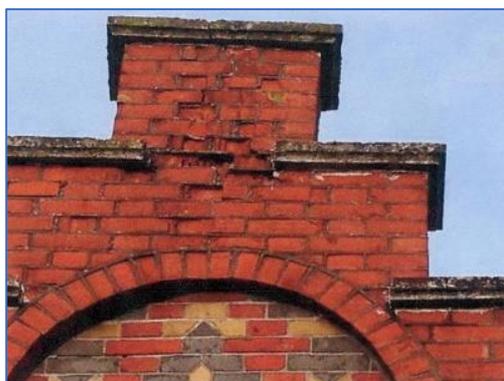
*Figures 86. Left. Example of a gable top as a high-risk element due to lack of connection to the roof and strong erosion of the masonry.*

Parapets or free-standing gable tops and projecting balconies may also fall under this category. After detecting a potentially high-risk situation, immediate action is taken or a more Comprehensive Safety Investigation (EVS) is initiated.

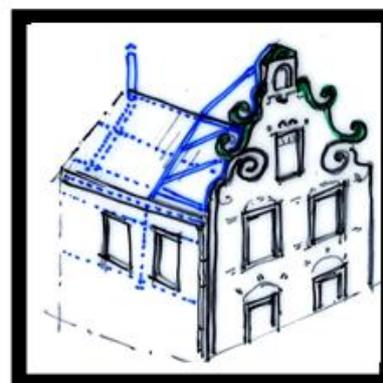
*Right. The top needs to be restored and properly connected to the roof.*

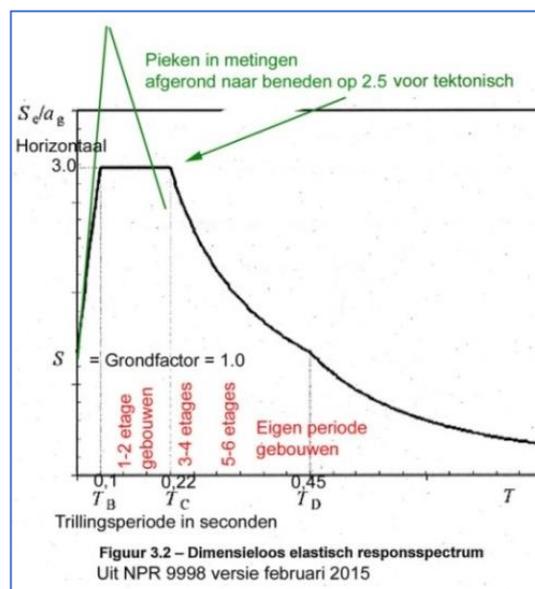
Figure 83. The reaction diagram or response spectrum combines the type of soil with the height and the building's own vibration frequency. Because low buildings have short vibration period, they are therefore subject to higher load than tall buildings.

The Eurocode 8 (NPR9998) indicates different methods to calculate this own building frequency. A simple method is  $T_1 = Ct \cdot H^{3/4}$  Formula (4.6). When the earthquake frequency is equal to the building's own frequency, long-term tectonic earthquakes can cause dangerous building resonance. This is not the case in Groningen because the duration of the shocks is very short (tenths of a second). In a building on Base-isolation, the heavy shock of the earthquake is not transferred to the building above but slowed down and converted to a much smaller movement.

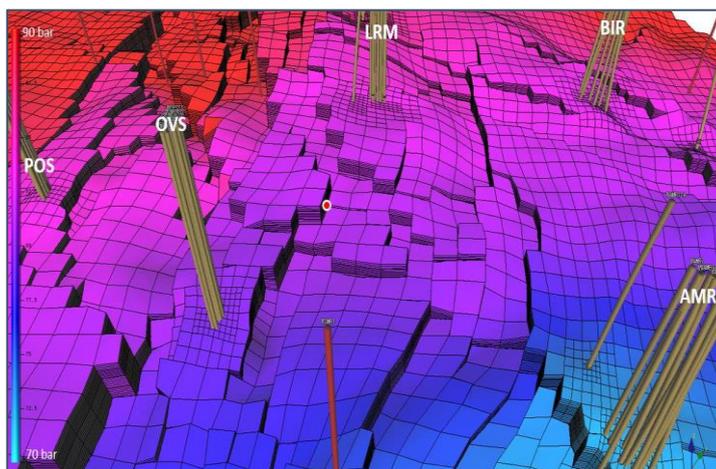
Figure 82<sup>119</sup>. The beige lines are the pipes from the drilling sites. Due to faster gas extraction in the AMR zone (bottom right) than from the other boreholes, the reservoir pressure is the lowest there. Minimizing the pressure drift through less extraction will reduce the number and strength of shocks.

The red line and dot is the hypocentre of the earthquake of 21 August 2017 near Appingedam. The vertical scale of this graph is 10 x horizontal scale.

By measuring the pressure drop in the reservoir over time at each borehole, pressure differences in the reservoir can be recorded. The greater the pressure differences between adjoining sections, the greater the chance of earthquakes or the more shocks can occur.

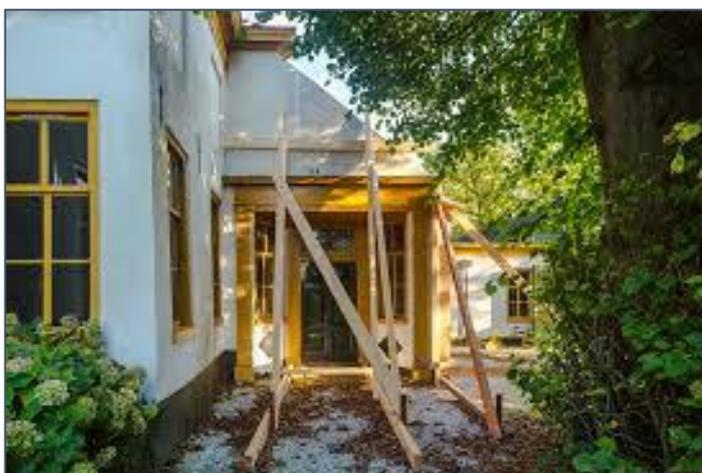
*Figure 83. Struts around an entrance part of a house. Lack of structural cohesion (floor diaphragm) and an irregular floor plan are often the causes of cracks.*

*Cracks in the masonry are seldom critically in the sense that the construction of the building is compromised and in risk of collapse.*

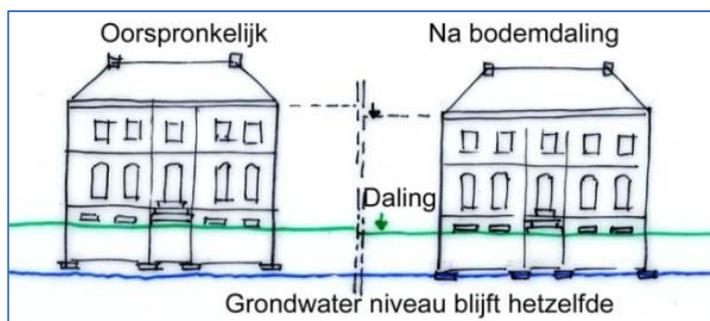
Oorspronkelijk = original      Na bodemdaling = After soil subsidence      Daling = subsidence  
 Grondwaterniveau blijft hetzelfde = Groundwater level remains the same

Figure 85. In case of subsidence or compaction, all buildings as a whole sink very slowly, while the ground level in relation to the building remains at the same level. This prevents cracks from forming. The groundwater then rises in relation to the ground level.

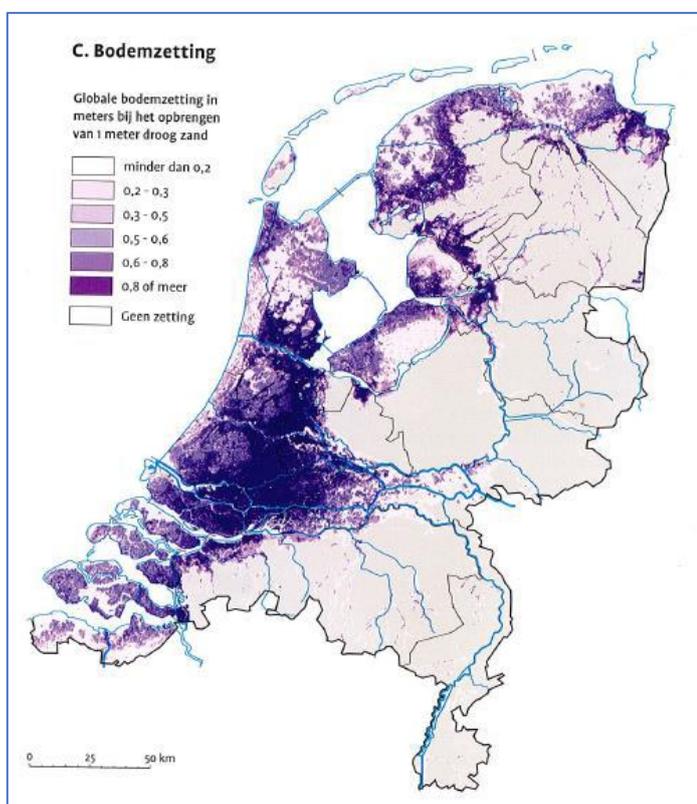
Figure 86. This map from the Dutch Bos atlas indicates how much settlement will take place if the soil level is raised with 1 m of sand.

This is common practice for new suburbs. In the province of Groningen this settlement can be up to 0.8 m; this then happens evenly over a long period of time. In the province of Groningen this occurs in clay soils.

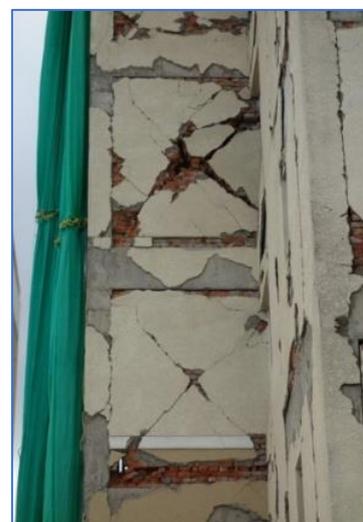
*Figure 87. Fill-in walls are secondary building components (non-load-bearing walls). During an earthquake, these can contribute strength to supporting column structures (the building's primary load-bearing structure) so that their movement is damped.*

*In this high-rise apartment building, the brick infill walls contributed to the damping of the horizontal building movements, so that the columns underwent less deformation in their maximum moment zones. Secondary building elements contributed here to the building strength after the deformation of the primary elements (columns).*

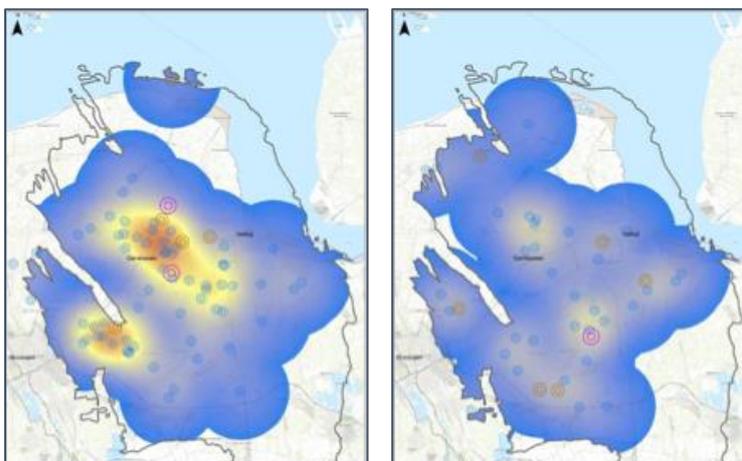
*In the central area around the municipality of Loppersum, gas extraction was less in 2014, resulting in less seismicity.*

*Right: March 2015-2016.*

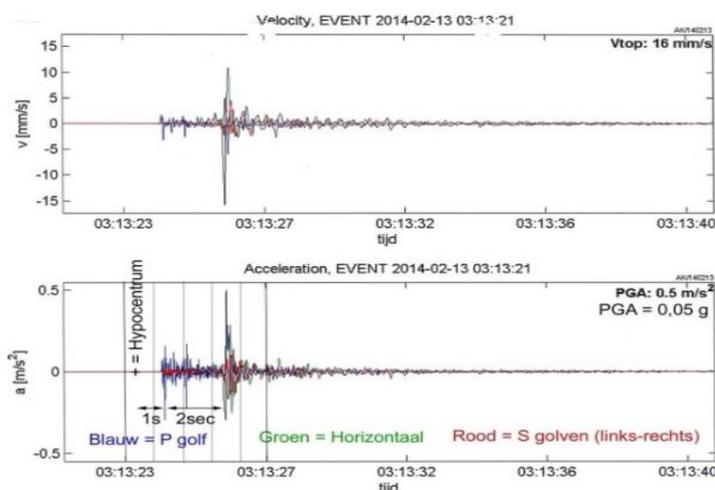
*This 2014 shock started on second 23 and reached the Earth's surface in second 26.5 and lasted less than half a second.*

*Depending on its construction, a building will reverberate. A seismometer on a foundation will give an extended vibration reading.*

A seismogram (*Figure above*) is a recorded result of a seismic survey by means of a seismograph of generated vibrations in the subsurface. Three movements are recorded. The vertical vibrations (pressure or P-waves), the horizontal radial waves (from the epicentre outwards), and the horizontal transverse S-waves (back-and-forth movement from the epicentre). The PGA is determined based on these horizontal radial waves. For some earthquakes, both the vertical and horizontal PGA are indicated. The horizontal PGA causes the heaviest building load.

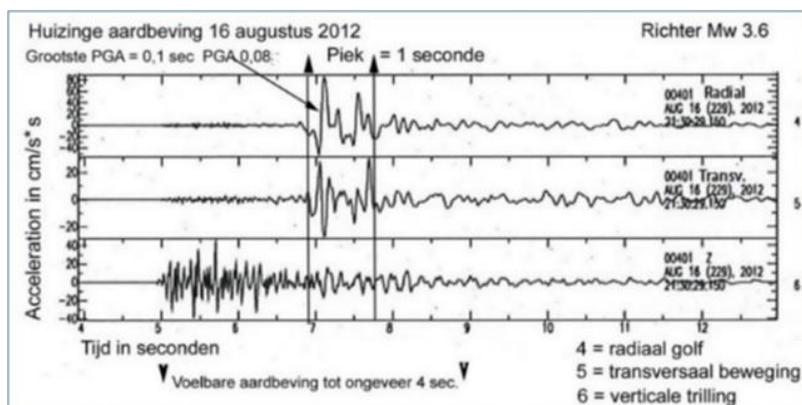
*The transversal left-right tremors were considerably less with a PGAg of 0.025.*

*The vertical PGAg was also half at 0.04, but buildings can withstand these loads. However, subsidence can occur because of the vertical vibrations when the foundations are too narrow.*

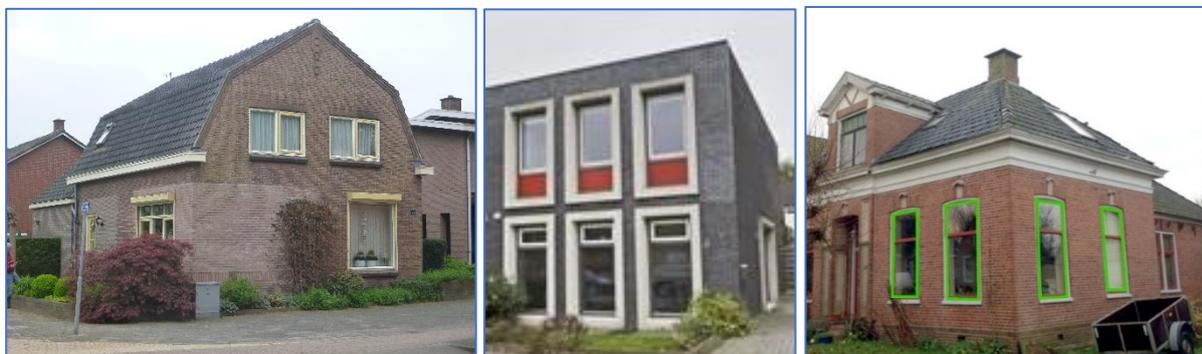
Walls with large windows and narrow piers are seismically weak constructions. By filling in the window openings with masonry, the walls (in the plane of the wall) will be reinforced. Left photo below. The wall strength can also be improved by making strong window frames or strong frame edges, image bottom centre. For historic buildings or monuments, these are often not acceptable solutions for monument conservation<sup>131</sup>.

By placing hardened (tempered), multi-laminated (insulation) glass panels in the window frames and gluing them fixed in a high pressure-resistant manner, the wall piers become much larger and the strength of the building in the plane of the facade increases considerably, image bottom right.

Figures 92. *Left. Masoned-up window* *Middle. Strong window edges* *Right. Constructive Glass panels*

The strong glass panels must be fitted tightly in the window frames of seismically weak buildings with whole brick masoned walls (photo on the right). It must be assured that the ceiling-attic floor forms strong diaphragms and connect all the walls, this way a seismically strong construction is created.

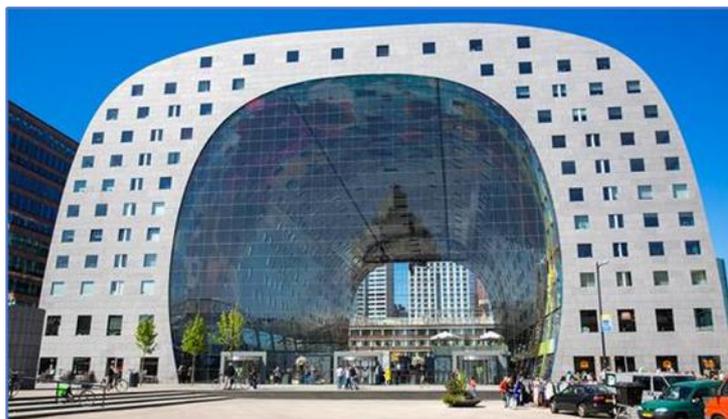
Figure 93. The market hall in Rotterdam is an example with a strong facade of laminated glass panels.

Thermally insulated, laminated glass panels are used in large projects and are therefore not unknown techniques.

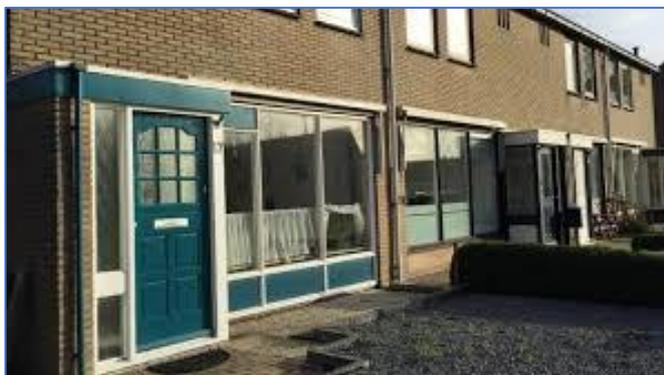
Figure 94. Jarino houses from the 1970s, with structural flaws in the facade and foundations, poor thermal insulation, and small rooms.

Due to the construction errors in the façade and foundations, these houses could not be economically strengthened. When insulating on the inside, beds of 200 cm would no longer fit in the smallest rooms.

For example, structural reinforcement was urgent for 57 Jarino homes (photo above) where a major structural defect in the facade lintel supports was exposed due to the Huizinge earthquake. Upon further inspection, it was found that weak foundation beams also caused the interior walls to crack vertically over the pile foundation.

Because of the large front and rear windows, the lateral strength in the façade is low, but with the faulty beam construction it was almost non-existent. In many cases, structural reinforcement is a measure to solve a specific acute problem or to secure an identified high-risk situation.

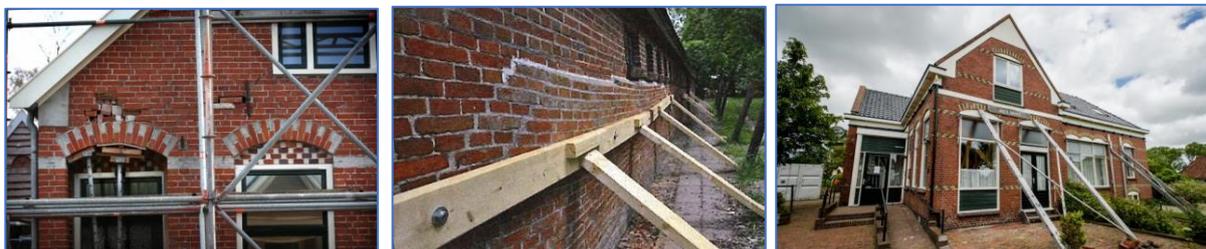
*Figures 95. Different methods of shoring are used including scaffolding inside the buildings. Because of the publicity from these struts by the media, a lot of attention was paid to the buildings with these struts.<sup>132</sup>*

The shoring is a temporary safety measure, pending repair or reinforcement or demolition. The shoring up of a structure does not immediately mean that the cause of a foundation subsidence or wall damage is directly attributable to an earthquake. In some cases, there are construction errors and even inherent defects. There was no financing made available for the homeowners to repair their own defects or construction errors, or to strengthen foundations, so the struts were left standing for long periods while arbitration was ongoing.

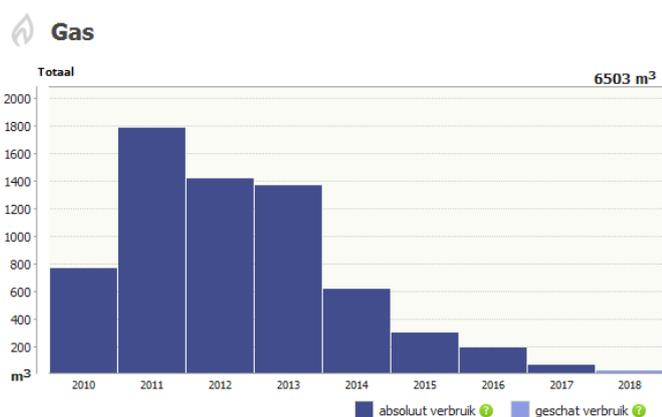
*Figure 97. Various types of sustainability were applied to a detached small house for 7 subsequent years (mainly thermal insulation, including PV), as a result of which gas consumption fell substantially. The gas use of the house is indicated in the graph. The average citizen does not have the funding for this.*

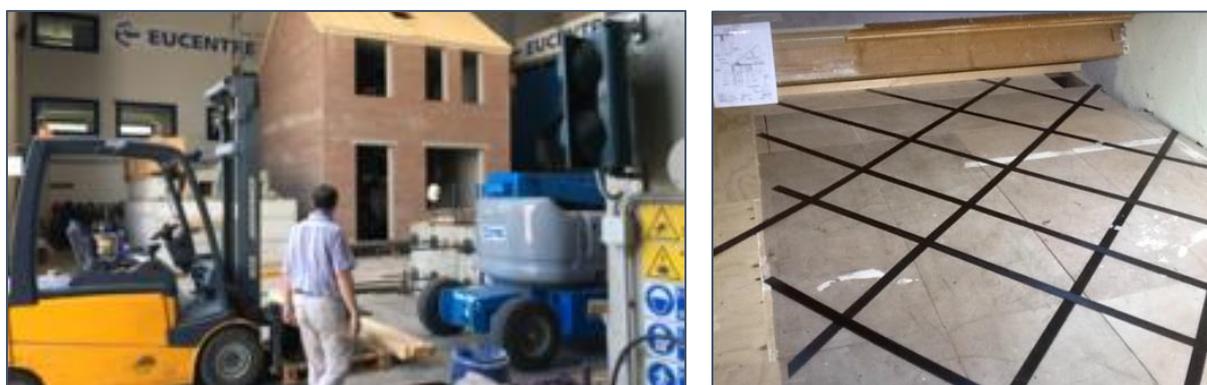
Figures 98. Left: A test house (reconstructed row house) was built in Italy on a vibrating table and subjected to series of tests.

Right above: Floor reinforcements were fitted in a purchased house to create floor diaphragms, holding the walls together.

In different types of houses in Groningen various seismic reinforcements were installed in test as a practical test and for demonstrations. These experiences made it clear to what extent these measures were practicable.

Right: The typical low working-class house.

The reconstruction and testing of these types of Groningen homes in Italy were very interesting contracts for the research organizations to calibrate the theory with reality and the very elaborate NLTHA method, but of limited relevance for the seismic strengthening of this type of old houses. In addition, the tests were carried out with earthquake loads that were many times stronger than could ever occur in Groningen, and with shock signals from tectonic earthquakes in Turkey.

The type of low worker's house (*photo figure 98*) is a common building type from over 100 years old that, because of its shape and layout, is highly vulnerable for seismic loads. By reconstructing the same in new masonry in Italy one overlooks the poor quality of the masonry of the original building, the modifications and extensions that often have occurred, while the one-piece shock table has little relation with the original masoned brick foundation on the clay soil in Groningen.

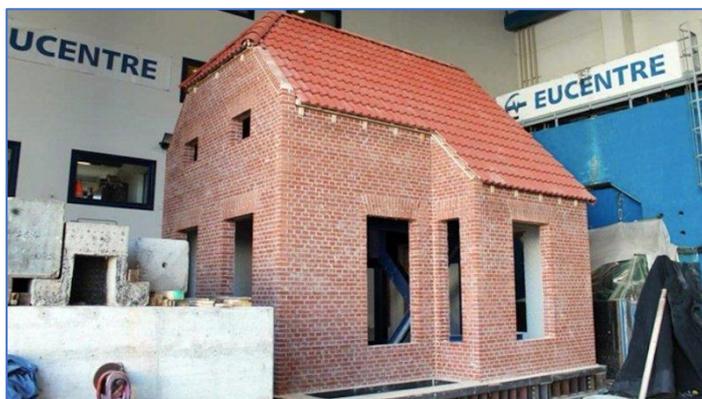
*Figures 99. When examining the test houses, it became clear that some wall sections were probably weaker than the standard calculations.*

*Left. Jointing is often not filled on the inside and over time there have been various facade adjustments. Right.*

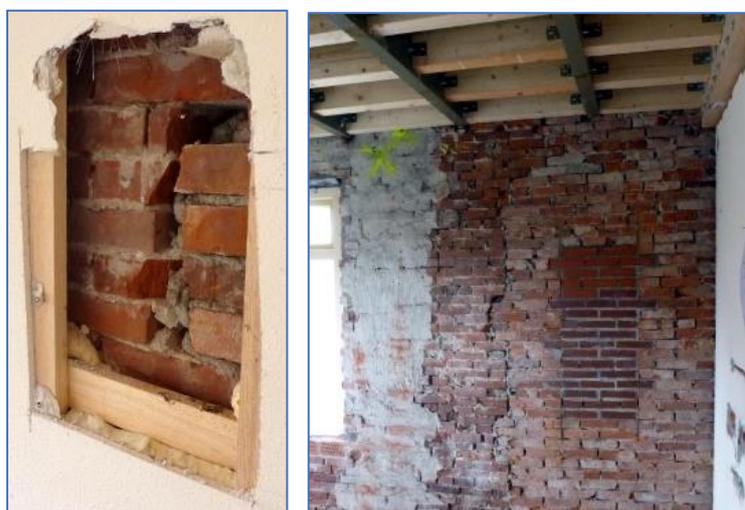
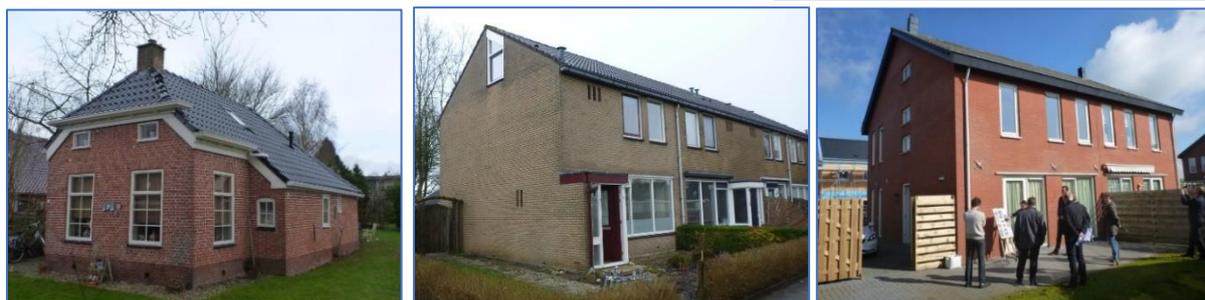
*Figures 100. Left. Old farmhouse. Middle. Terraced house from the 1970s. Right. One of the newer test homes. In these houses, the connections of the floor diaphragms to the outer shell were made or reinforced with different (experimental) new connection methods. The test homes provided insight into the practice of the measure and served also as an information and training location for designers and entrepreneurs.*

In one of these test houses, seismic reinforcements such as wall reinforcement and improved connections between floors and walls (diaphragms) were installed to test the feasibility of the different construction techniques and to evaluate the costs of installation. These test houses were also used to provide information to the press and residents about the possible options for reinforcement, with their advantages and disadvantages.

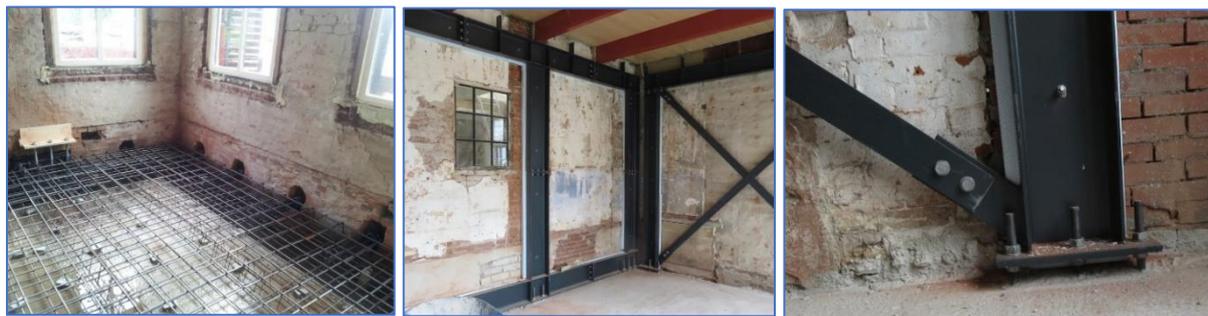
*Figures 101. In some test houses, a full (reinforced) platform foundation and extra heavy inner and outer wall reinforcements and diaphragms were applied in 2015 to withstand a PGAg 0.36 according to the NPR9998:2015 map. These integral reinforcement operations on old buildings usually cost twice more than the value of the entire house.*

The test homes were only used to improve the strength and coherence, but not to make the building more sustainable, such as reclassification of user areas or good thermal insulation. The extensive building reinforcements, including some Base-isolation projects, were undertaken as integral test activities to study to what extent the heavy building reinforcements were possible.

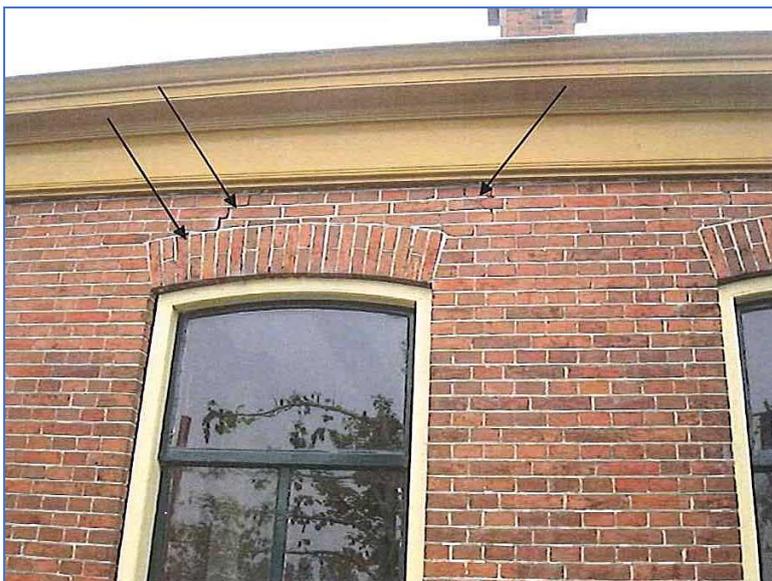
*Figure 102. Old buildings on firm soil and without a lintel construction often have stresses in the masonry due to settlements. These stresses can increase with additional vibrations and discharge into visible cracks.*

*Lateral pressure from a round masoned window arch in combination with a higher side load on the piers can cause the piers to move sideways/outwards.*

As a result of subsidence and settlement of foundations, elastic stresses will arise in walls. Those built-up stresses can still result in crack damage in the event of additional vibrations or earthquakes. The cracks that then become visible are claimed as earthquake damage, when in fact the previously built-up stress in the wall due to natural subsidence by other causes may have been the main cause. It is also possible/likely that the many small non-human-sensed vibrations since 1970 generated by the gas exploitation have accelerated the settlement of foundations.

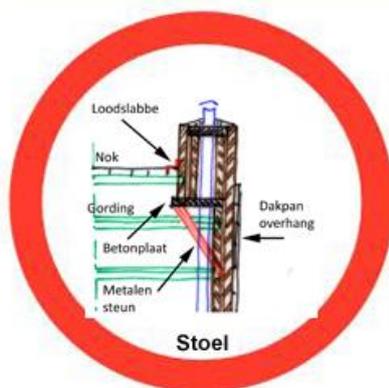
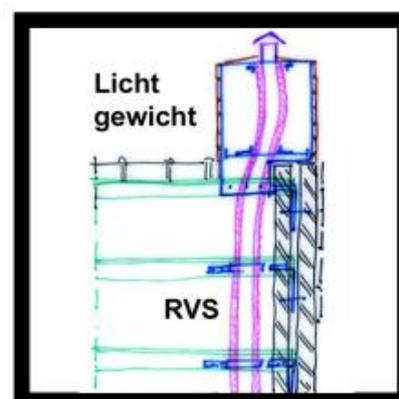
*Figures 103. Left. Heavy brick chimneys on flexible wooden roof constructions and gable ends on thin walls are particularly risky. (RED)*

*Right. A lightweight chimney. The masonry top facade and its anchoring remain problematic, which is why this second sketch does not have a blue frame.*

An unsafe situation (in relation to earthquakes) is a situation that, in the event of additional or multiple shocks or more severe earthquakes, can lead to building components falling off or buildings or building components (e.g., chimneys) collapsing or floor and roof structures collapsing.

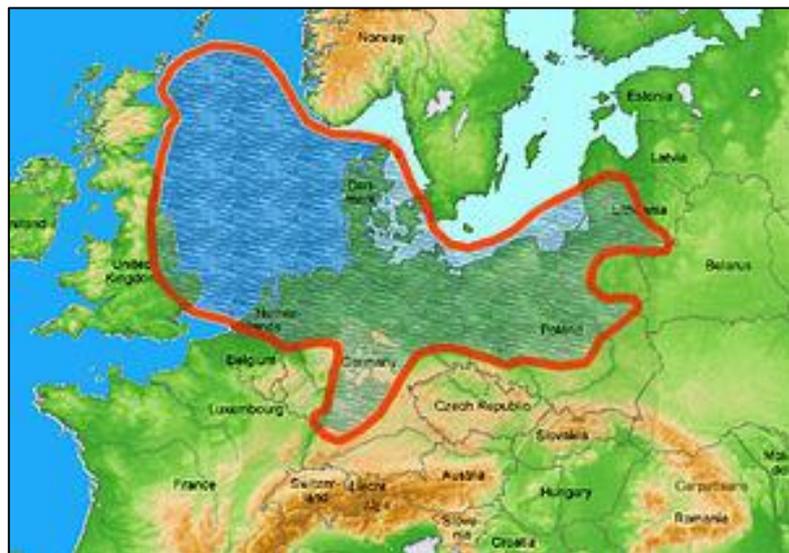
*Figure 108. (Internet) The Zechstein see was a shallow inland sea that stretched across what is now north-western Europe about 260 million years ago. (Wikipedia)*

*During the millions of years of the Earth's hot period, the water in this sea evaporated, creating a salt deposit. So far, the Groningen gas field is the largest that has been found under the Zechstein. Many small gas fields have been found under the North Sea area.*

Zechstein translates to 'Salt stone'. This base layer is hard and tough at the same time and therefore has no internal fracture surfaces. The Zechstein under Groningen is on average about one km thick (sometimes with large bulges in places) and trapped the methane gas in the underlying sandstone layer, which originally came from the lower Carboniferous layer under The Netherlands, Germany, Poland and the North Sea.

It is possible that these thick salt stone ridges influence the direction and strength of the earthquakes. Due to the hardness and toughness of this salt layer that lies above the gas-containing sandstone, it probably causes a shorter vibration during earthquakes than in the areas where this salt layer is deeper. It can also result in a spread in time of compaction settlements in that sandstone.
